# Architectural Restoration and Seismic Strengthening of Gönpa Gang

U.S. Ambassadors Fund for Cultural Preservation, Award No. SNP40022GR0039

**Final Project Report, April 2025**

**Norbusum Foundation (NGO)**

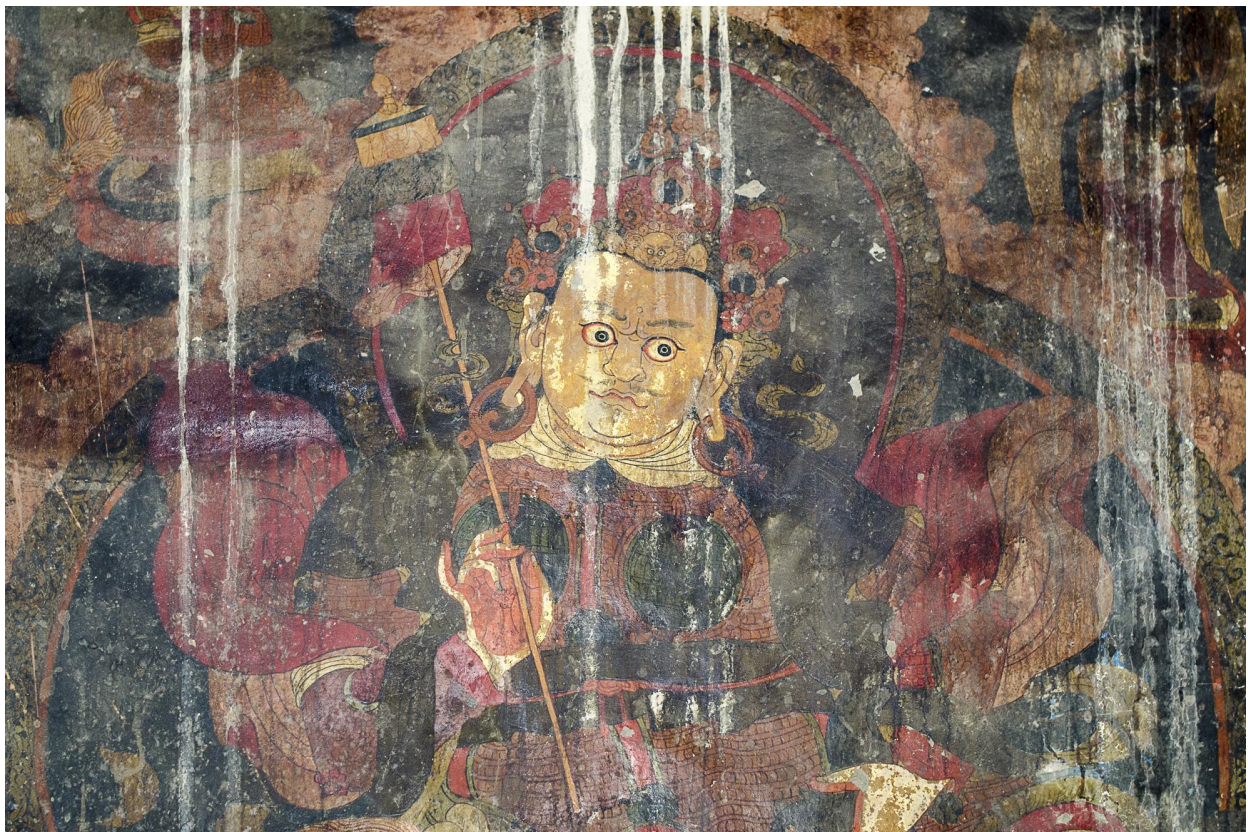
Figure 5: The murals of the temple have suffered considerably over time. This depiction of the wealth deity Vaiśravaṇa in the Assembly Hall demonstrates the original quality of the paintings, but also their damages.

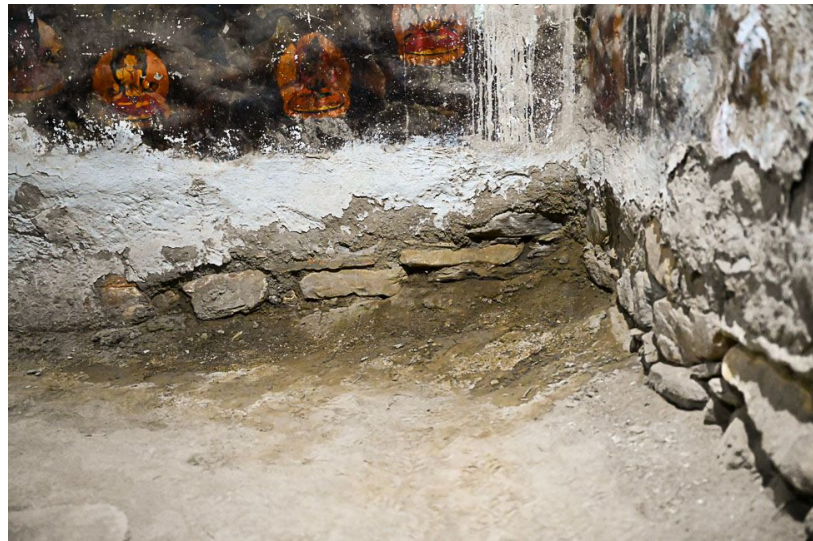
The acuteness of the project was demonstrated in early October 2022 when unusually heavy rains at the beginning of October did affect Gönpa Gang. A simple structure to the right-hand side of the building's entrance has partially collapsed (Figure 13) and it was said that the crack on this side of the wall got bigger. Further, inside the Assembly Hall, in the niche behind the big Maitreya Buddha image, water entered the interior of the building.

*Figure 14: Water entered the building behind the main Buddha image as seen on October 15, 2022 (in the gallery this photo is replaced by one from October 20, as the original could not be found).*

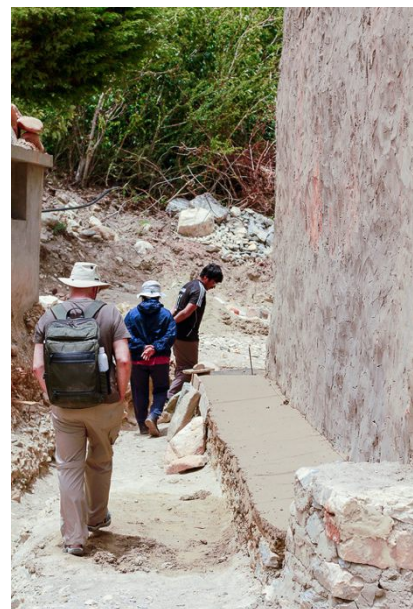
The clearing work revealed that the structure was erected with a very weak foundation, a new issue that needed to be addressed during the restoration. After analyzing the condition of the foundation around the building and identifying potential risks (damages

*Figure 60: The most precarious area in the northwestern corner of the building.*

and distress) and weaknesses, we concluded that it is necessary to build a continuous stone wall adjacent to existing foundation to increase the stability of the walls.

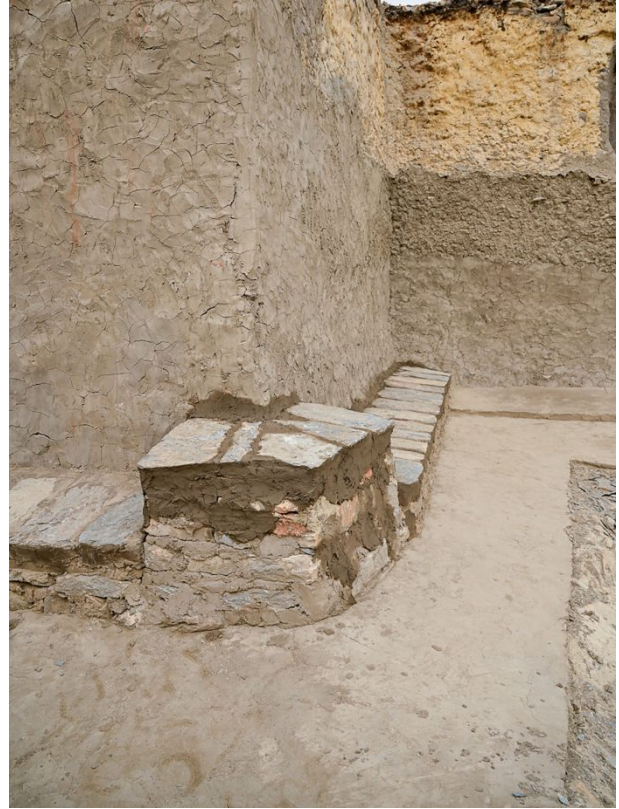
At the southwest corner of the apse a buttress stone wall needed to be constructed to consolidate the corner. The wall at this corner was rather weak with loose stones.

Figure 68: At one corner a higher buttress was built to make it more stable.

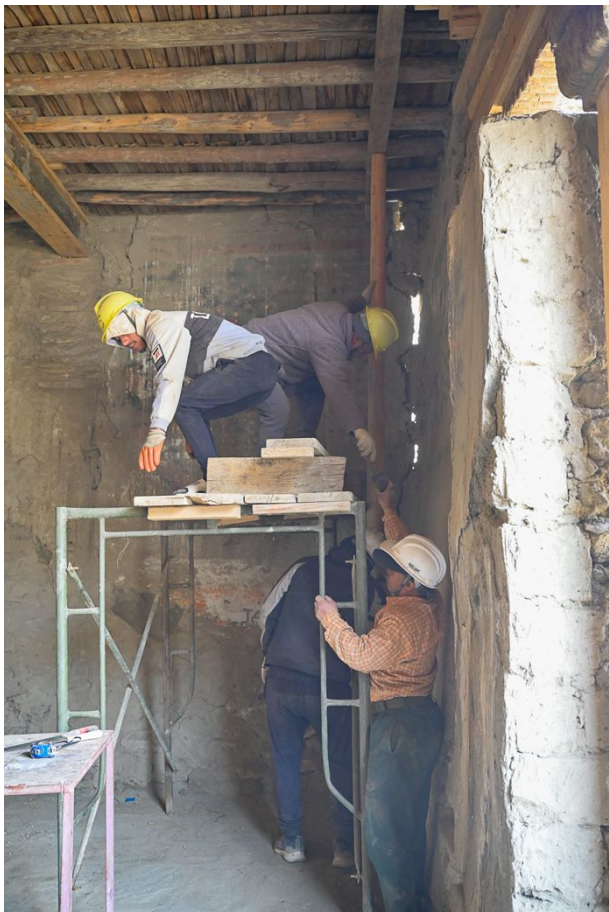
An issue remaining from the first year's work was a major crack in the northeast corner of the Entry Hall. Since the crack appeared to have expanded during the restoration, more than just a repair was needed to tackle this issue. On the ground floor the inner walls are covered with murals, these walls therefore could not be touched. Instead, it was decided to take down a larger section of the corner of the balcony room above and rebuild it in a way that ties the two corner walls together, and in this way prevents the crack on the lower floor to widen.

Figure 122: Supporting the cross beams of the northeast corner on the ground floor level.

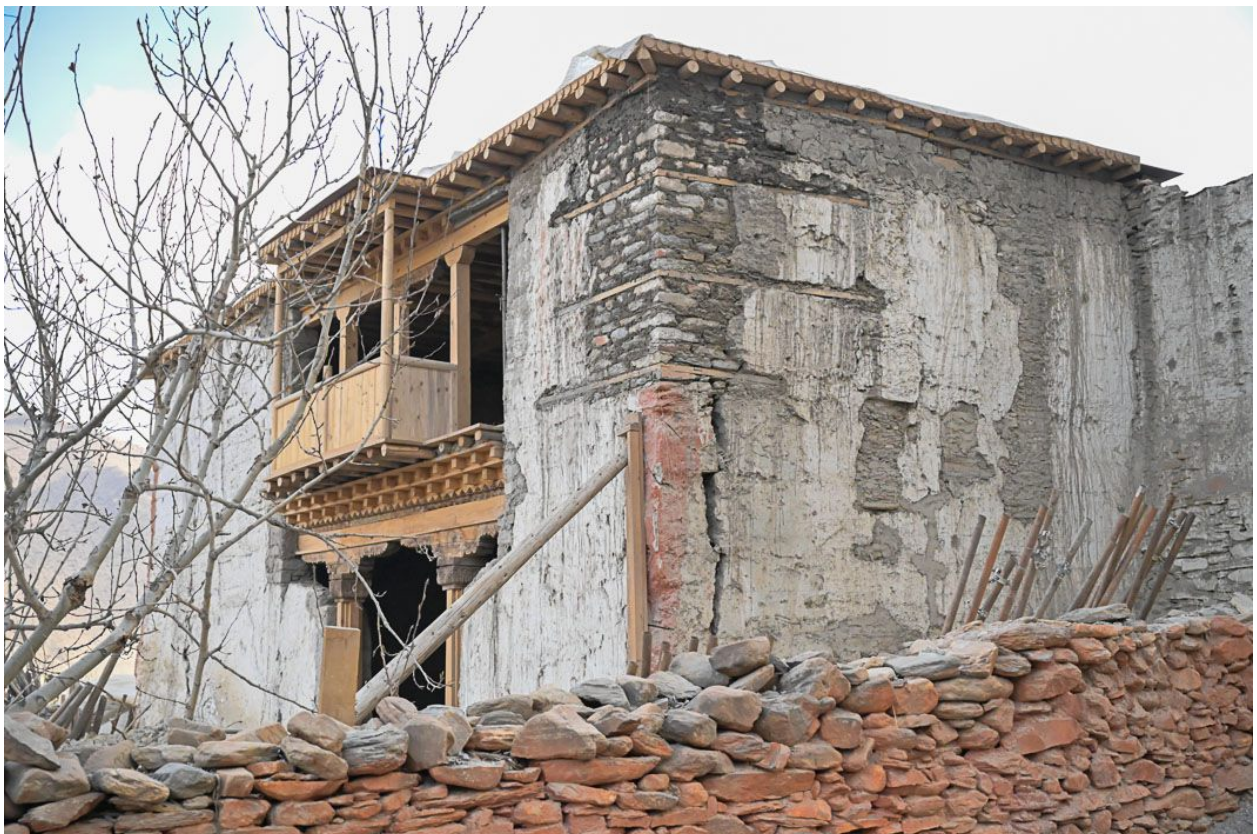
*Figure 128: The northeast corner after reconstruction, the crack still visible on the lower floor.*

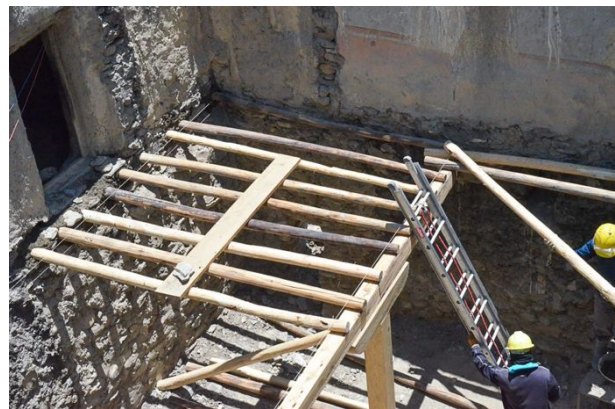
*Figure 136: While some of the original joists could be reused, many had to be replaced.*

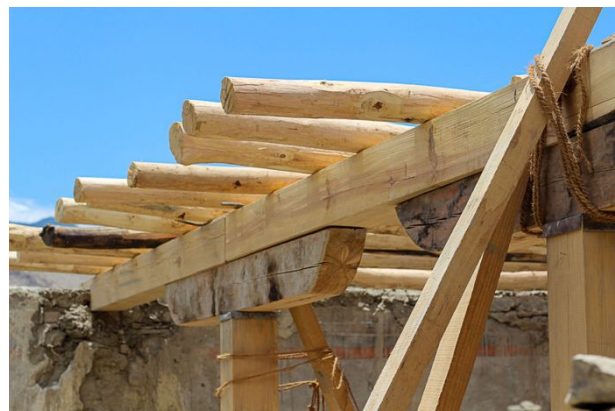
Figure 140: A few exceptions aside, the joists of the top floor needed to be replaced throughout.

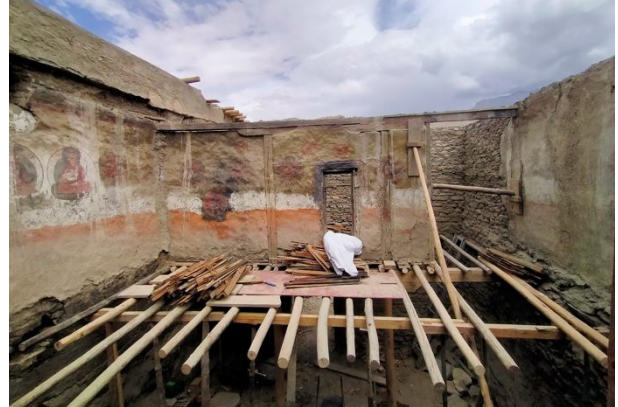
Figure 175: The painted room with the new beam under the painted wall installed.

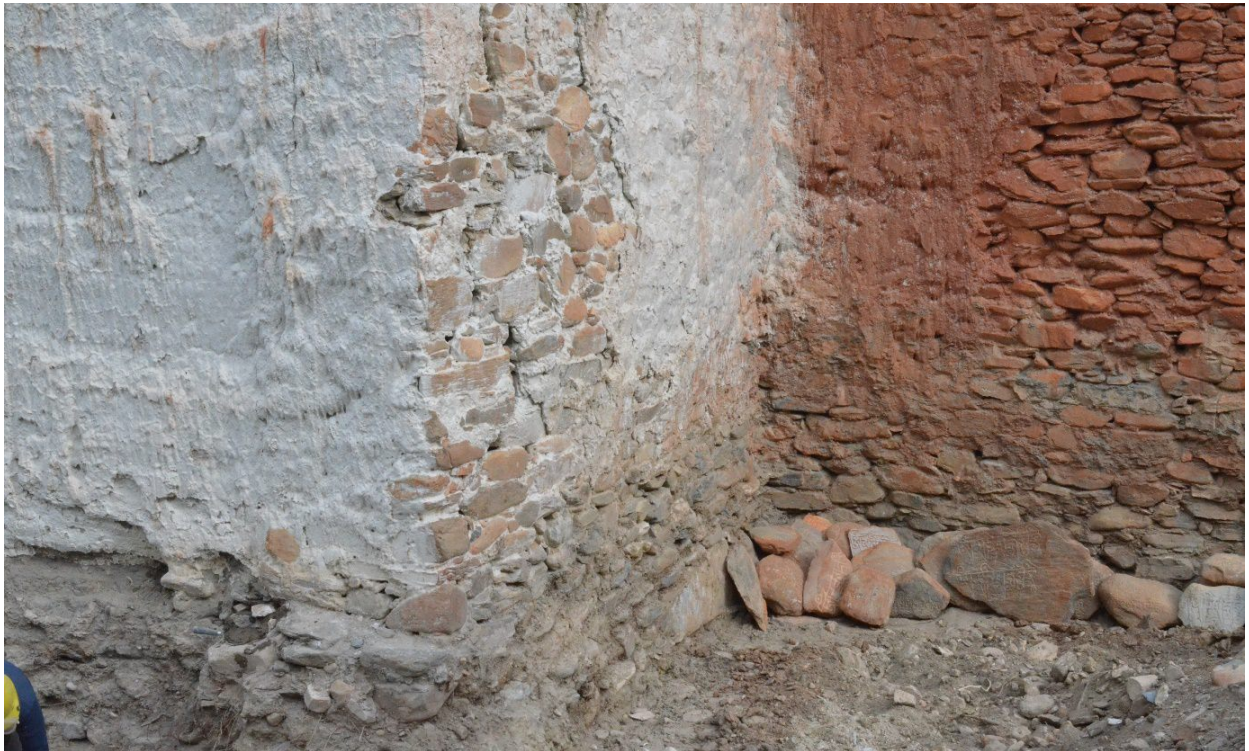
*Figure 190: View of the northwest corner with the wall cracked and bulging.*

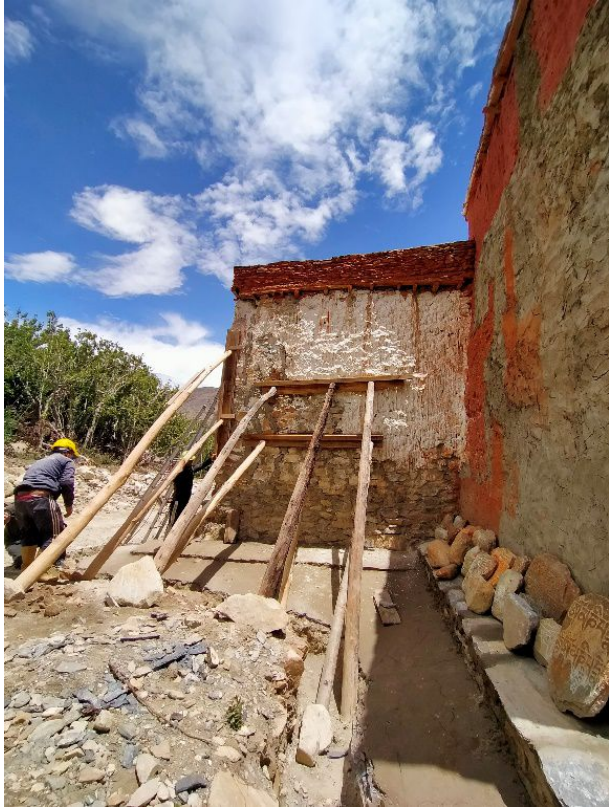
*Figure 191: First the wall was shored up to prepare the dismantling from the top.*

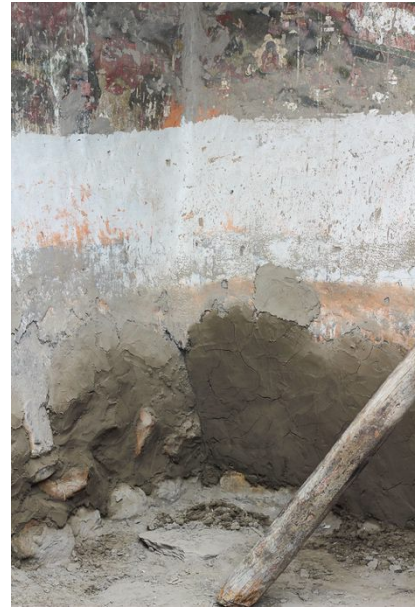
Figure 206: In the interior of the Entry Hall plaster losses were repaired as well.

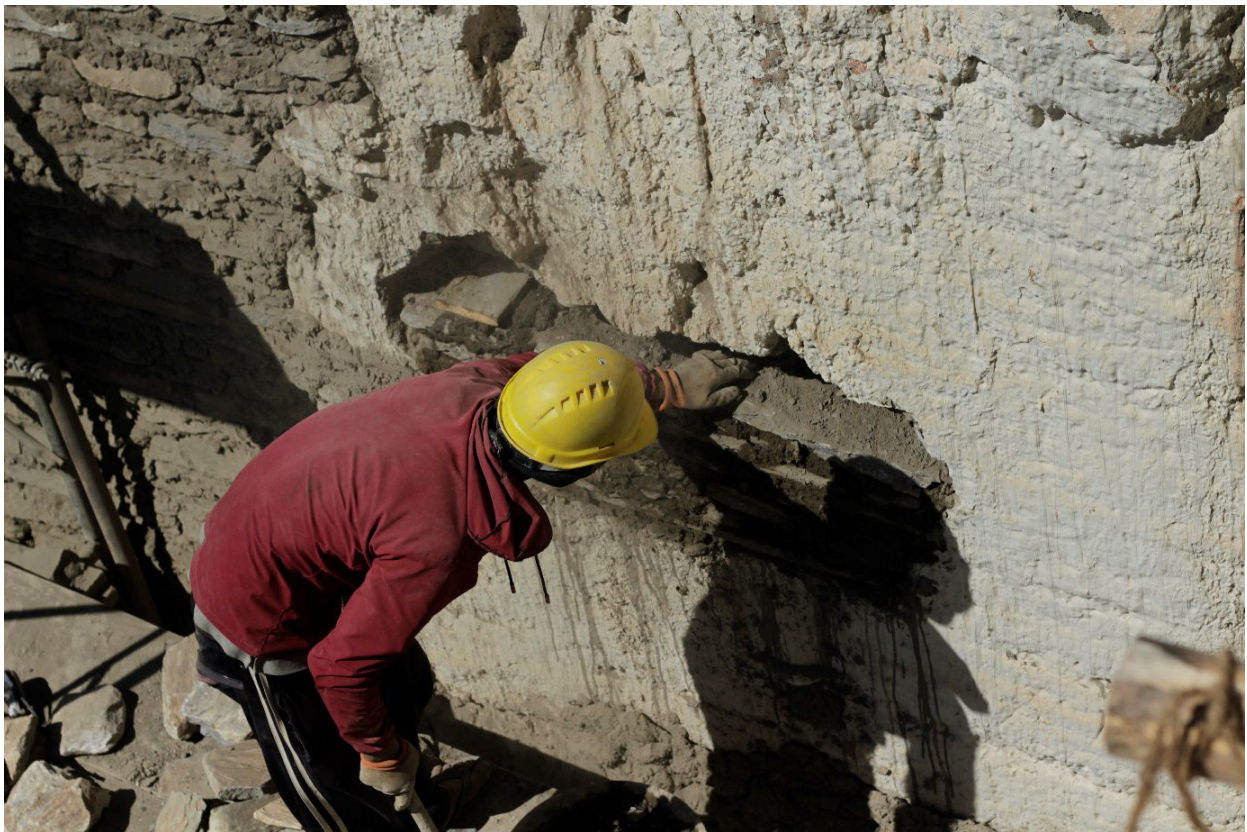
*Figure 208: View from top during the repair of a stone wall showing wooden members to connect the repair to the original wall.*

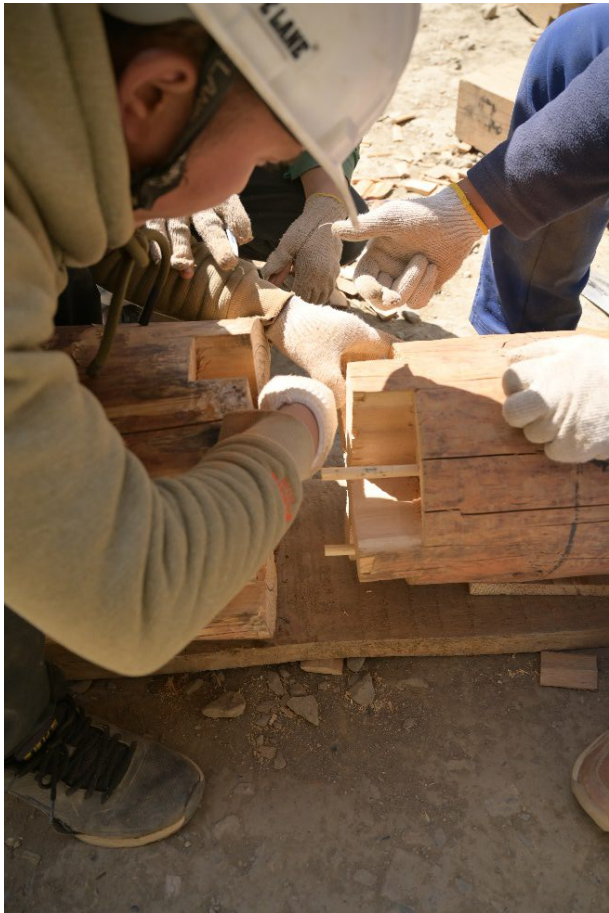
Figure 250: Once the structure was taken down the rotten bottom parts of the pillars were replaced.

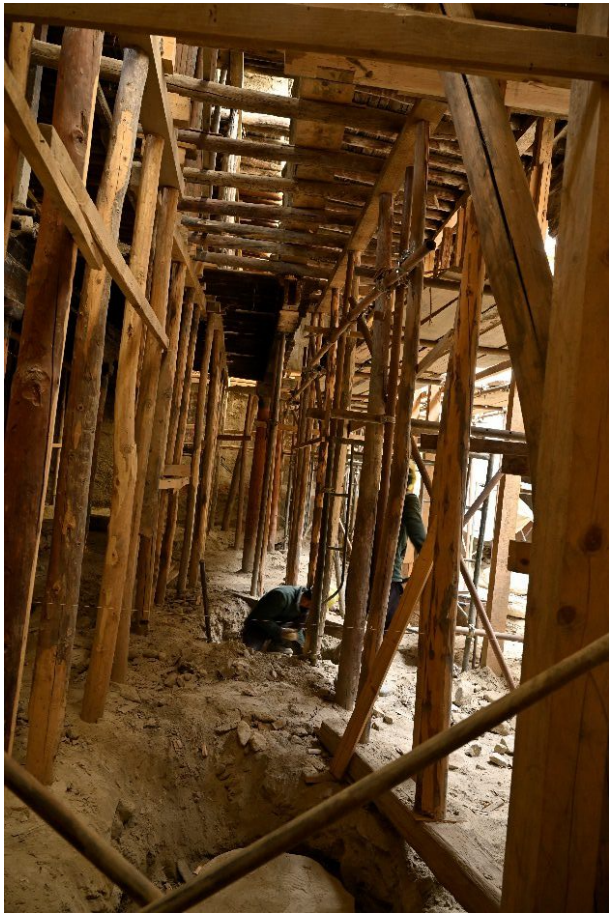
*Figure 287: The temporary support structure underneath the painted wall with the original pillars removed.*

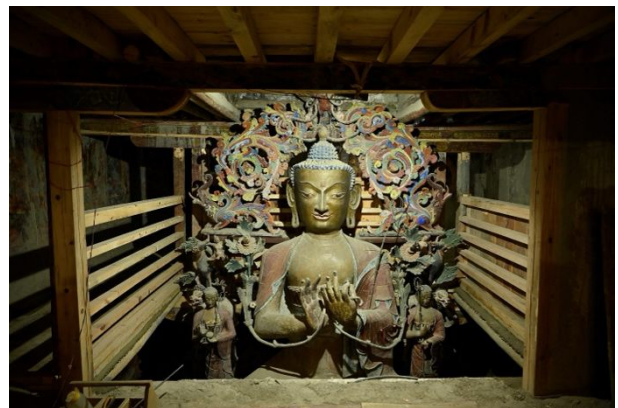
Figure 387: The Buddha image after the restoration of the broken beam and the frame around it.
