# Seismic Strengthening and Restoration of Lo Gekhar

U.S. Ambassadors Fund for Cultural Preservation, Award No. SNP40020GR0042

**Project Report, Second Year, Fourth Quarter – July to September 2022**

**Norbusum Foundation (NGO)**

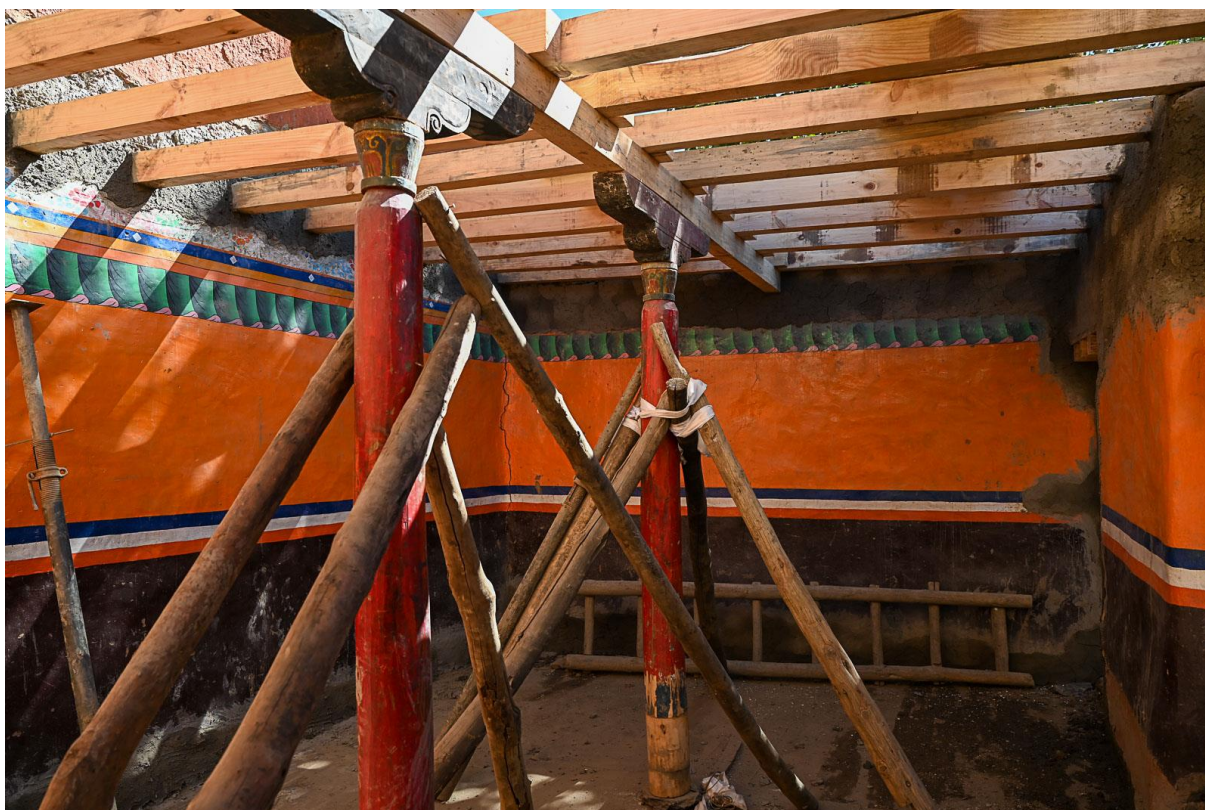
*Figure 1: The so-called VIP room after removing the roof and replacing the joists.*

In the room that has mainly been used to accommodate VIP guests—hence its name—the damaged round beam and the joists were completely replaced with square ones, while the carved and painted columns and capitals were reused (Figure 1). The low door was replaced with a larger one.

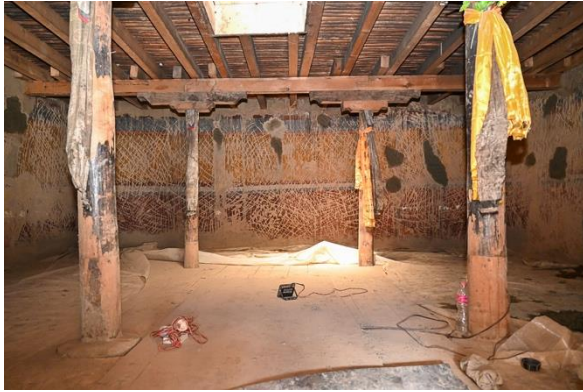
*Figure 2: The Upper sanctum with the walls patched and scratched to hold the new plaster.*

In July and August all temple spaces on the upper level, including the Upper Sanctum, were plastered. This work was done by a specialist local craftsman from Lo Monthang using plaster clay sourced from his home area. In preparation to the plastering the walls had to be scratched and uneven and loose areas had to be patched (Figure 2, Figure 3). Then plaster was applied to all areas and smoothed (Figure 4). The rooms still need to be painted.

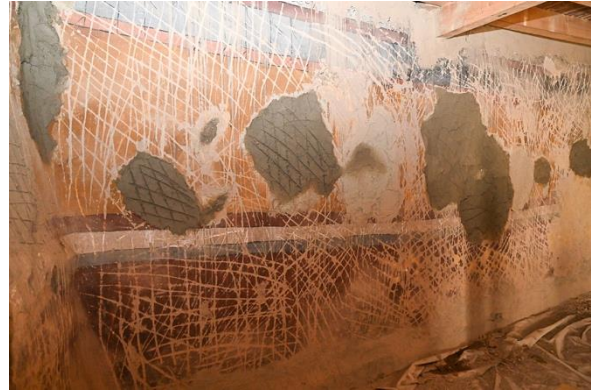
*Figure 3: Detail of the patching and scratching to support the new plaster.*

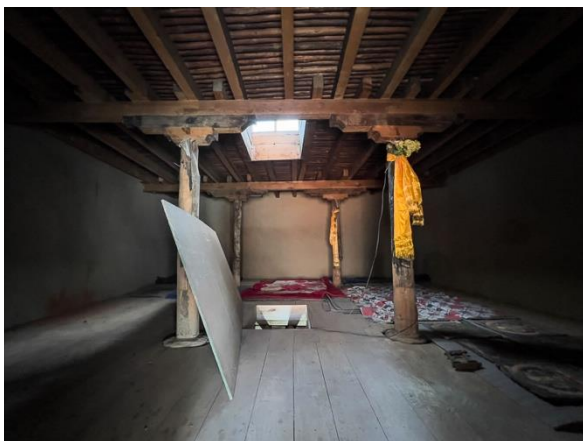
*Figure 4: The upper sanctum after plastering with the stone panels stored on its floor.*

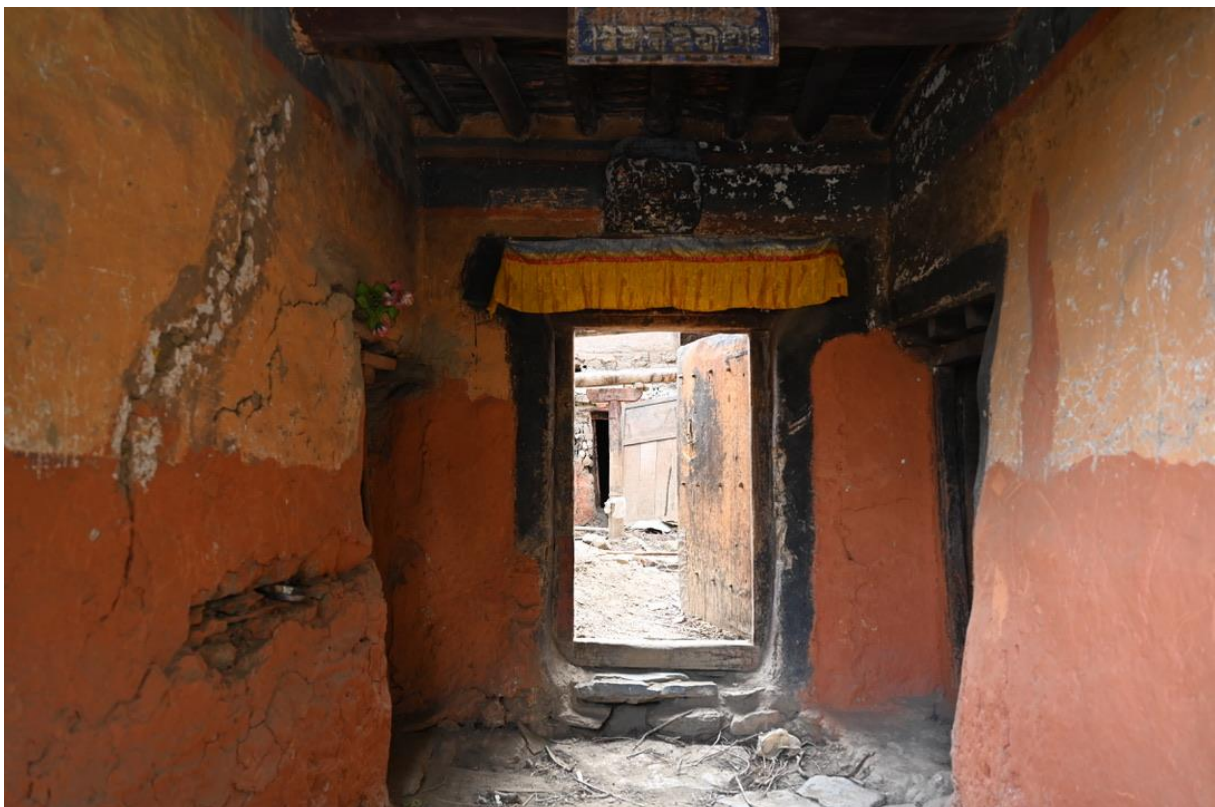
*Figure 6: View of the main entry before restoration.*

The entry to the caretaker's mansion had to be reinforced to support the superstructure above (Figure 6).

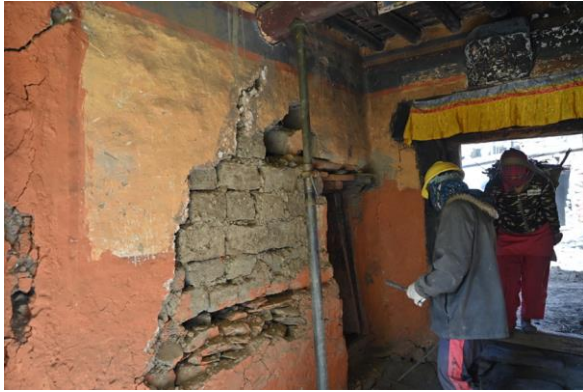
Figure 7: Left side wall before restoration, showing the stress cracks and poor foundation for the mud bricks.

The walls below the main beam had severe stress cracks which were reinforced by introducing slates and replacing the cracked sections with new mud brick walls (Figure 8, Figure 7).

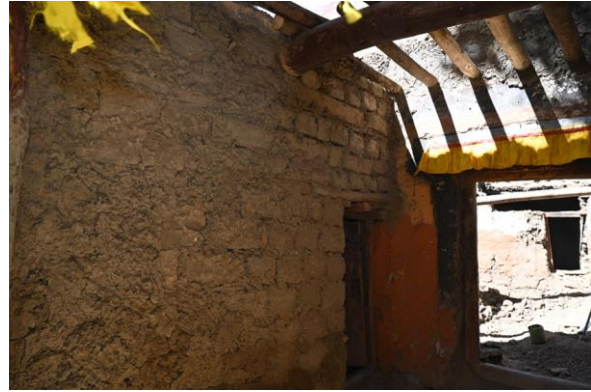
Figure 8: Left side wall after rebuilding during the restoration.

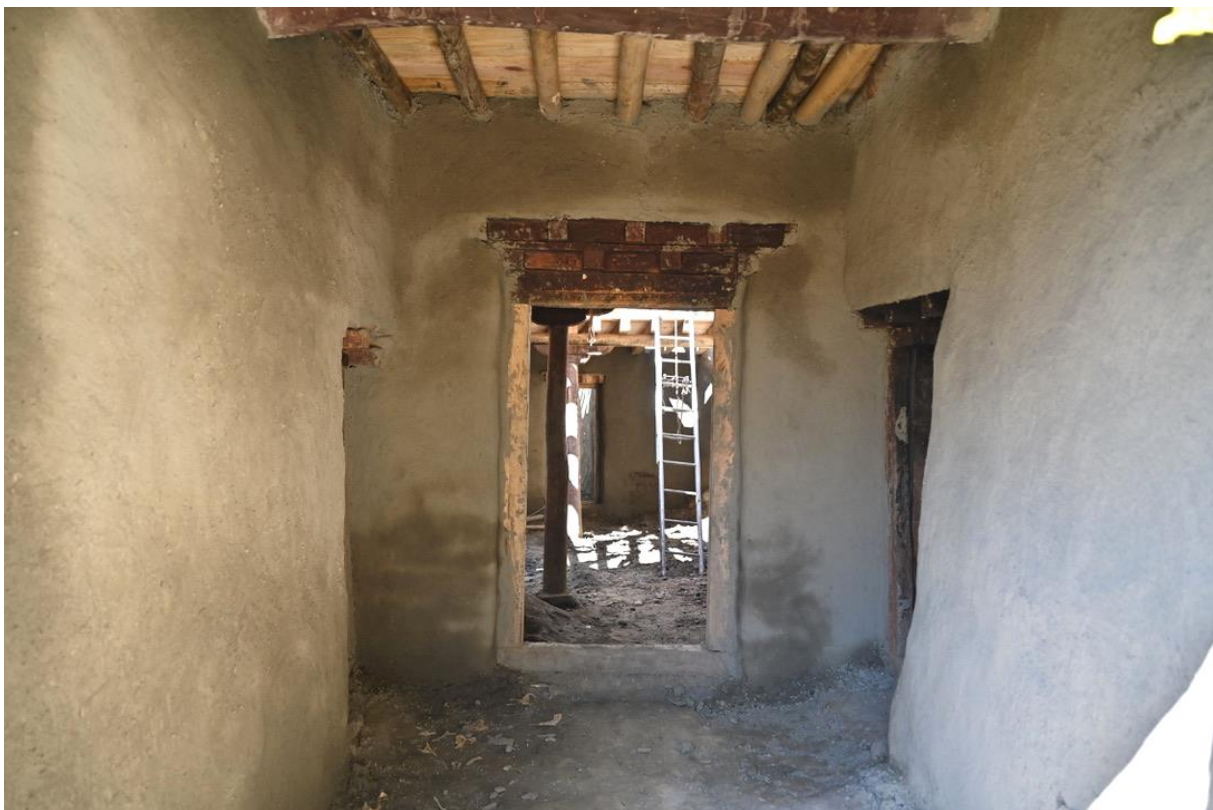
Figure 9: The main entry after the restoration of the walls with the top of the original door reused.

with longer ones to increase the door's height for convenient access to visitors and pilgrims. Other door parts were retained and restored to their original form (Figure 9).

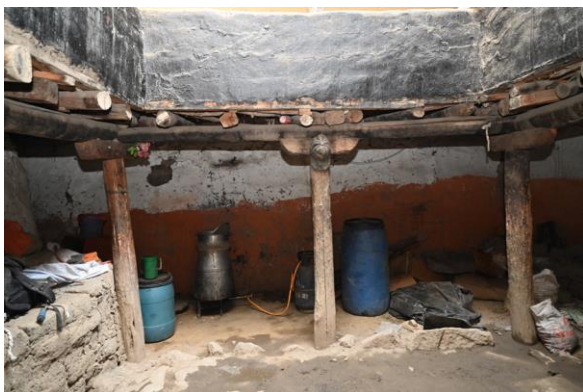
The overall height of the lower floor atrium was incredibly low (Figure 14), therefore it was planned to increase its height by lowering its floor level to that of the entrance area. Thus, the stone pavement was removed, and the floor was dug to that level, which unearthed piles of animal waste that had accumulated there over the time. The atrium had previously been used as shed for horses and to shelter the horse of the local pilgrims and visitors.

*Figure 14: East side of the lower atrium with its short columns before restoration.*

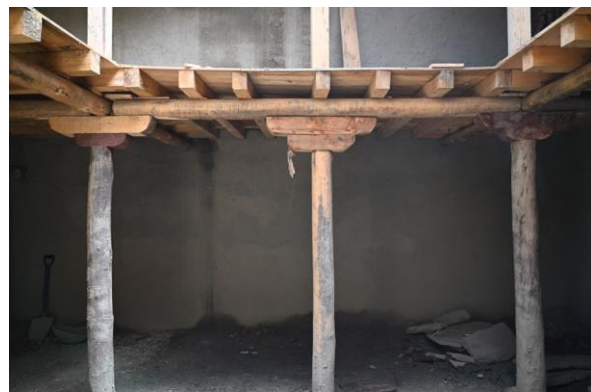
*Figure 15: The east side of the lower atrium with double capitals and longer columns after restoration.*

The now too short and damaged columns and capitals were replaced with stronger salvaged ones (Figure 15). Similarly, the main beams were replaced with new round ones. The floor was paved with flat stones locally sourced from Marpha.

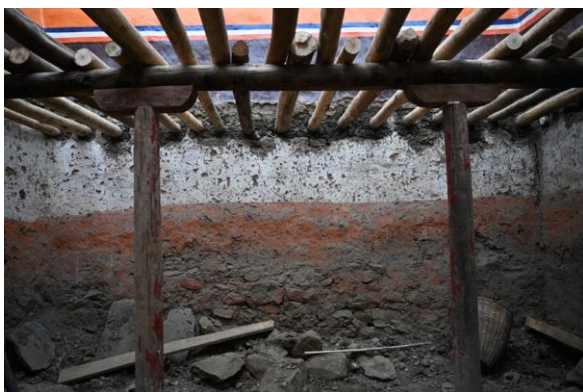
The wall underneath the main beam had stress cracks which were reinforced by installing stone slates inside the wall. The damaged columns and capitals were replaced. The joists had earlier been placed at considerable distances, which were reduced overall by the addition of several new joists (compare Figure 17 with Figure 18).

*Figure 17: View into the storage room with new joists introduced.*

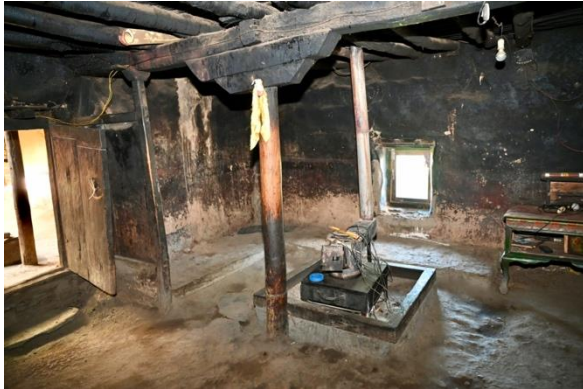
The dismantling of the roofs on the caretaker's kitchen side resumed after the front section was completed. The beam, column and joists were not reusable. So, they needed to be replaced by new ones. Accordingly, the old wooden structure was redone

*Figure 31: The caretaker's kitchen before restoration.*

with new square beams and joists. A new window with two panels now replaces the damaged old one. The mud floor has also been replaced with a wooden floor which was installed on a frame filled with clay.

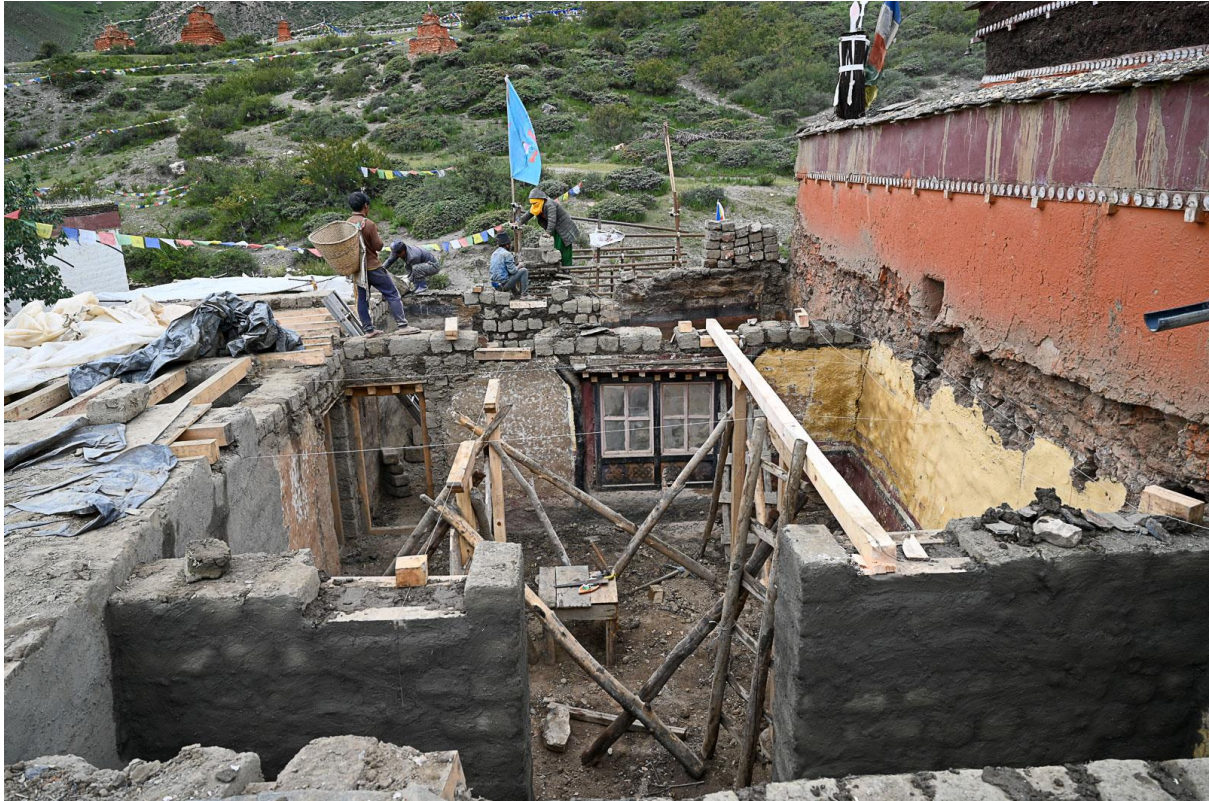
*Figure 35: Restoration of the guest room with the higher walls flanking the entrance and the installation of the new beams.*

Due to their weight, the raised mud brick platforms along the walls on which the mattresses were placed were removed. The old columns, beams and joists have been replaced with new square ones. The walls on the entry side, which did not reach up to the ceiling level, were increased in height with mud bricks, and an entrance was built in the middle of the wall. These walls now support beams and joists (Figure 35).

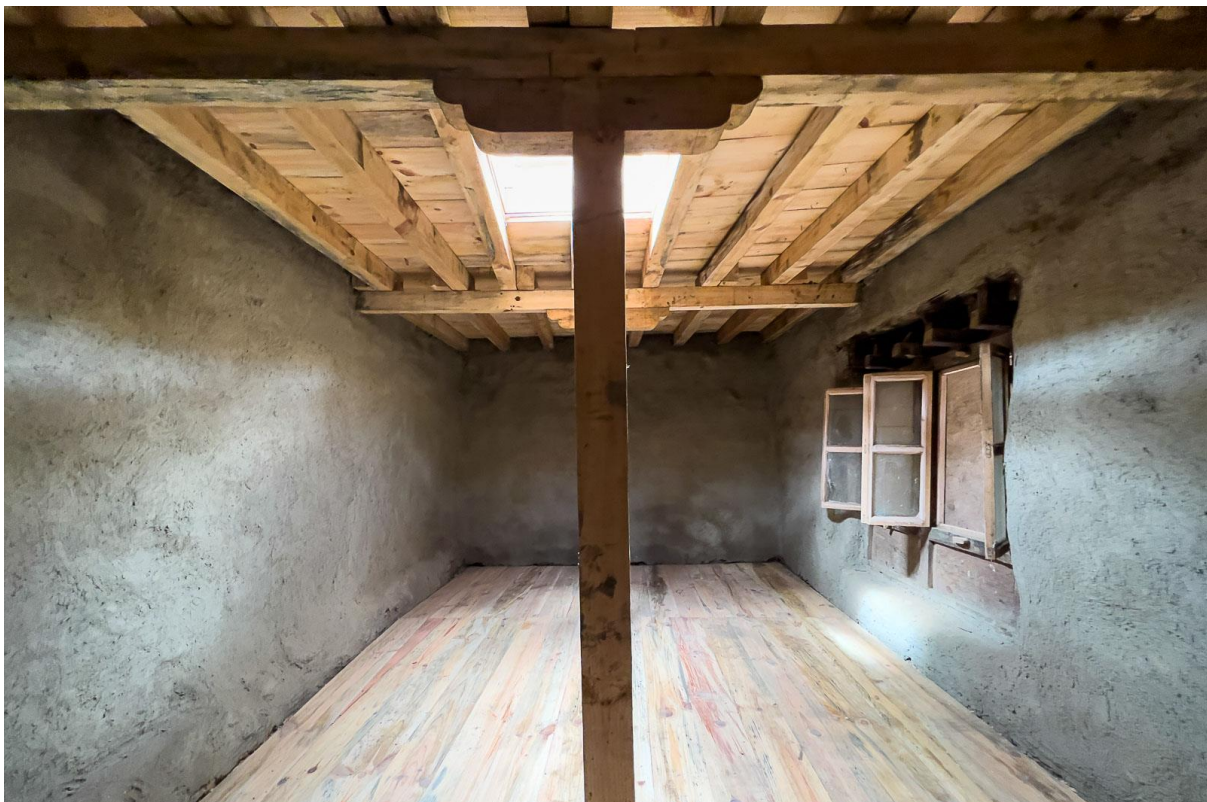
The west side of the wall had cracks at several sections, some of which were see through. These cracked sections were demolished and rebuilt with new mud bricks and reinforced with horizontal wooden boards. The damaged round beams, joists and columns were completely replaced with new square ones. A new skylight replaced the old one, and now enough natural light can enter the room. Again, the skylight was constructed as a square wooden frame covered by a poly sheet.

*Figure 38: The restored retreat room with skylight and its original window linking this room with the guest room in front of it.*
