# Restoration of the Murals of Dzong Monastery, Mustang, Nepal

Final Report; July 1, 2025 – October 31, 2025

**Norbusum Foundation (NGO)**

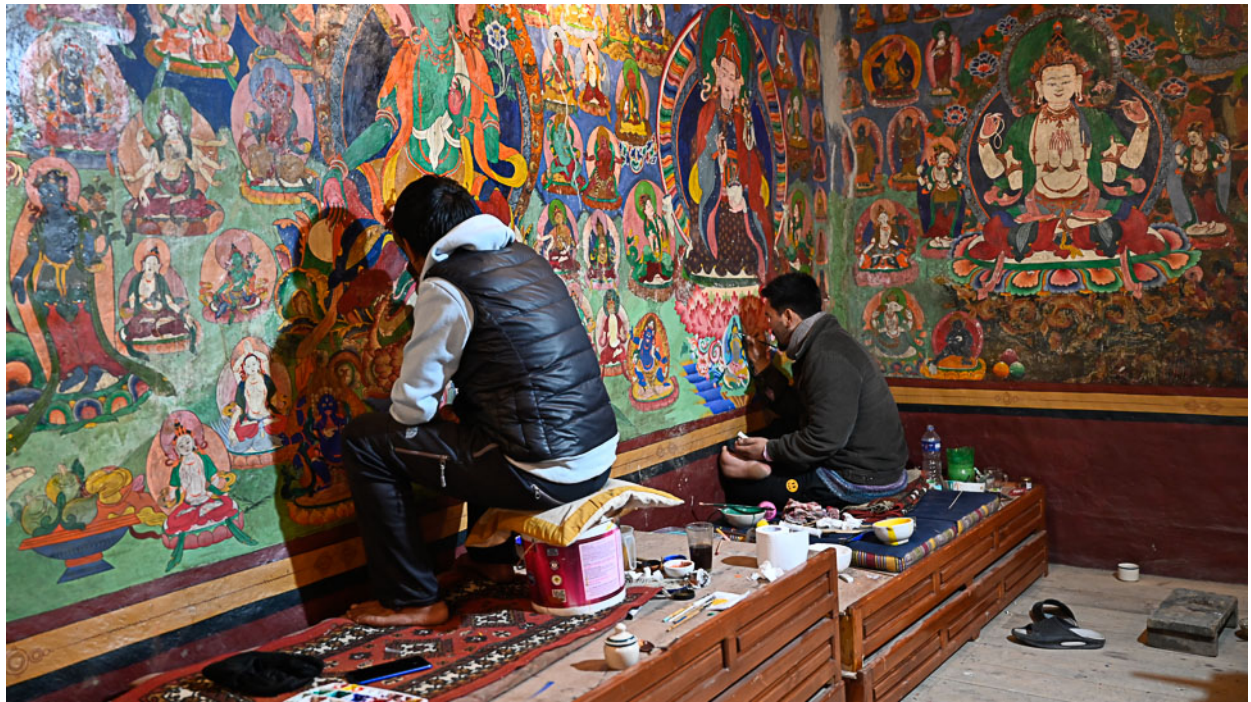
*Figure 1: Two of the painters complementing lost sections on the entry wall.*

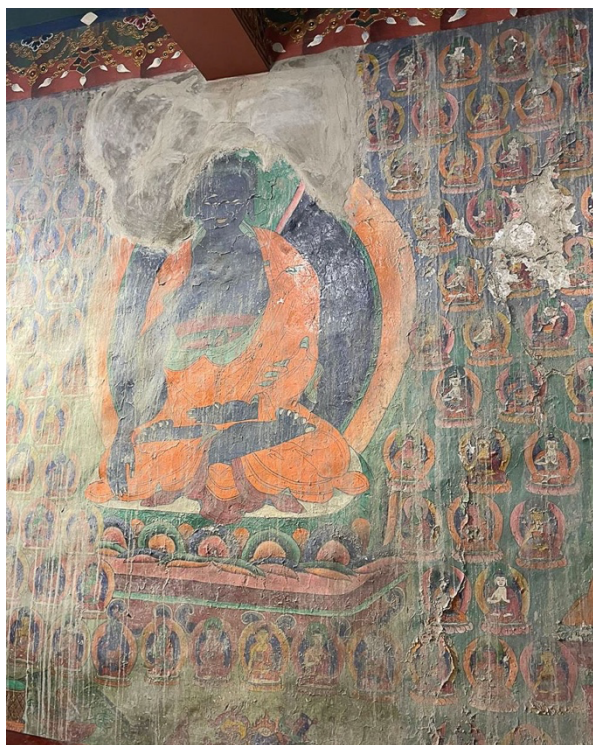
*Figure 3: Buddha Akṣobhya prior to the restoration work.*

The murals on the main wall sections to the sides of the niche, featuring two Buddhas on each side, were covered with clay throughout and thus in worse condition than any of the other murals. In the case of Buddha Akṣobhya this included the loss of a painted area underneath the beam, flaking murals and water streaks (Figure 3). Here, the cleaning and consolidation undertaken in phase one already had a major impact on the appearance of the murals (Figure 4).

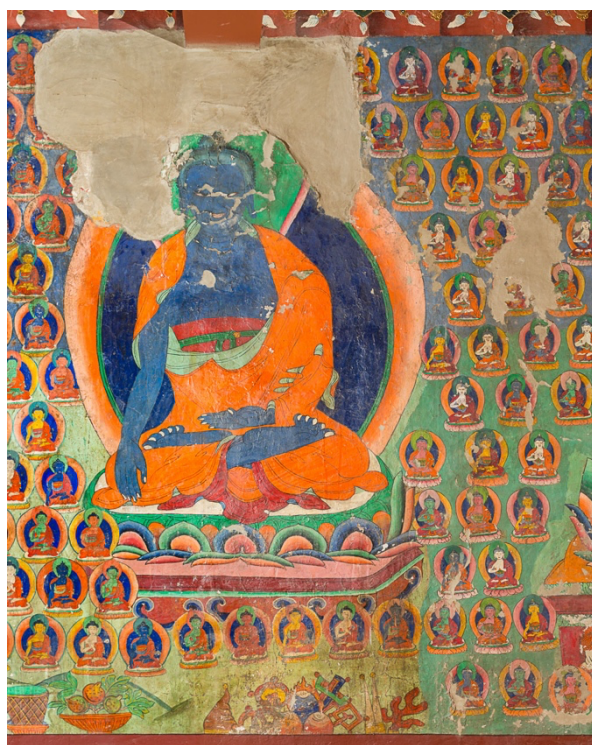
*Figure 4: The same section with Buddha Akṣobhya after consolidation of the paint layer and cleaning.*

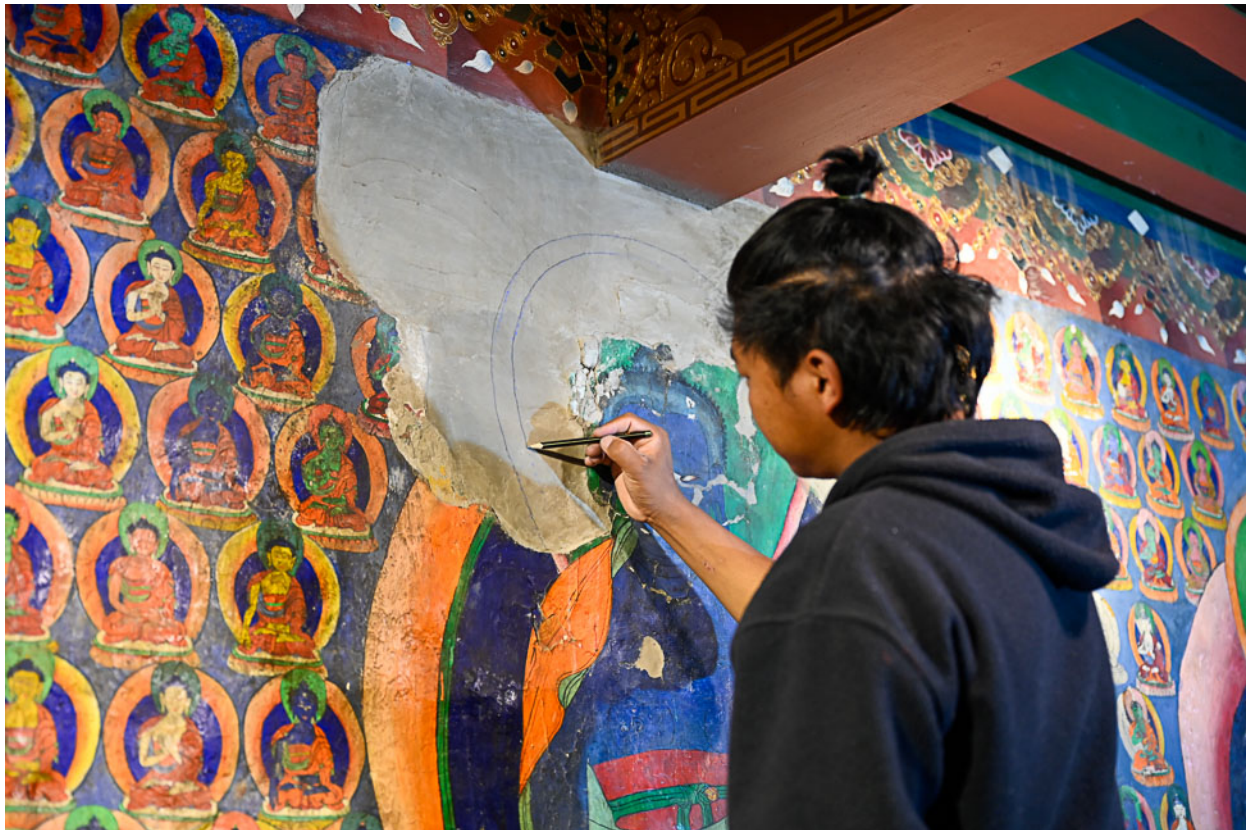
*Figure 5: Outlining the halo of the Buddha.*

Phase 2 then focused on restoring the areas around the Buddha's head that had been lost. The new paintings were first outlined, then gradually painted in, with the colouring adjusted to that of neighbouring areas. Thereby, the small Buddha images around the halo had to be reconstructed in the same style as the extant ones. Final adjustments assured the integration of the new murals with the old ones. The following images document different stages of this process and conclude with two views of the final appearance.

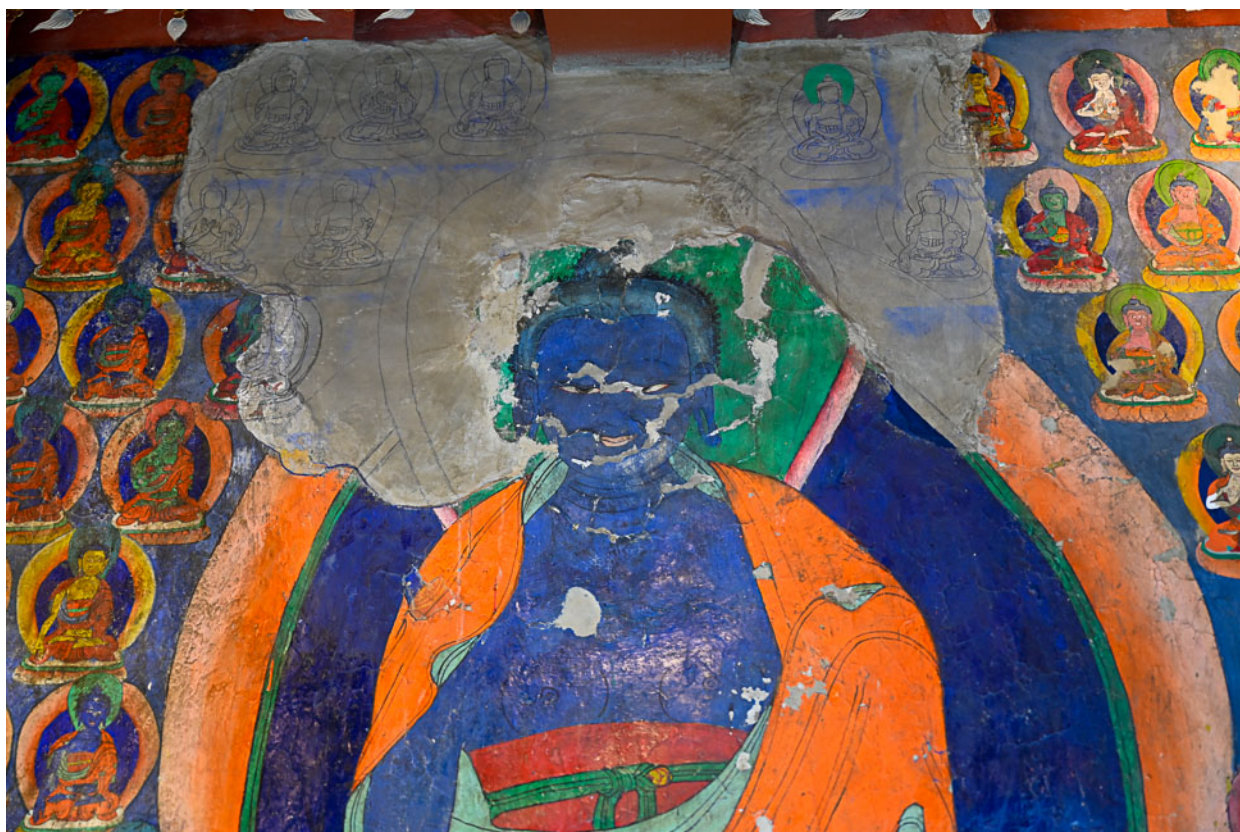
Figure 6: The outlines now include the Buddha images around the halo.

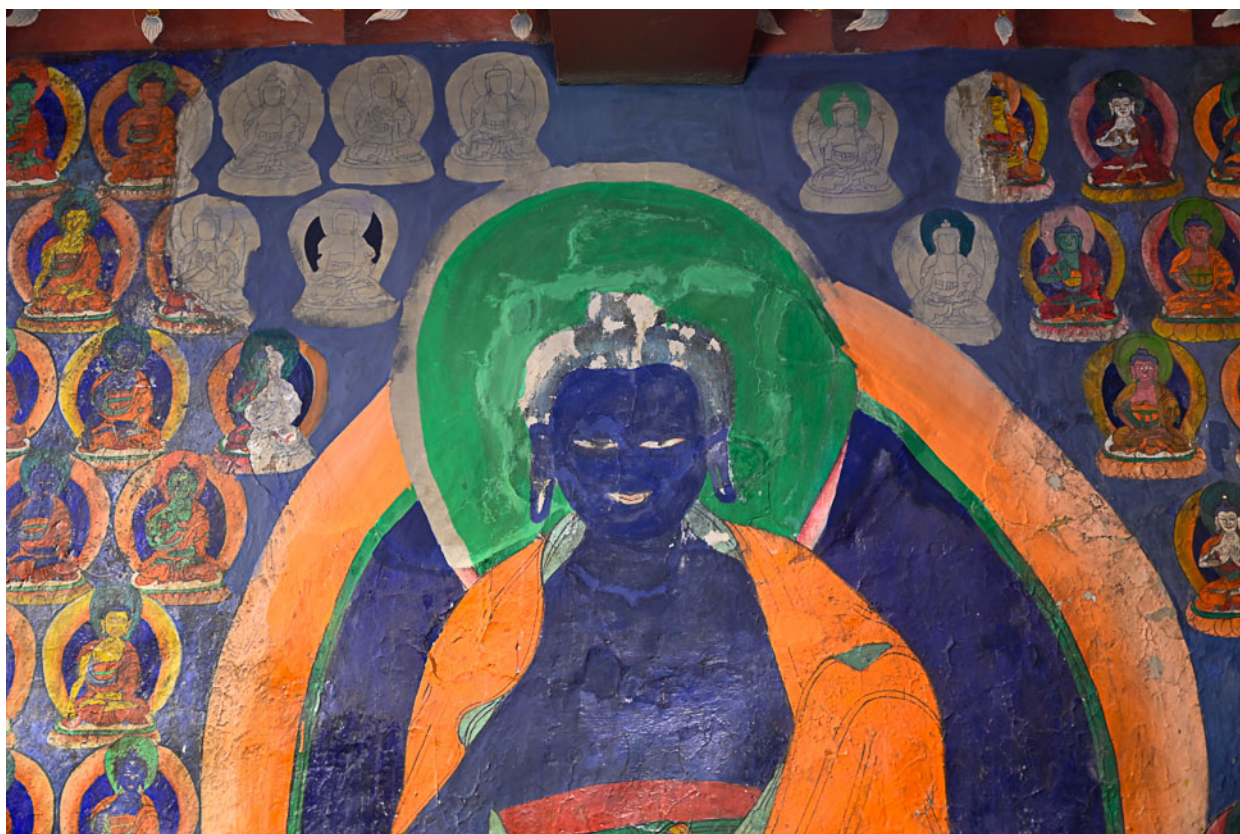
Figure 7: The same are with the background painted in.

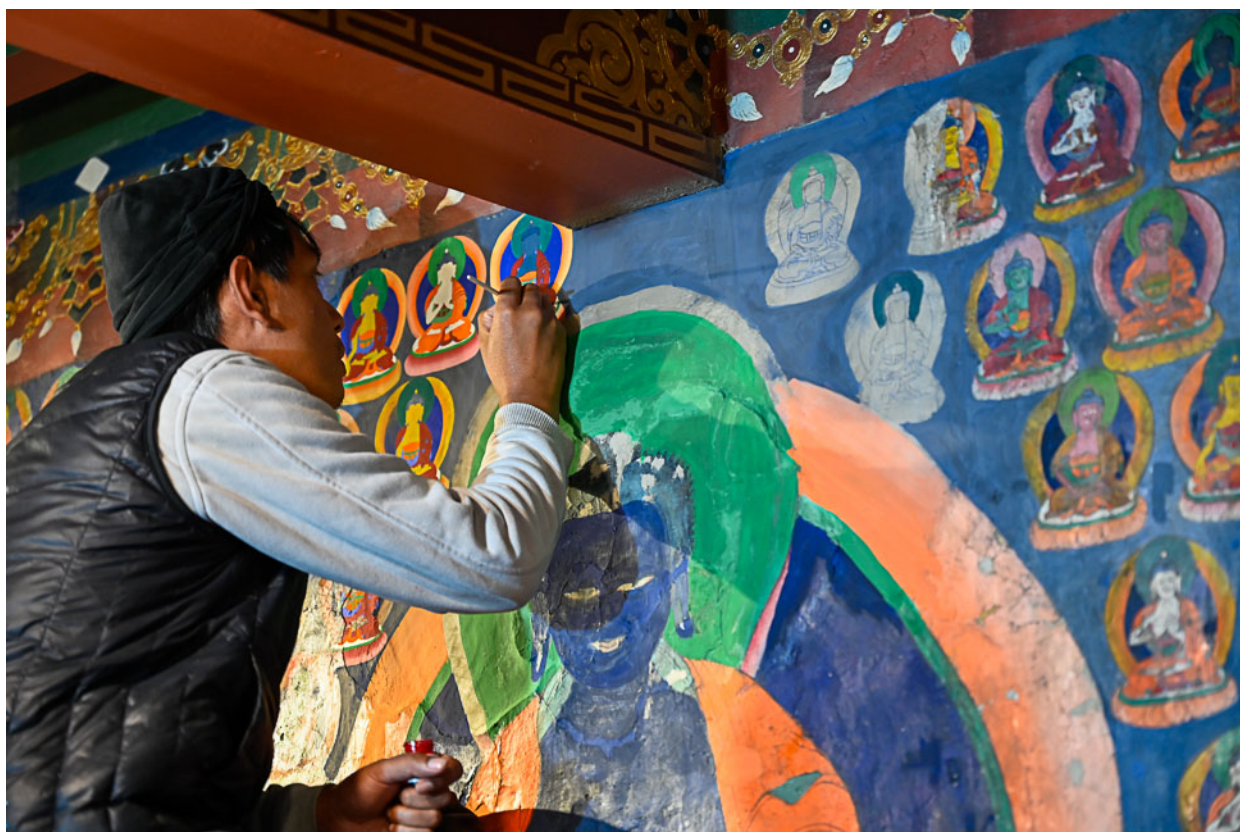
Figure 8: Painting the surrounding Buddha images.

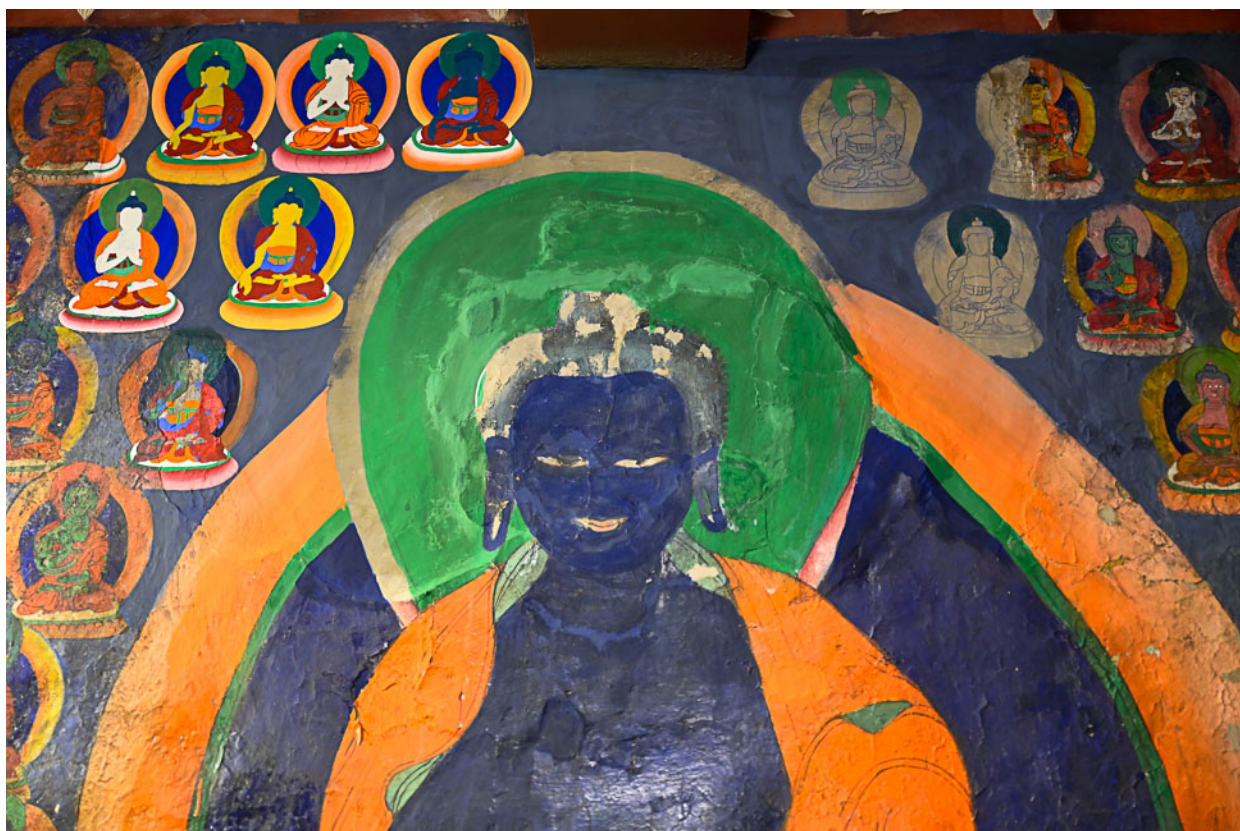
Figure 9: The same area with the surrounding Buddhas partially painted.

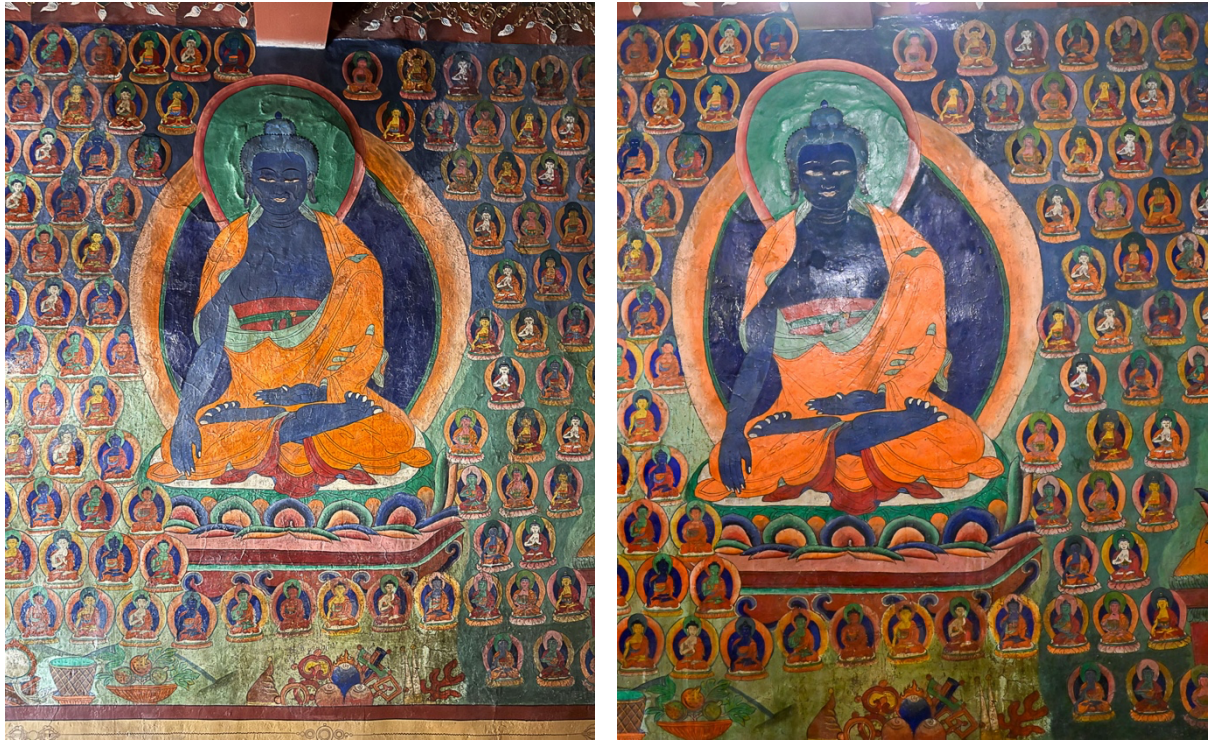
*Figure 10: Two views of Buddha Akṣobhya after the restoration work was completed.*

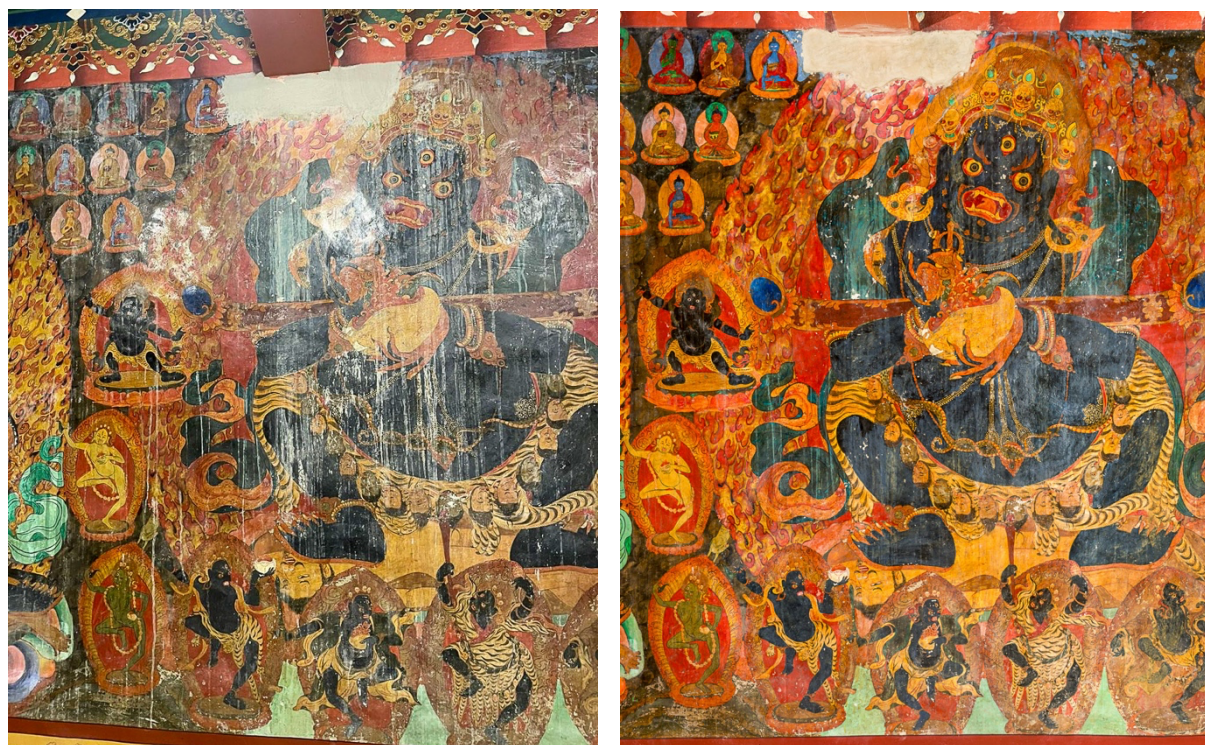
Also the sections of the protective deities on the entry wall were covered with streaks resulting from water intrusions. Above Pañjara Mahākāla there was also a lost section of his flaming mandorla. Again, consolidation and cleaning improved the murals' appearance considerably, and the lost sections were painted in.

Figure 11: Pañjara Mahākāla before and after cleaning; some of the white spots in the left picture are reflections.

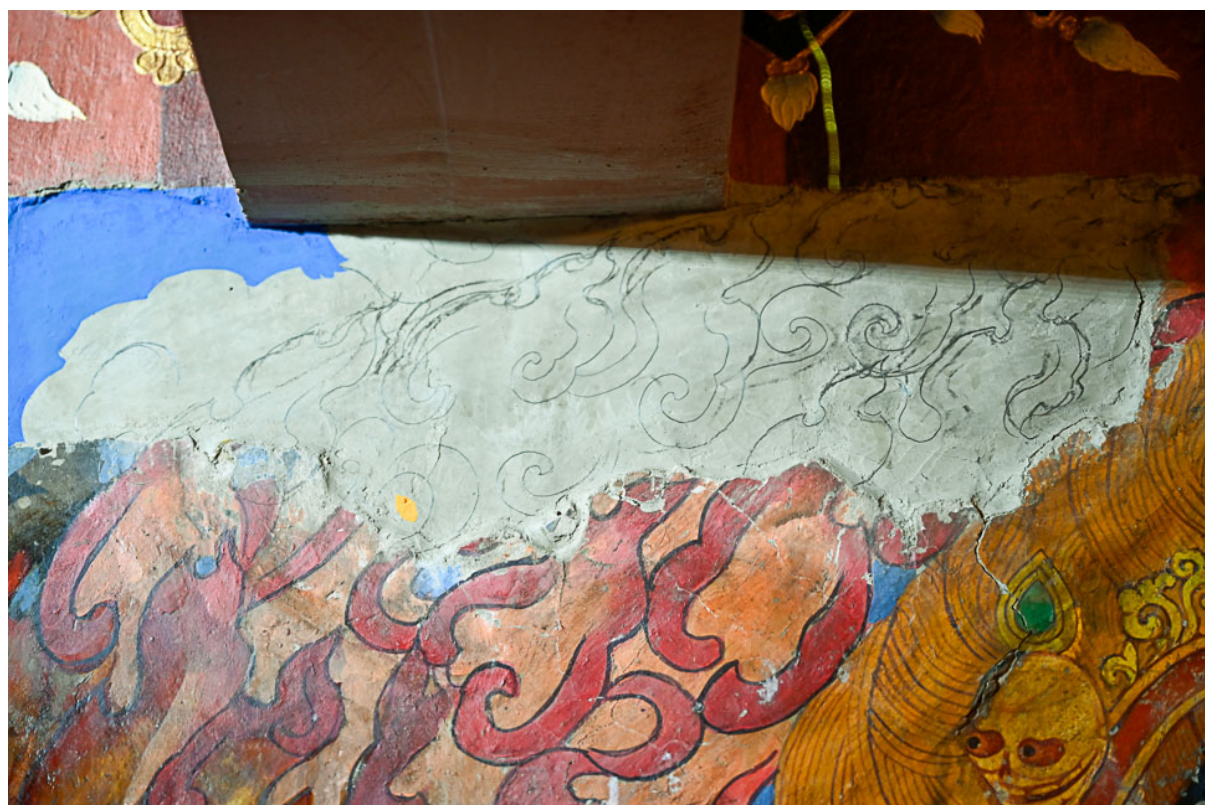
Figure 12: The area of the loss with the flames drawn.

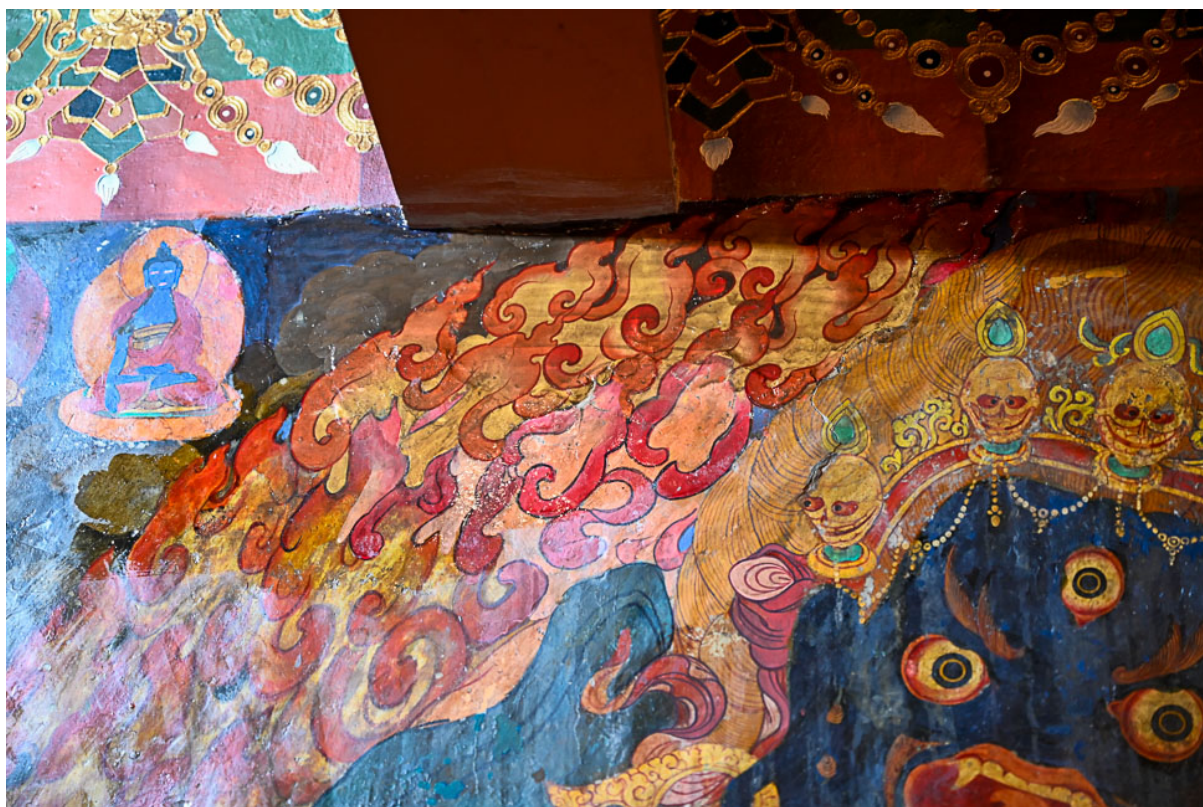
Figure 13: The area of the loss with the Buddha image and the flames painted in.

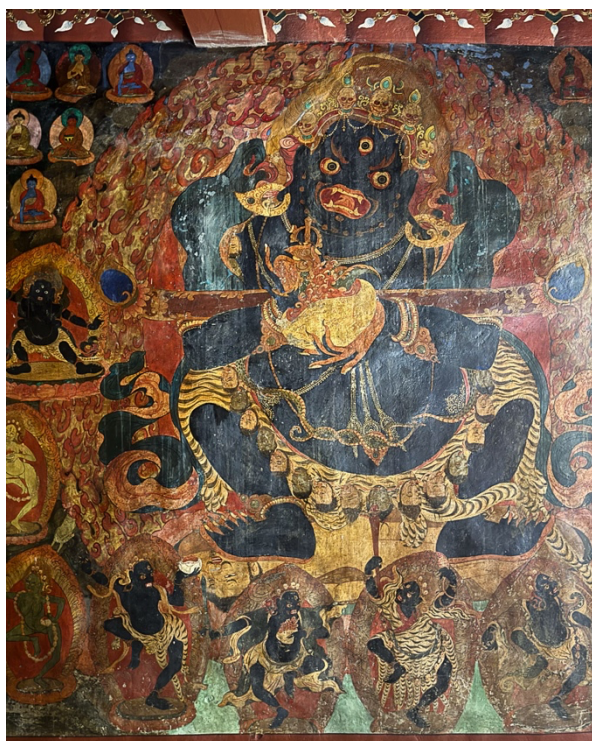
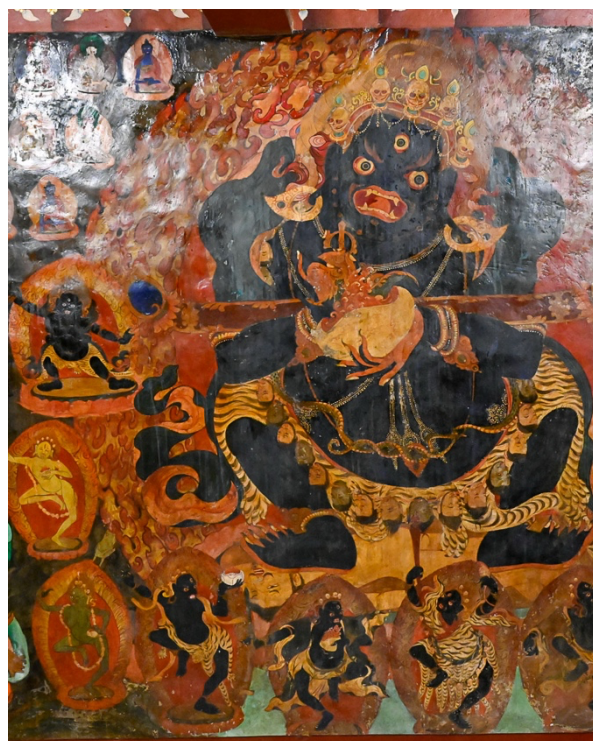
Figure 14: Two views of Pañjara Mahākāla after completing the inpainting.

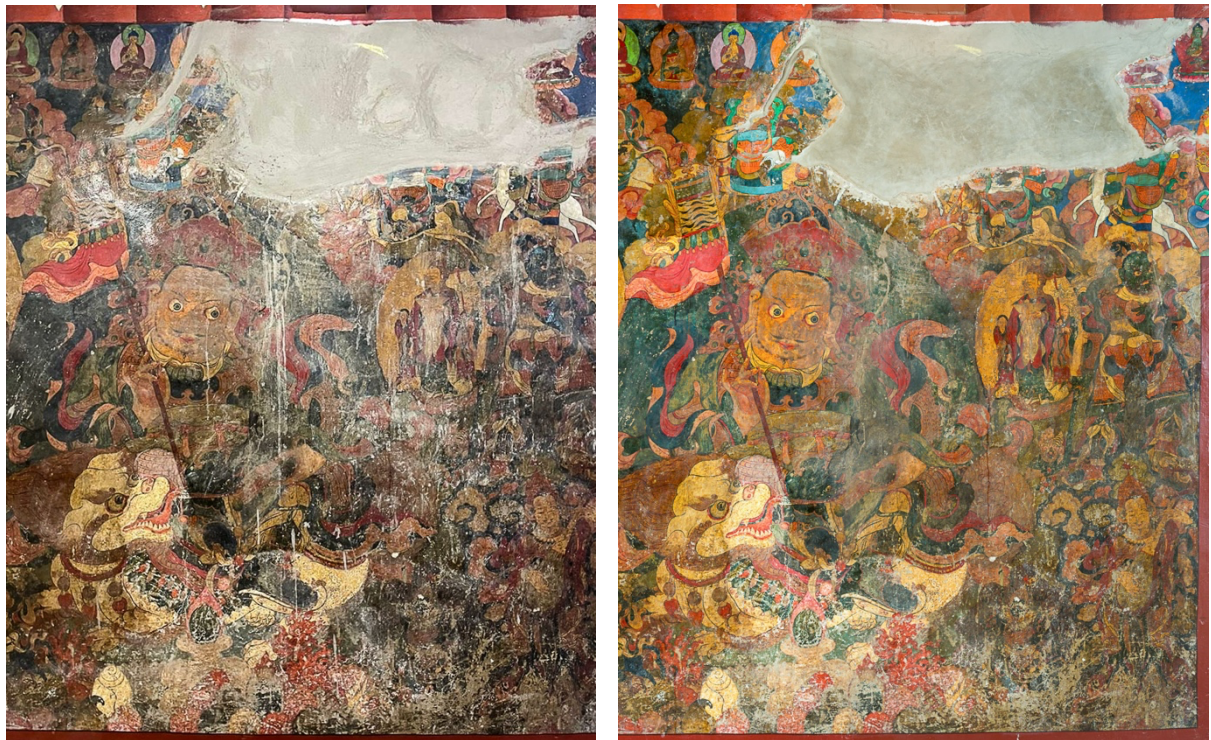
The situation around the wealth deity was similar to that in the previous example, but here an iconographically complex area featuring some of the eight generals surrounding the deity had to be complemented. Also the background colour around the loss has already been altered in a previous restoration. Further, being right next to the entrance, the lower part of the murals was more damaged than usual. These damages were left untouched, as the paint layer preserved here is original. With no direct extant model for the generals, more remote comparisons were suggested as reference points. The painters also had to ensure they correctly understood the remaining traces and reconstructed the generals in their original positions.

*Figure 15: The wealth deity Vaiśravaṇa before and after consolidation and cleaning.*

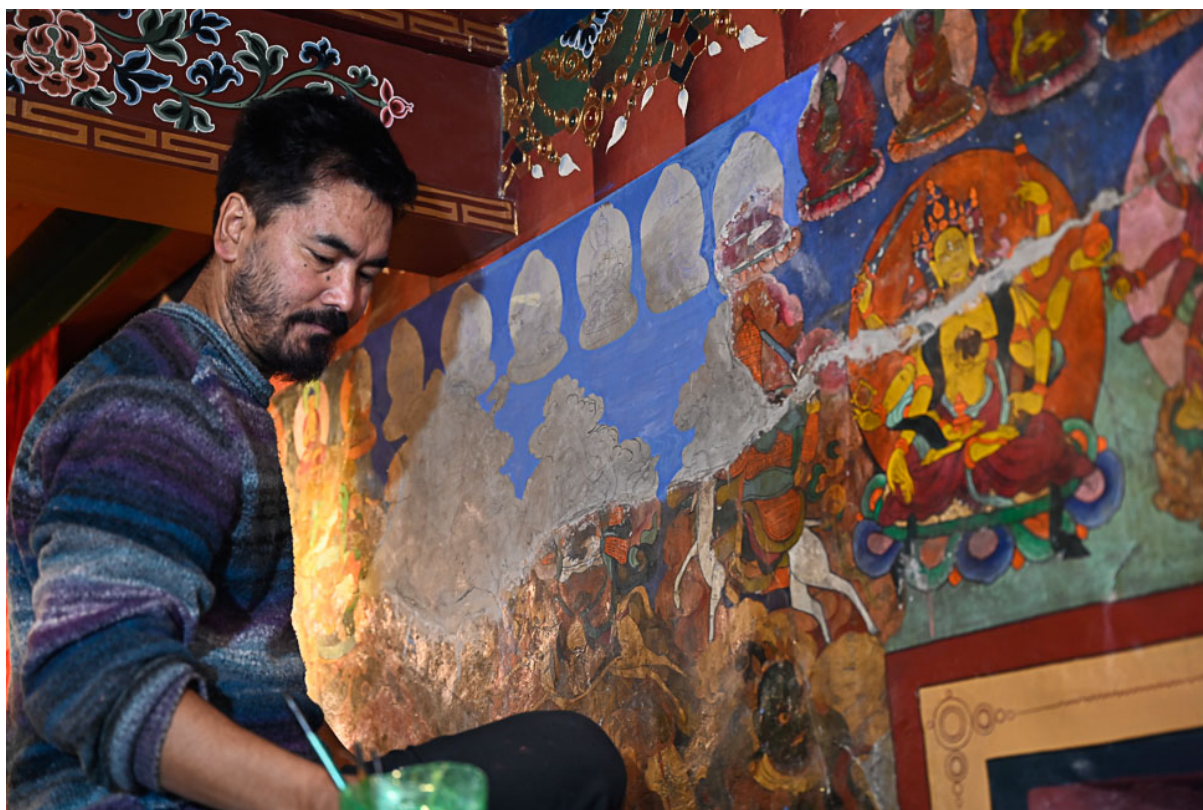
Figure 16: The painter drawing the outlines of the missing Buddha images and generals.

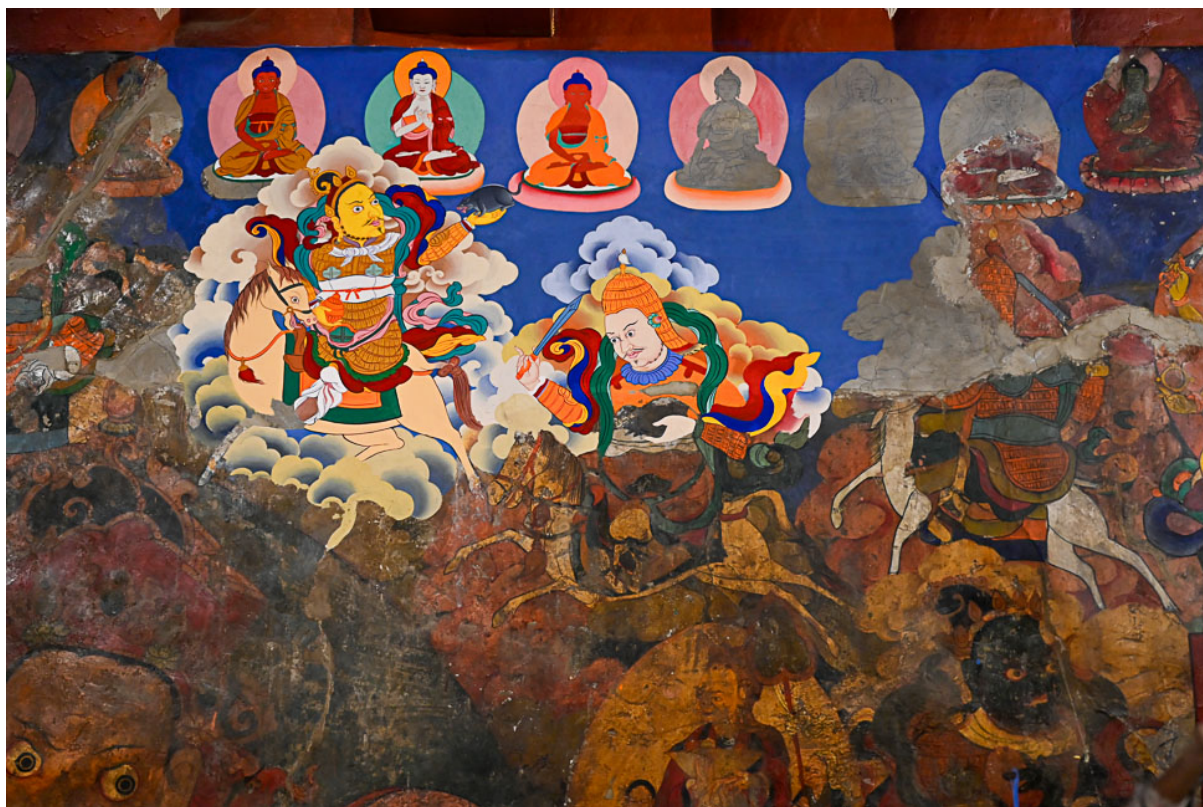
Figure 17: Some of the lost area already painted.

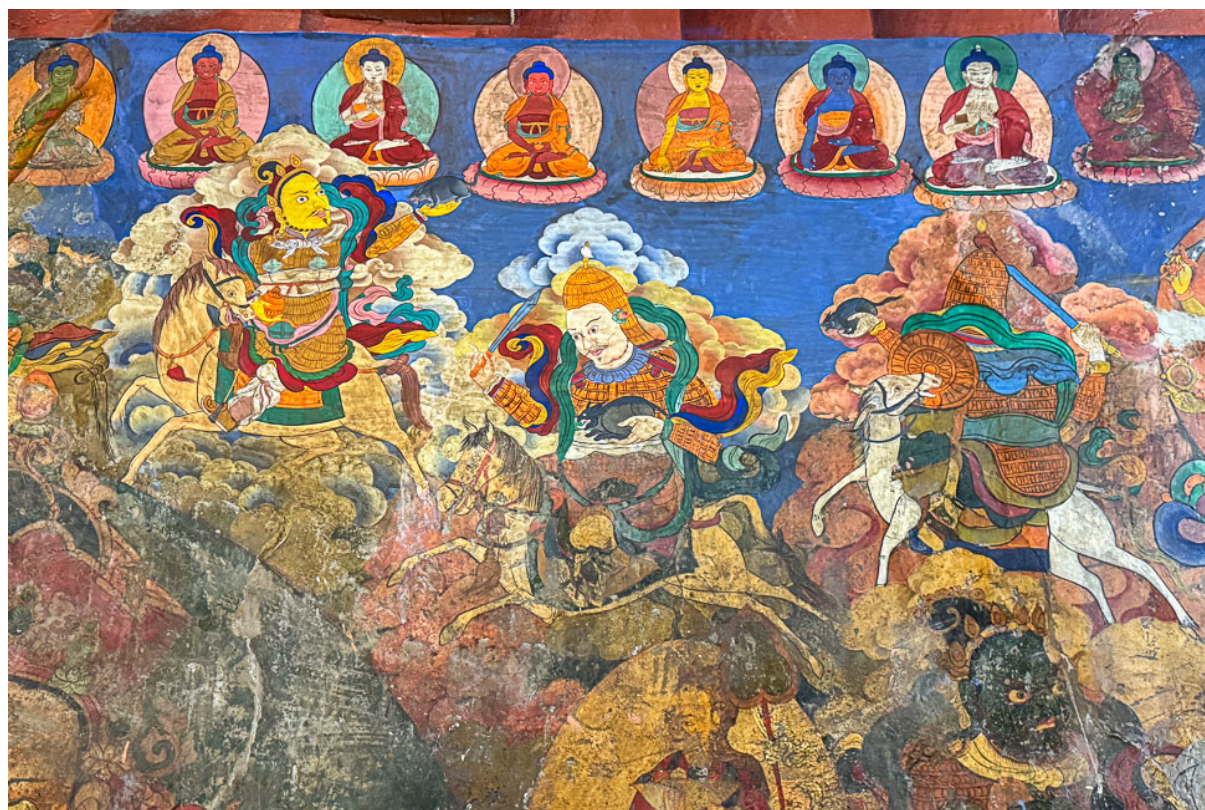
Figure 18: The inpainting of the Buddhas and generals is completed.

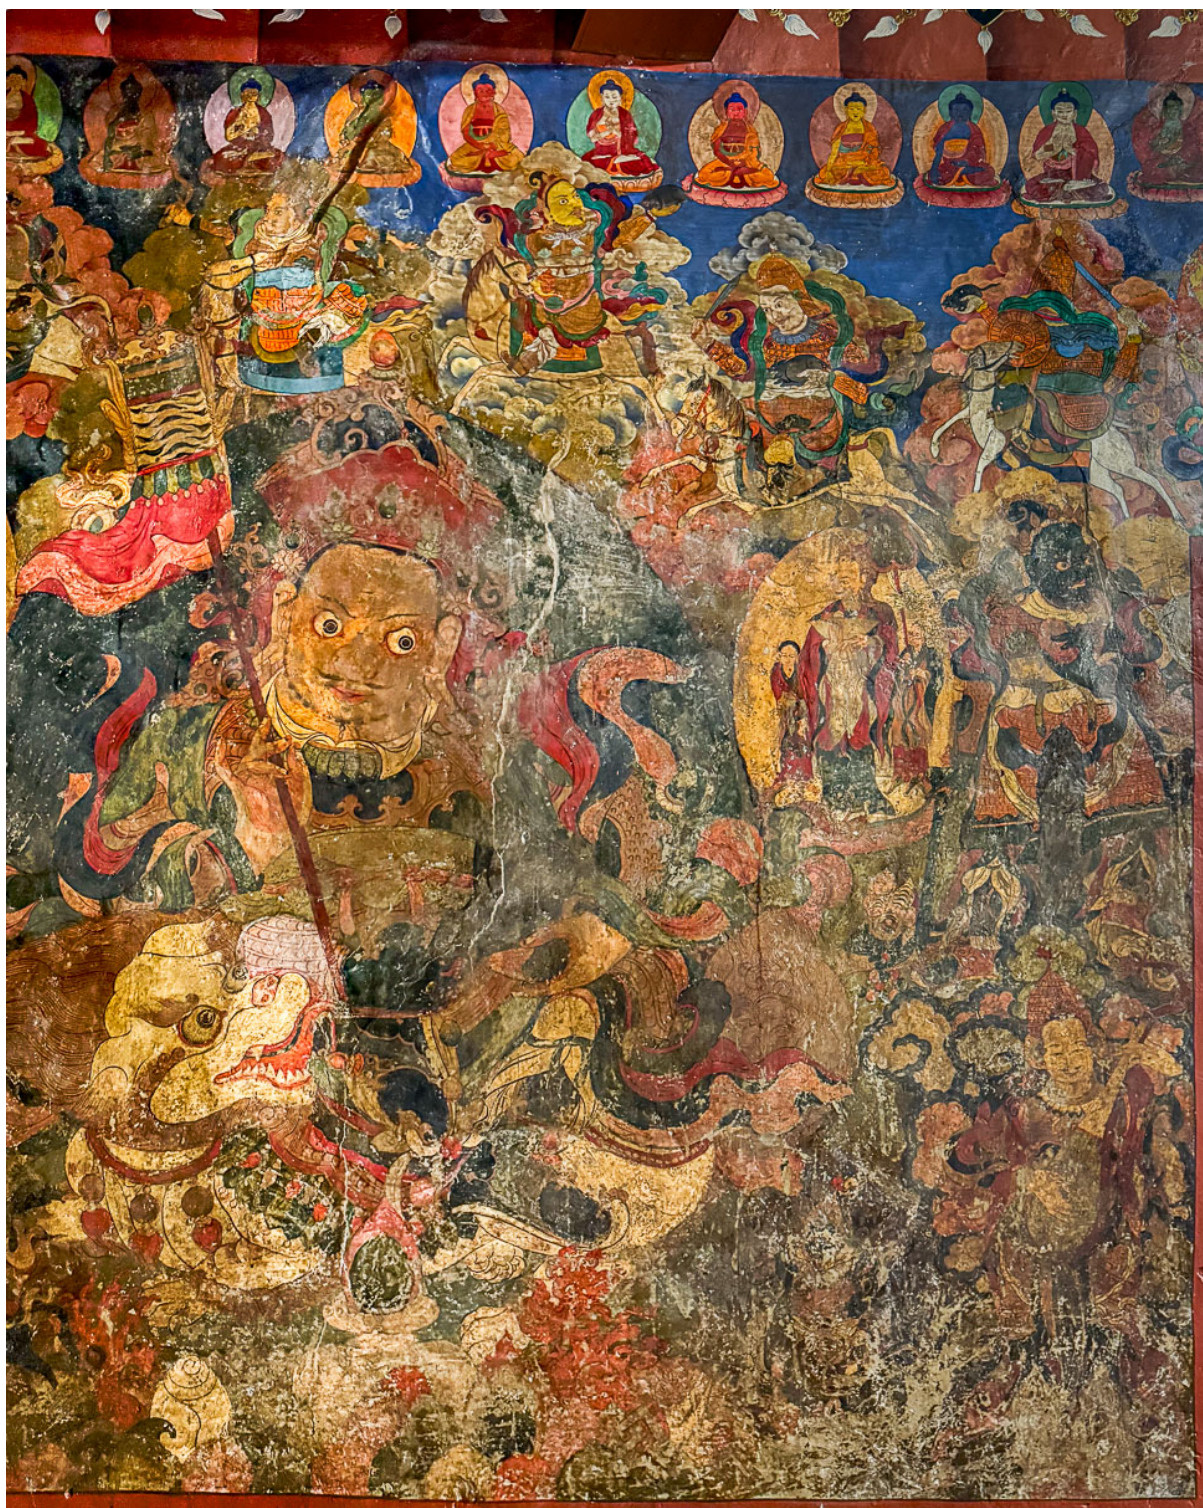
*Figure 19: View of Vaiśravaṇa with the surrounding deities completed.*

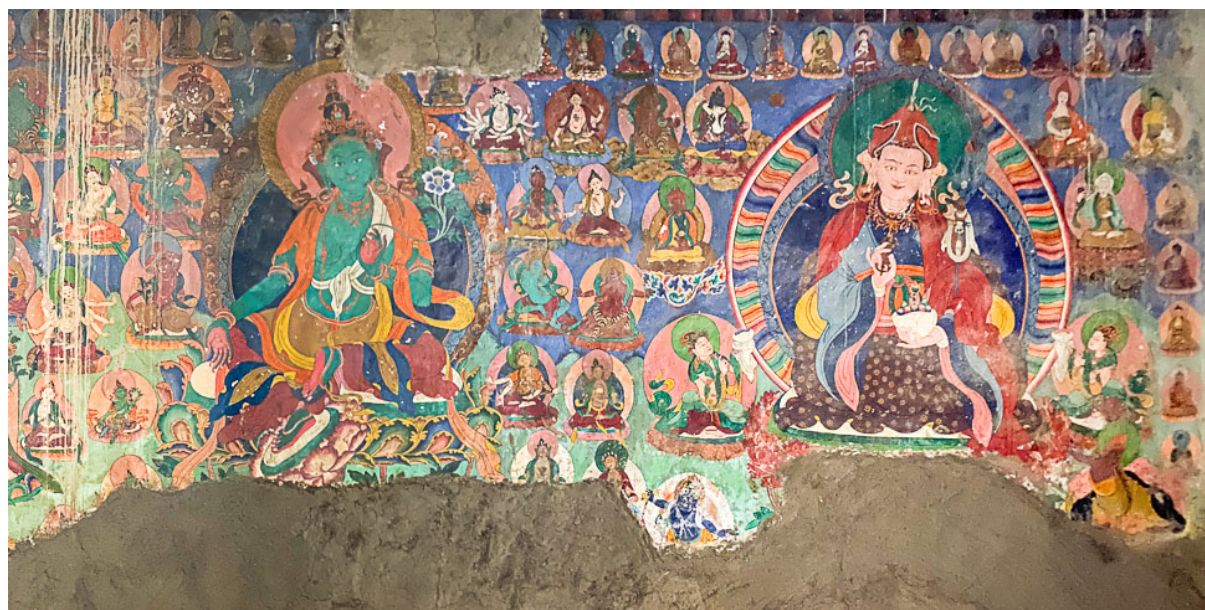
The most significant paint loss was in the area underneath the goddess Green Tārā and Padmasambhava. Both are surrounded by complex iconographic configurations, namely the twenty-one forms of Tārā and the eight manifestations of Padmasambhava.

Further, neither deity was preserved in its original form; both had already undergone prior restorations, obscuring the original iconography considerably. Reconstructing the lost sections was thus unusually difficult and continued to be discussed during the restoration with the abbot. In the end, the reconstructions proposed by Christian Luczanits in the previous report were followed.

*Figure 20: This photograph, showing the large losses under Green Tārā and Padamsambhava, was taken in 2021, before the new borders were painted.*

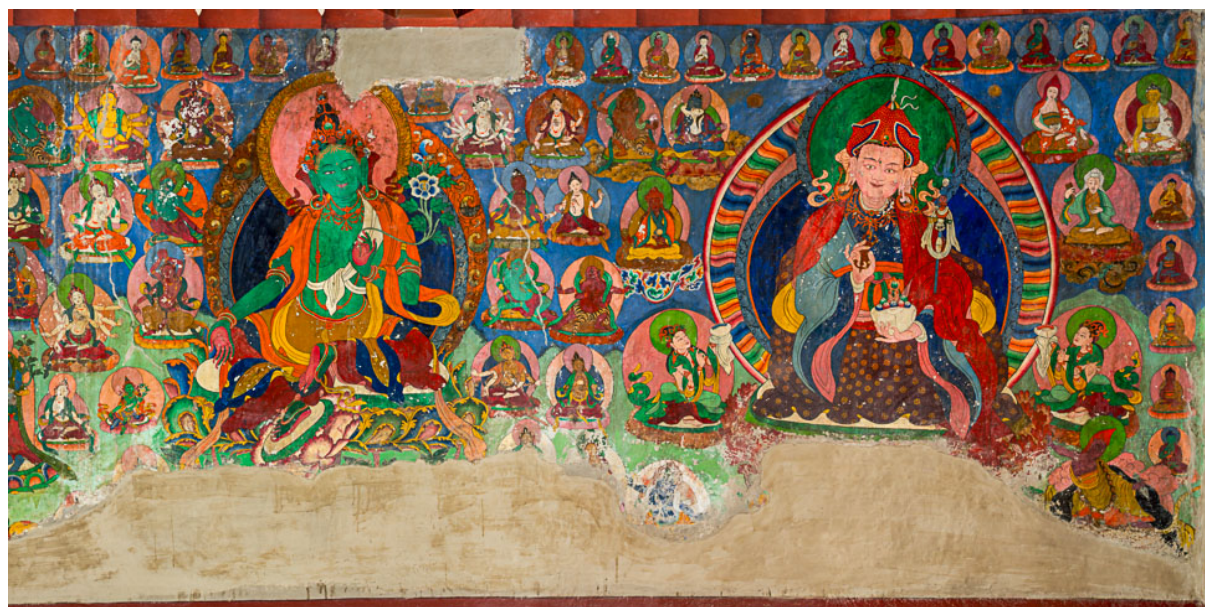
*Figure 21: The same area after the borders were painted, as well as after cleaning and consolidation.*

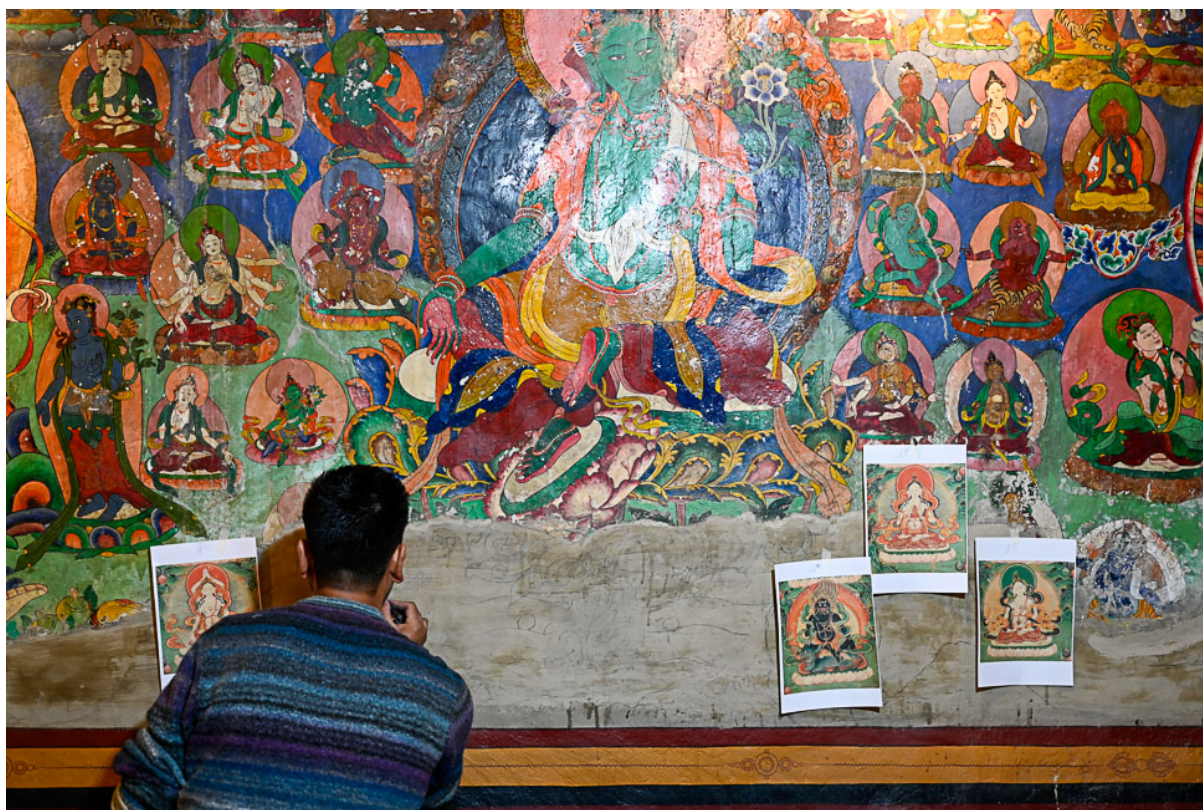
Figure 22: Drawing the missing forms of Tārā along the bottom area.

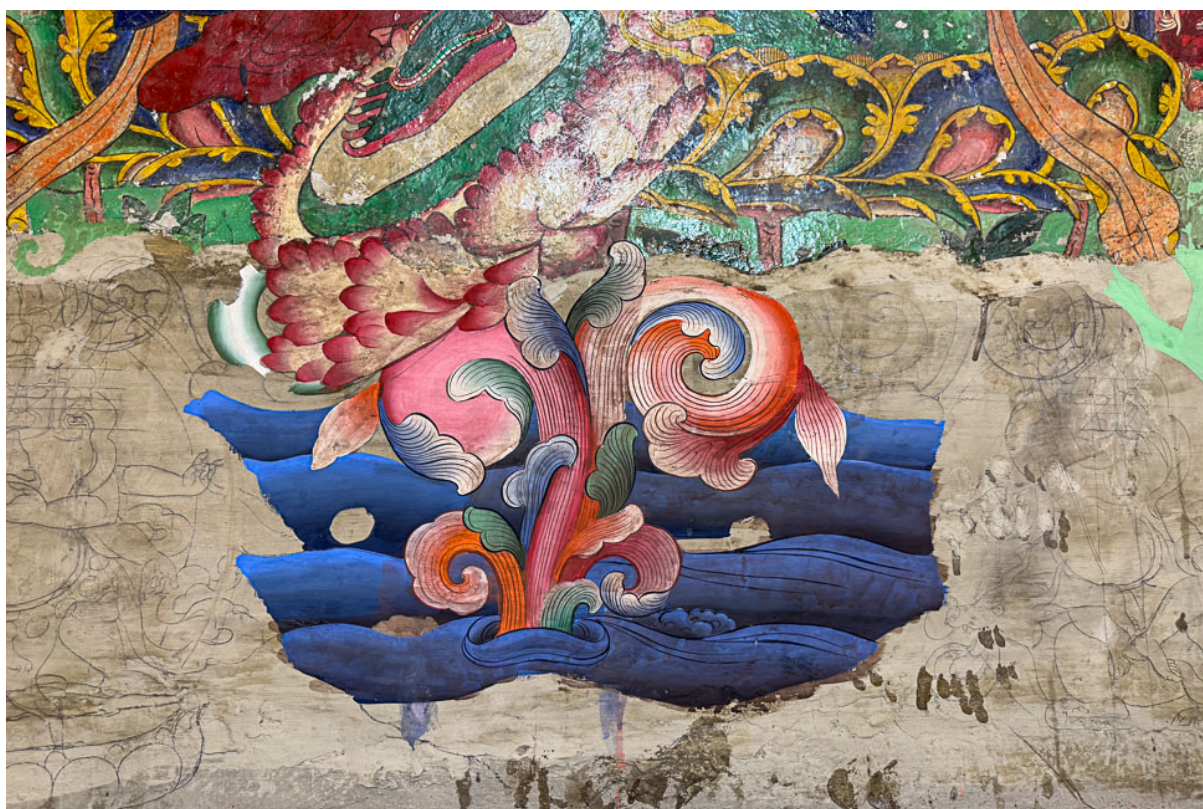
Figure 23: The new lotus pond and lotus stem painted underneath the foot of Green Tārā. To the sides are the outlines of other forms.

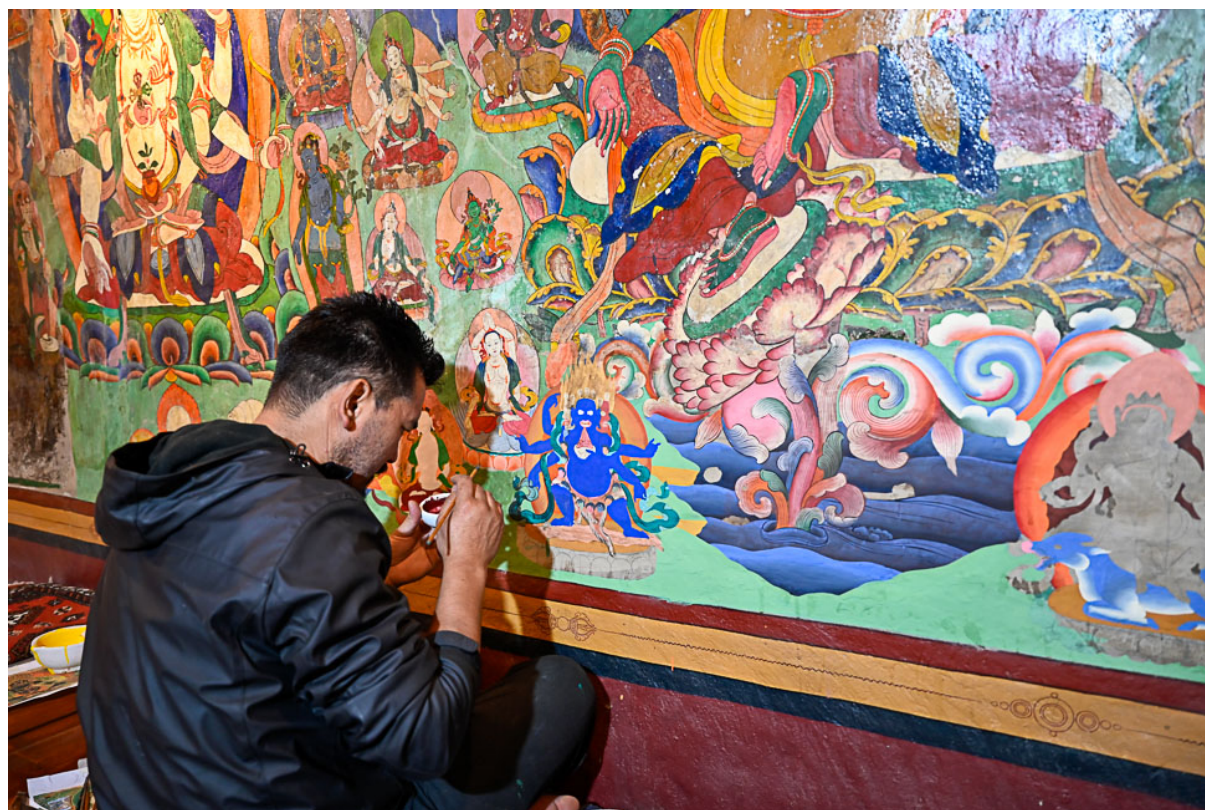
Figure 24: The painter working on the deities underneath Green Tārā.
