# Restoration of the Murals of Dzong Monastery, Mustang, Nepal

Final Report; July 1, 2025 – October 31, 2025

**Norbusum Foundation (NGO)**

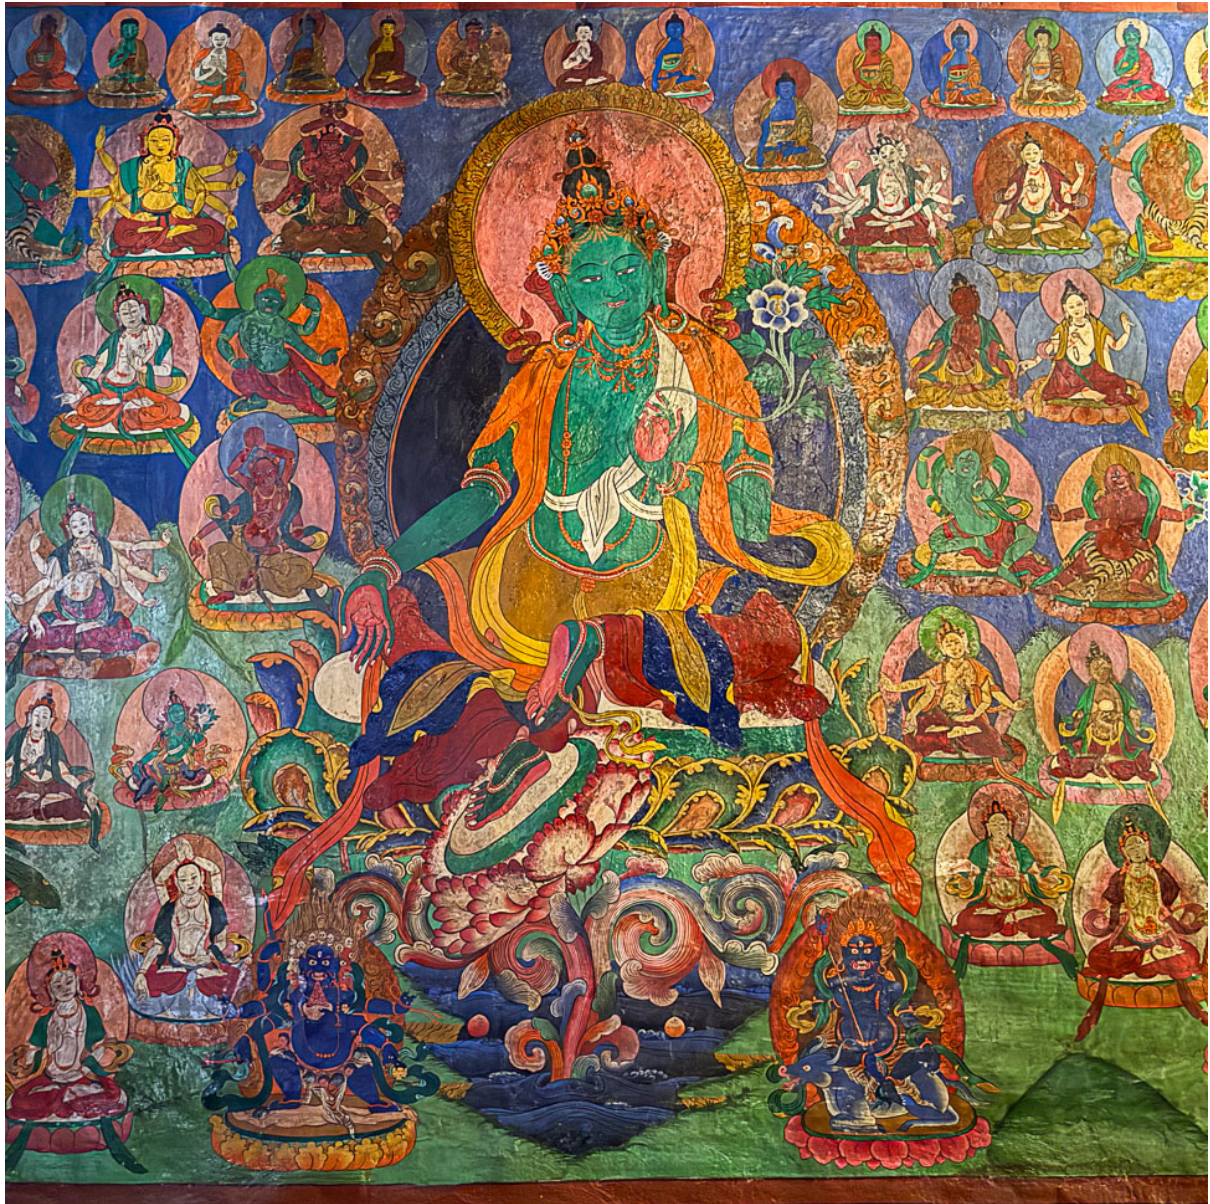
*Figure 25: The goddess Green Tārā with her lotus pond and the missing forms complemented.*

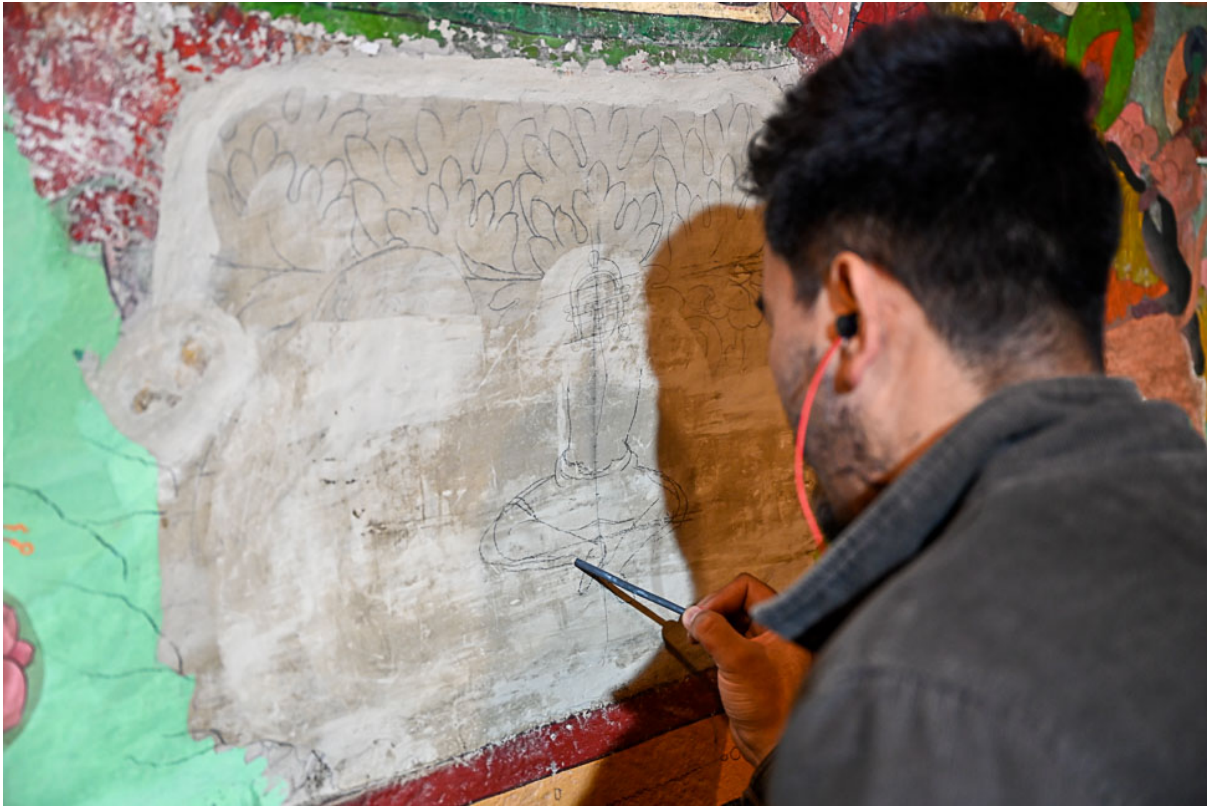
Figure 26: Outlining Guru Nyima Özer underneath Padmasambhava.

Among the eight manifestations of Padmasambhava, the location of Guru Nyima Özer was particularly contested. Christian Luczanits suggested that it must have been in the bottom centre before the lotus stem. While the Khenpo originally agreed to this reconstruction, when it came to painting it, it was questioned again. Only when Christian Luczanits could point out another example with the same composition was this reconstruction accepted.

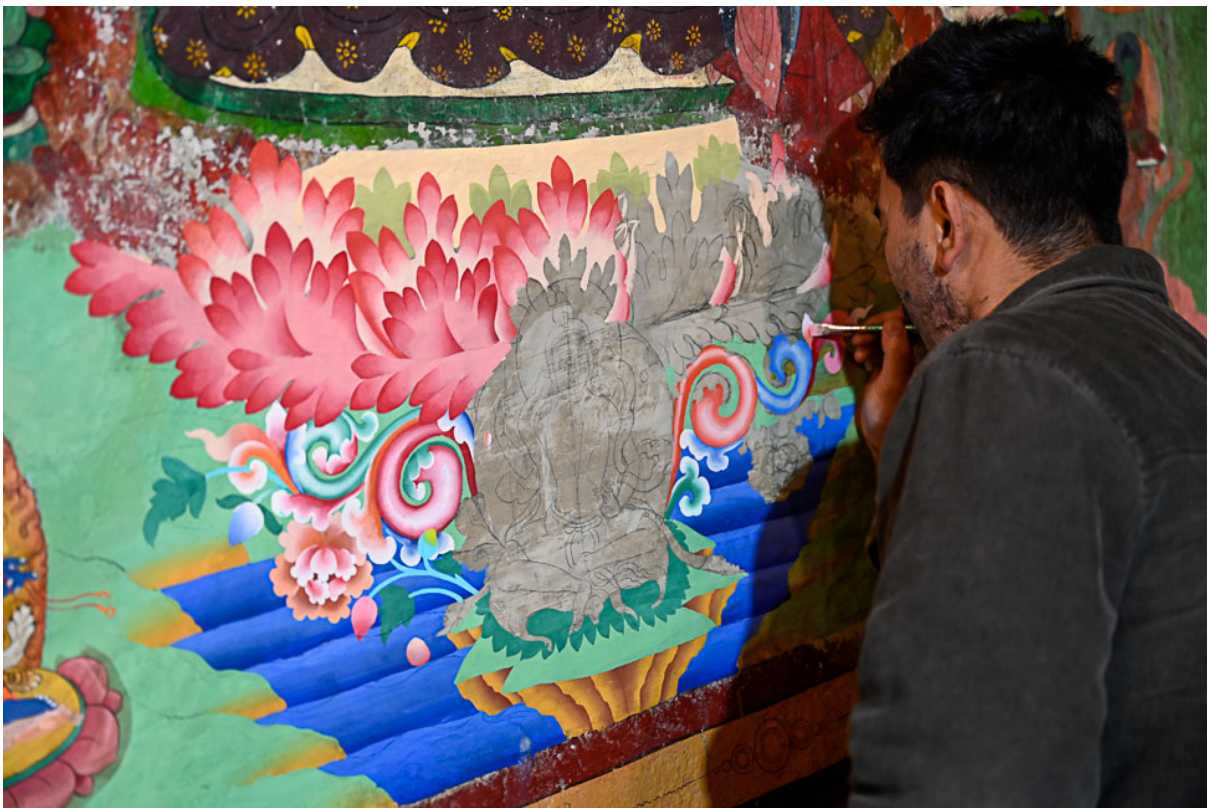
Figure 27: Completing the lotus underneath Padmasambhava.

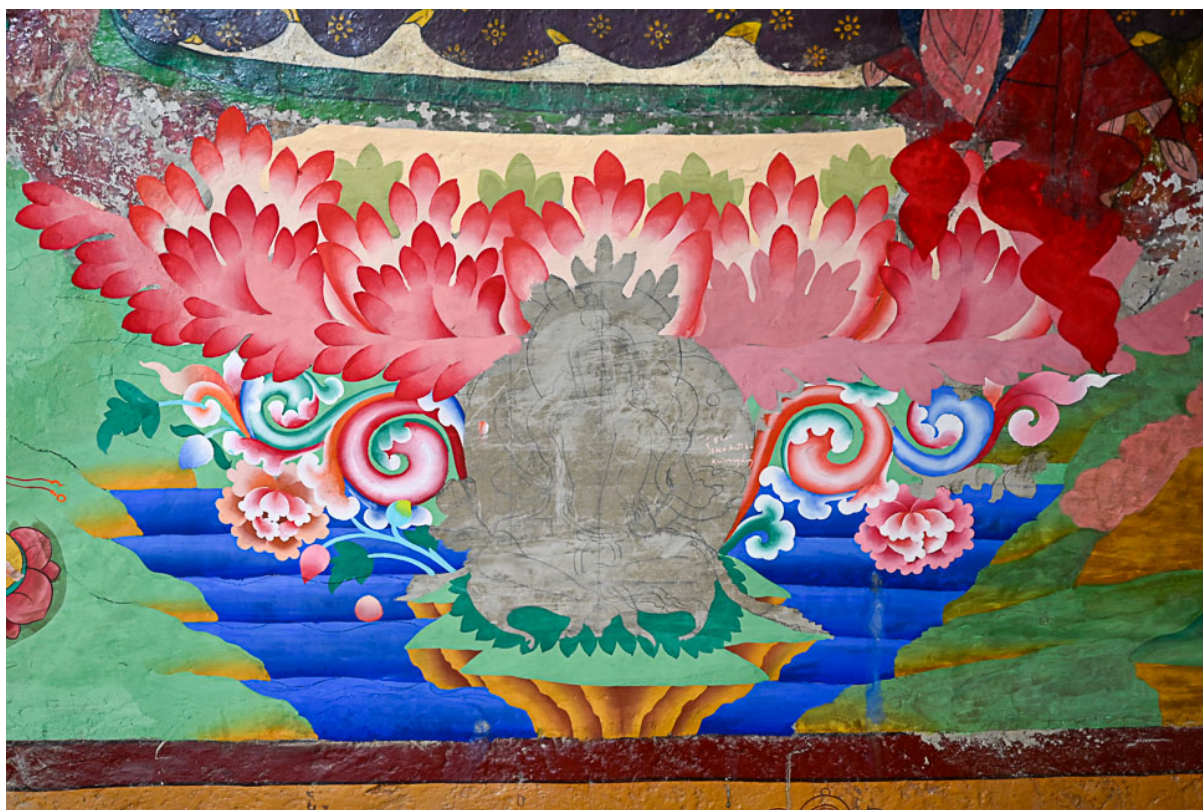
Figure 28: Much of Padmasambhava's lotus is painted, but the figure of Nyima Özer is still to be done.

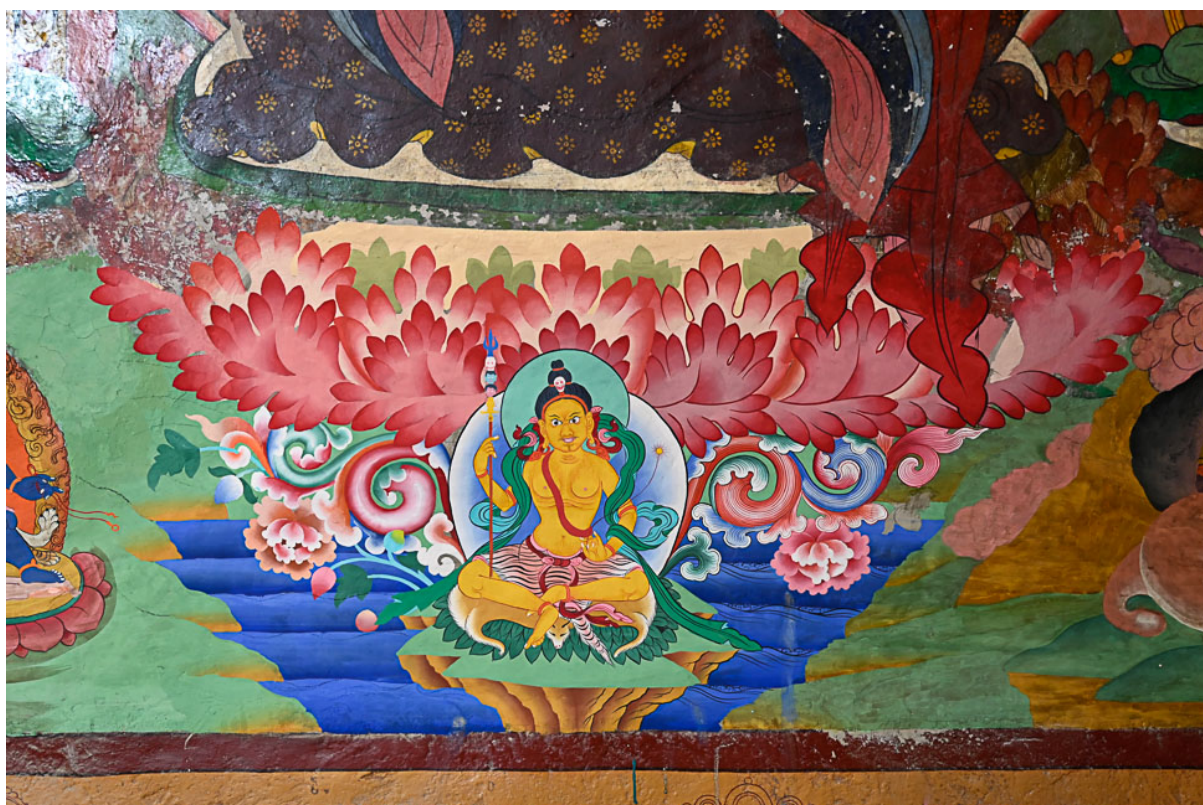
Figure 29: Much of the lotus and the figure of Nyima Özer are completed.

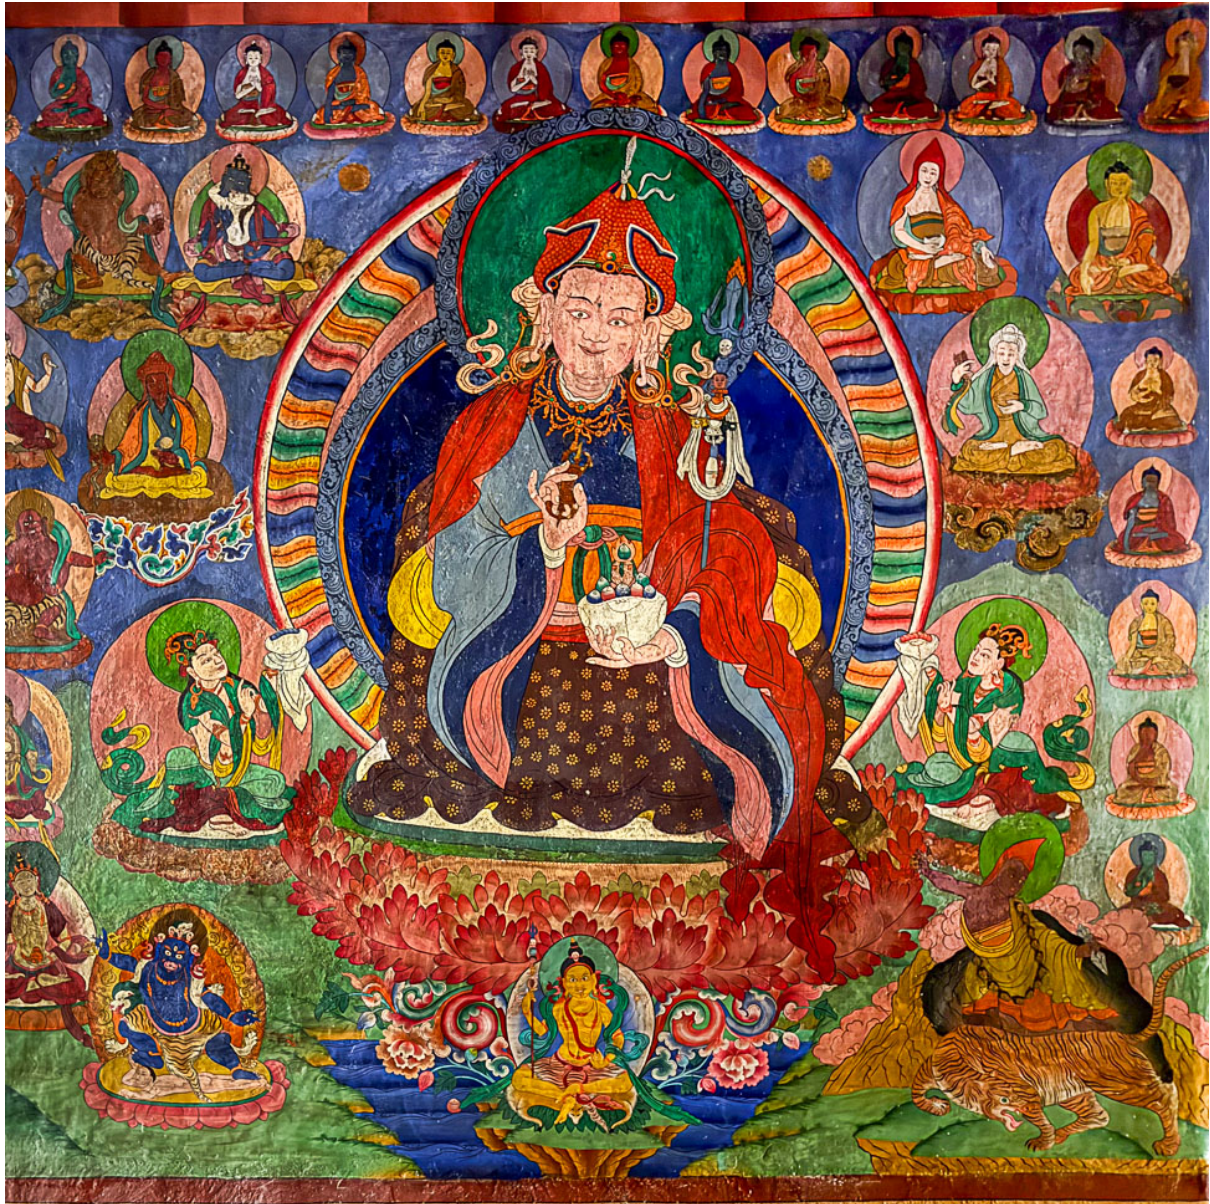
Figure 30: The restoration of Padmasambhava and his eight manifestations is completed.
