# Seismic Strengthening and Restoration of Lo Gekar

U.S. Ambassadors Fund for Cultural Preservation, Award No. SNP40020GR0042

## Final Project Report, 2021–2024

### Norbusum Foundation (NGO)

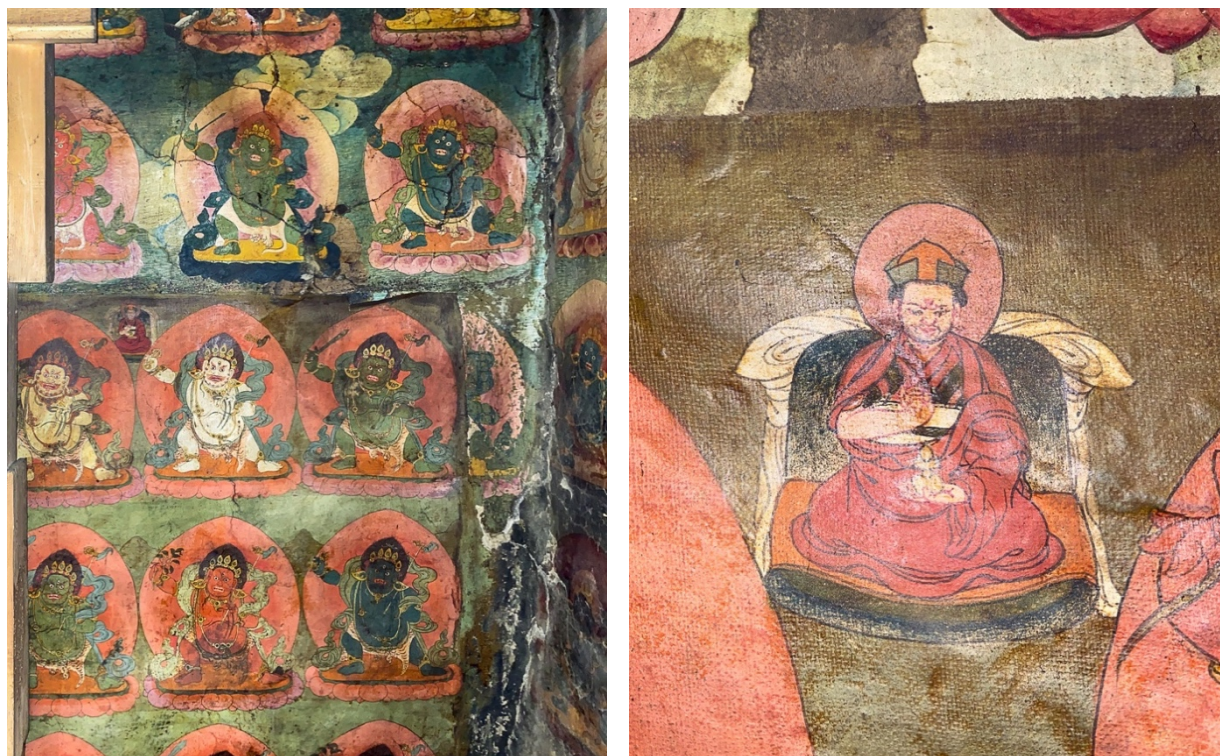
*Figure 8: Original and restored mural sections, the restored section on canvas and glued to the wall with a small portrait of Katok Rindzin in the centre.*

In this restoration the deities were painted on canvas attached to the wall, and on each patch a small portrait of Katok Rindzin has been added in the top center. This restoration is found throughout the sanctum in the lower parts of the walls, indicating considerable problems with moisture in the walls affecting the original paintings.

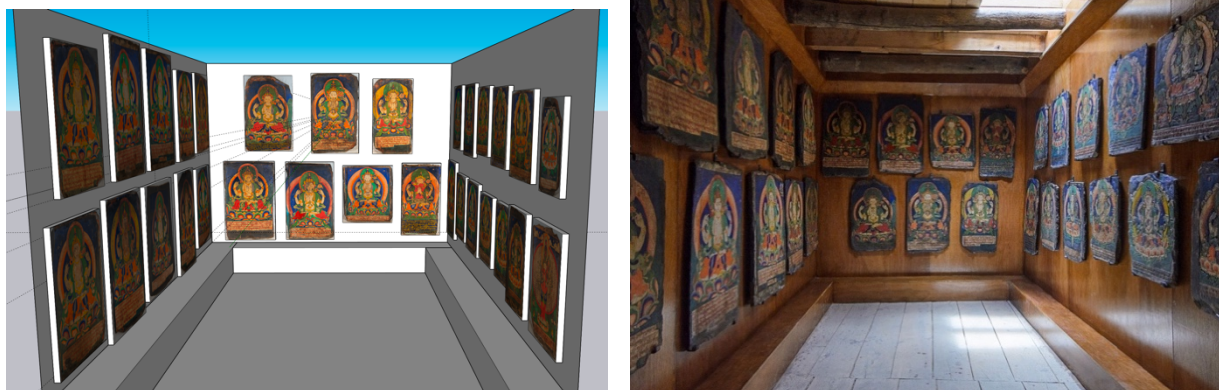
*Figure 13: Planning the distribution of the stone panels of the Avalokiteśvara Temple in the new location.*

The solution for the Avalokiteśvara panels needed to be different as here the panels are of different sizes. This fact also resulted in many of them being damaged in the past to fit them in the previously used frames. Instead, Christian Luczanits proposed to mount them with iron clamps on sturdy plywood support forming a shrine-like environment. This also enabled to display of these panels in their historical succession from the left side of the entrance to the room clockwise (Figure 13).

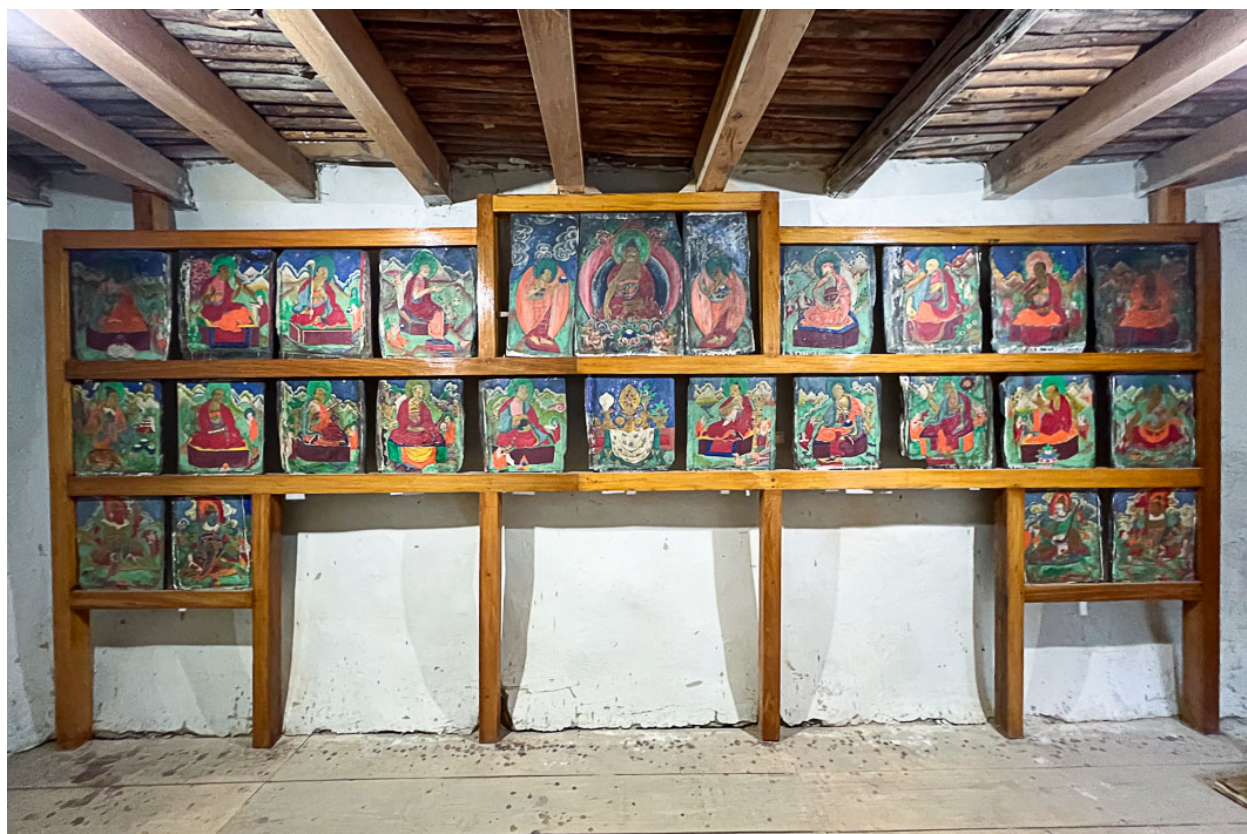
*Figure 17: The panels in their new frame towards the end of the restoration in 2023.*

The partial reconstruction of the original composition also made clear that the new frame can be planned similar to the ones in the Upper Sanctum with four uprights supporting the horizontal bases for the panels.

In the front room, the panels depicting the sixteen arhats were installed (Figure 17), while the corner room was made the new Avalokiteśvara Temple (Figure 14). For the Arhat panels the same framing system was used as in the Guru Lhakhang, once their original arrangement had been reconstructed by Christian Luczanits (Figure 15). Once the room was set up the caretaker also moved the shrine with the protective deities from into this room. The new shrine thus contains the same deities as the original room, even though their combination is rather unusual (see following figures).

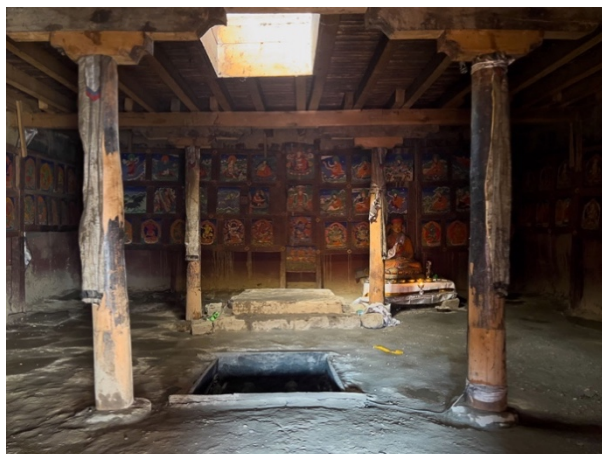
*Figure 20: The Upper Sanctum before restoration in April 2022.*

The principal sculpture of Padmasambhava and all the sculptures in the sanctum, and the carved slate panels in the adjoining Dukhang on the ground floor, needed to be covered with polythene sheets to protect them during the work on the floor above. Once the mud floor was completely removed along with the layer of round wooden sticks traditionally placed on the joists the structural issues of this room became apparent.

The mud layer turned out to be very thick, resulting in considerable weight on the joists and beams underneath. The joists were not only bent but, in some areas, there were wide gaps between them. Some of these gaps have been filled by the earlier restoration from below, but others, above the main images, remained. It had been hoped that the recent ceiling boards fitted by the village in the sanctum to prevent dust dropping through could be removed to reveal the original beams and then lay new ceiling boards above the beams. However, the existing joists were found to be extremely uneven in form and dimensions, and some had been replaced by squared ones during repairs in 2004. So, it was decided to leave the recent lower ceiling boards in place. To even the gaps between the joists, it was necessary to add several new ones.

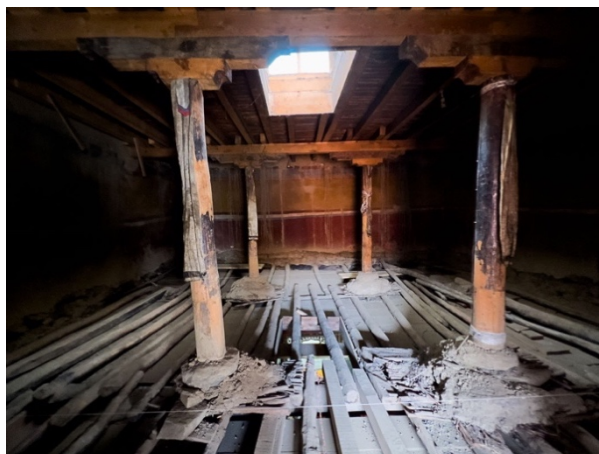
*Figure 21: The Upper Sanctum with the mud floor removed. Note the uneven spacing of the joists and the precarious bases of the beams. The panelling underneath the joists are the false ceiling of the lower sanctum.*

Then a secondary timber floor structure was built up to avoid excessive weight on the original structure. Further, it turned out that the four columns supporting the roof stood on clay and the wooden sticks underneath, representing an obvious structural risk. Rather than replacing them with longer ones, it was decided to support their base by square frames around the foot of the columns. To enable this, the round sticks were carefully trimmed with a hand grinder where necessary. The square frames were then built and filled with mud and aggregate mortar.

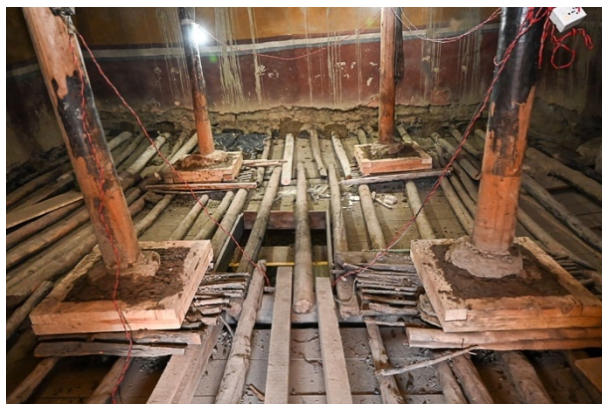
*Figure 22: The wooden frames to support the bases of the pillars.*

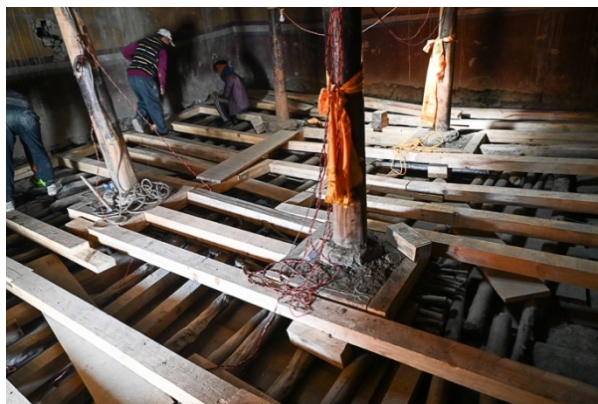
*Figure 23: The timber structure to support the new flooring.*

A new wooden timber frame made of 4 x 5-inch members needed to be constructed on top of the old ones to support the new floor and the new square frames around the foot of the pillars. All the square joints of the new frames were prepared in the woodworking facility and then installed with screws to avoid damage to the murals in the main sanctum underneath. The new timber frame supported ½ inch plywood sheeting screwed to it as a seismic measure. Then 1-inch-thick pine wood floor panels were screwed on top to form the actual floor.

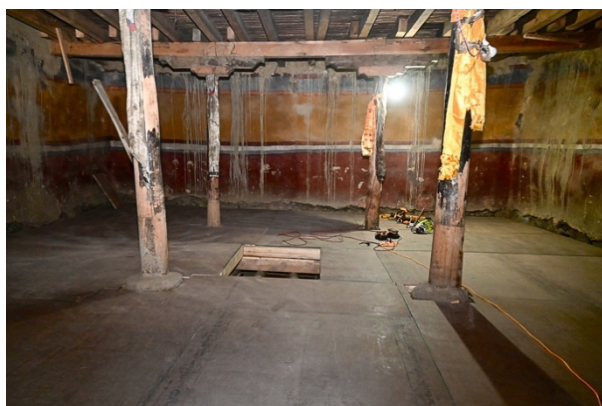
*Figure 24: Plywood panels were screwed to the wooden framework to improve seismic stability.*

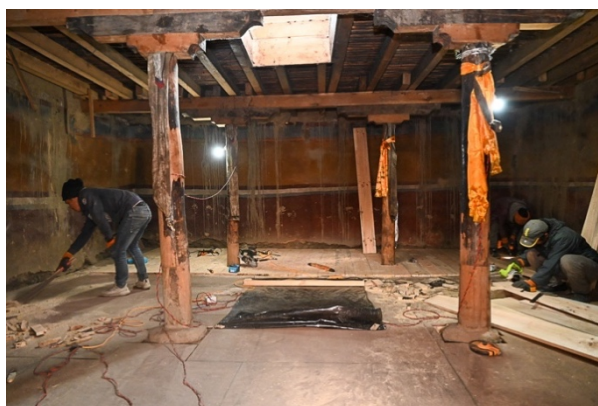
*Figure 25: Then the actual flooring of the room was screwed to the panels.*

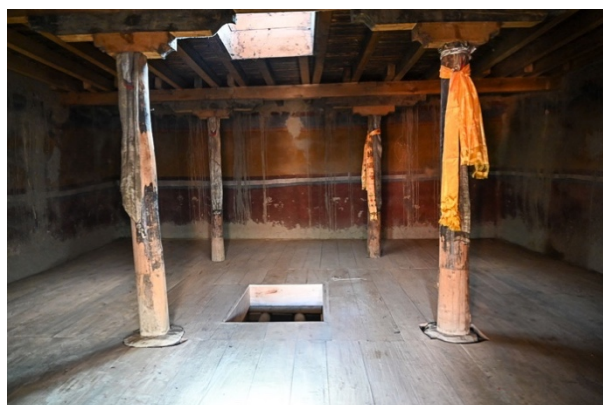
*Figure 26: The Upper Sanctum with its new flooring completed.*

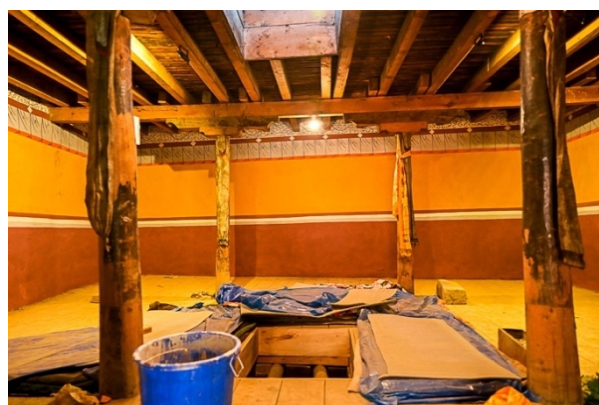
*Figure 27: The Upper Sanctum after the new paintings have been applied.*

Once sourced, these natural colors need to be hand-ground, sieved, and soaked in water before application. All the colors—red, yellow, white, and blue—were soaked in water and mixed with a water-soluble glue. The maroon color was further boiled with sugar and then sieved again on a muslin cloth before application. Temple spaces, like the Guru Lhakhang were painted with the usual border motifs, namely a cloth valance at the top and multicolored stripes marking the bottom of the main area.

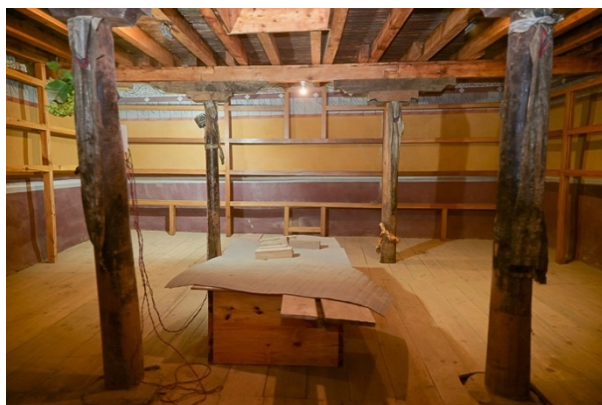
*Figure 28: The Upper Sanctum after the construction of the new frames for the stone panels.*

The new frames holding the stone panels, thus, were only completed in In July 2023. They were then sanded, and shellac polish was applied. The grooves were cut deep enough to insert the panels easily by lifting and releasing. In contrast to the earlier mounting, the panels now rest in the frames without taking pressure from any side to avoid any further

damage to them. In future, these panels can be easily taken out or put back into their frames for cleaning and maintenance.

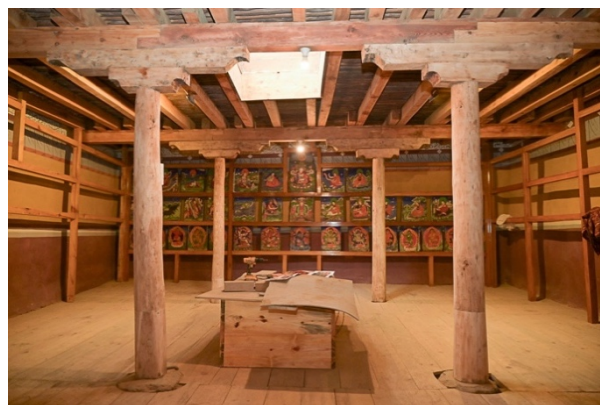
*Figure 29: The Upper Sanctum with most of the stone panels on the main wall installed.*

At this phase the masking of the gaps between the stone panels was not completed. This happened during only during the final works in 2024. As the wood used for that was slightly brighter than the Salwood used for the frames, its color had to be adjusted through paint.

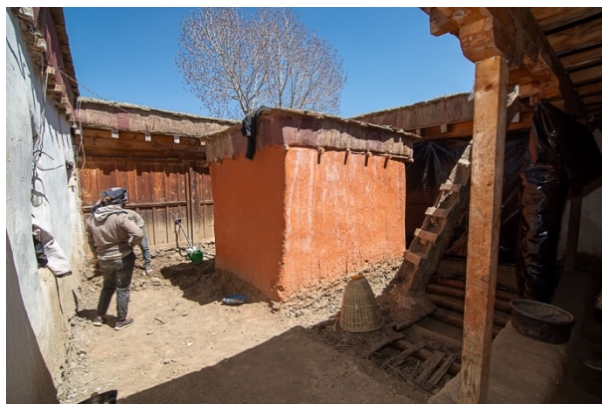
*Figure 32: Removing of the mud floor in the courtyard.*

Shortly after the Upper Sanctum, work also commenced on the courtyard immediately in front of it. While the project considered covering the entire courtyard with a transparent roof in the second phase, its floor was completely restored to make it waterproof for all eventualities. As in the sanctum itself, in the courtyard, the mud floor was completely removed and the original joists and recent ceiling boards of the Dukhang were exposed.

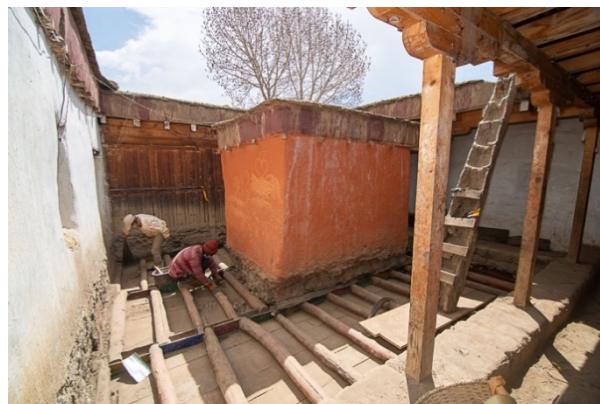
*Figure 33: The courtyard with the mud removed.*

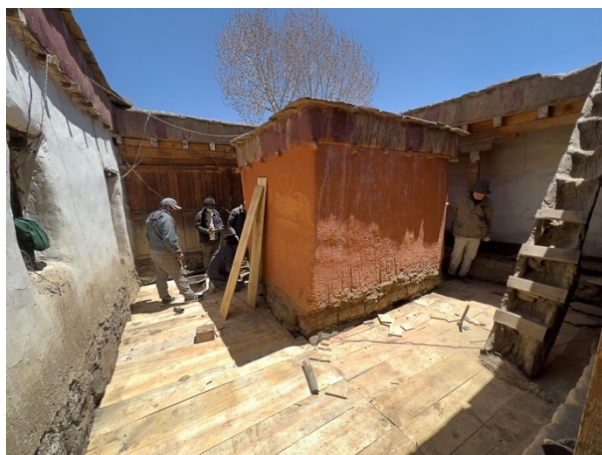
*Figure 34: Planking on the original joists in the courtyard.*

The thin plastic waterproofing membrane, fitted in 2004, was removed. New ceiling boards were then fitted and screwed above the joists. To reach the original drainage level, a timber frame needed to be installed around the lantern (Figures 35, 36). The frame itself already has the necessary inclination towards the drainage spout on the east side. Plywood was then screwed over the prepared frame. It was then covered with a Sika waterproof membrane using bituminous paint and a blowtorch. Finally, the membrane was covered with mud mortar mixed with chopped straws and the floor was laid with flat stones to form the new topmost layer of the floor (Figures 37–39). The drainage pipe was carefully inspected by temporarily removing a few floorboards in the guest room in front of the courtyard to make sure it was not clogged.

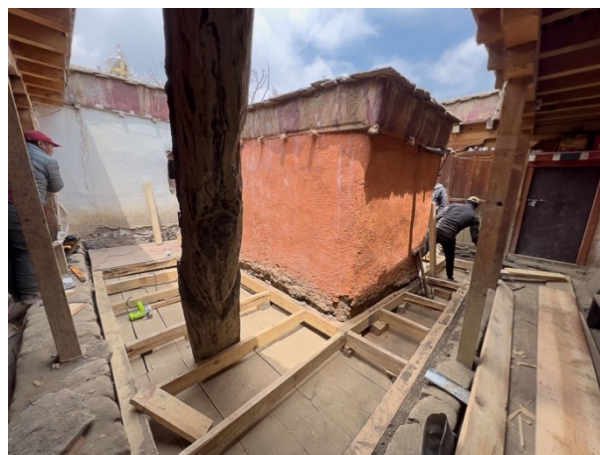
*Figure 35: Adding a second wooden frame to bring the new floor to the original level.*

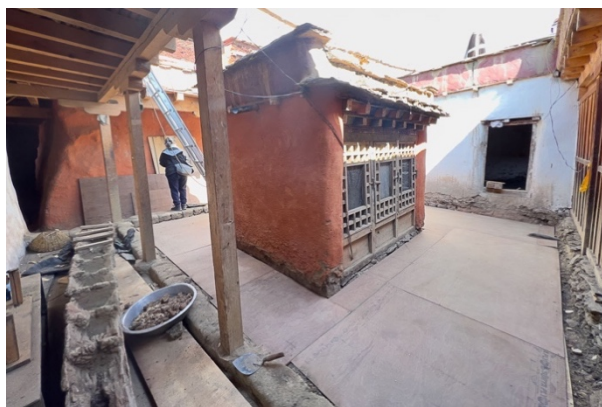
*Figure 36: Waterproof plywood was attached to the wooden frame.*

connected to the square frame to provide support for the rafters and the corrugated fiber sheets. Rectangular rafters were then screwed onto the poplar joists and then completed with the fiber sheets. Pine boards were installed over the frames on the internal side while waterproof plyboards were used for the exterior surface. Similarly, bitumen sheets were extended on the plywood surface as a waterproofing measure and for the durability of the exterior wooden surfaces from natural wear.

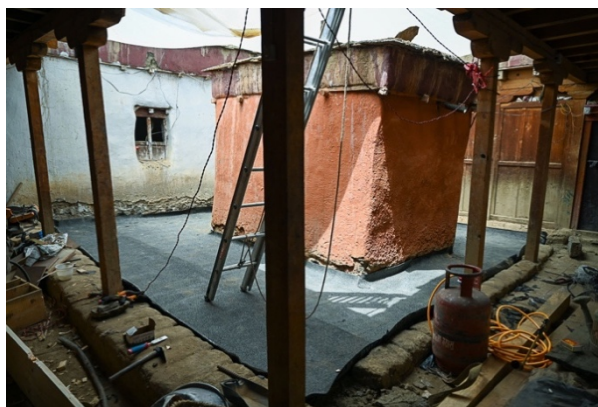
*Figure 37: The plywood was then topped with a bitumen layer.*

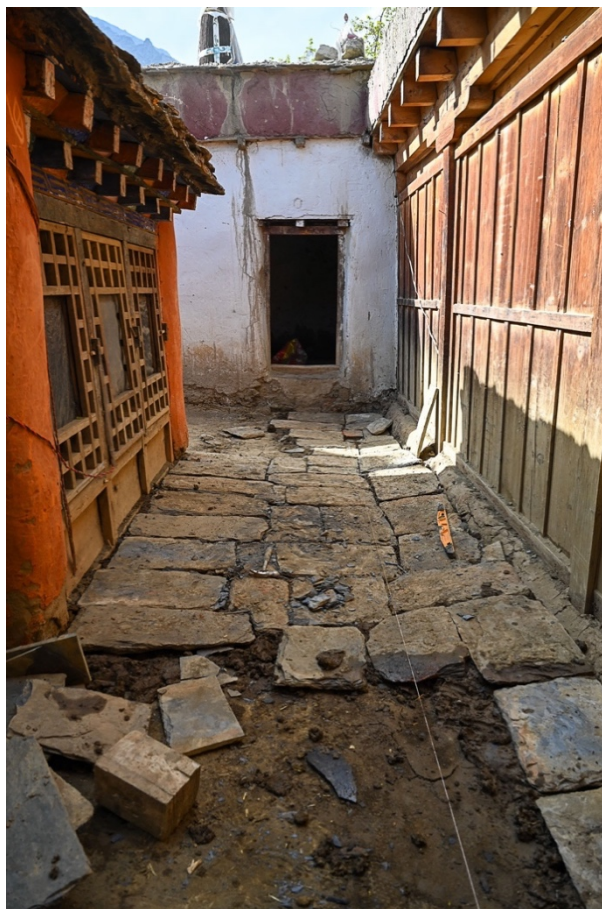
*Figure 38: Paving the courtyard with stone. The door in the back leads to the new Arhat and Avalokiteśvara temples.*

Finally, a stone pavement was installed in the exposed parts of the courtyard. The previous mud floor was impassable after rain but the new Arhat and Avalokiteśvara temples need to always be accessible.

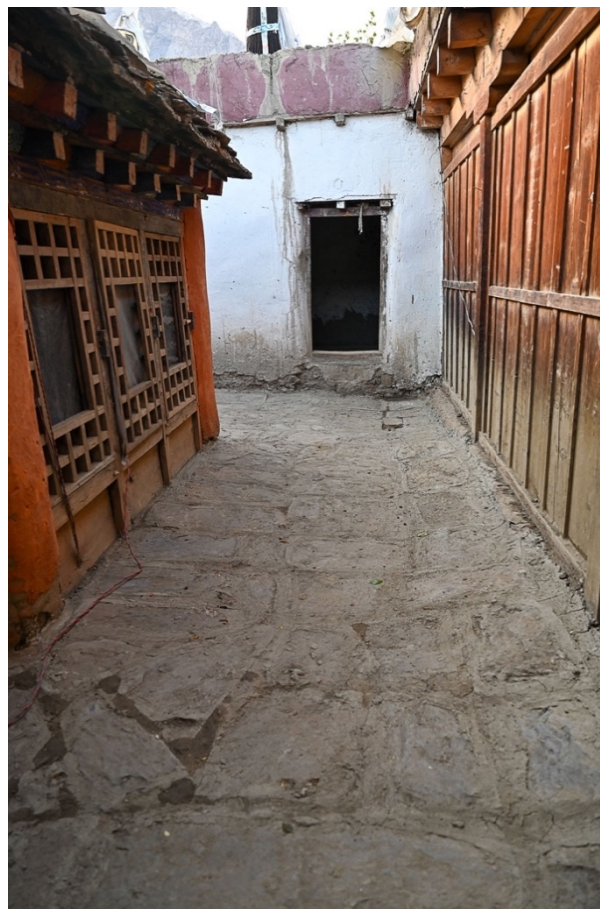
*Figure 39: The completed stone pavement.*

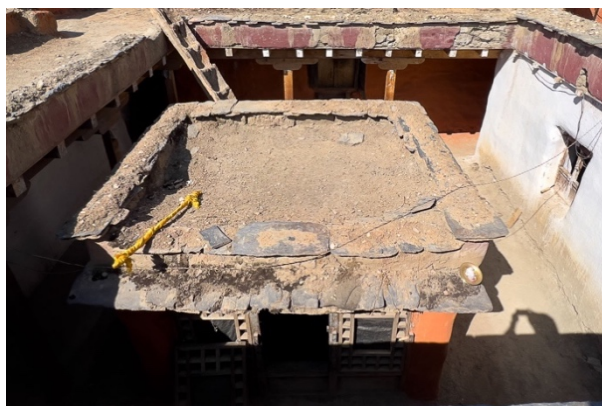
*Figure 40: The lantern roof before restoration.*

The roof of the lantern in the courtyard was redone to protect the murals underneath when the entire courtyard was exposed. The mud layer was completely removed, and new ceiling boards were installed over the existing joists. Waterproof plywood was then screwed over the ceiling board and then bitumen membrane was applied over the entire lantern roof. The former adobe parapet wall was lowered in height to reduce the weight it put on the walls rebuilt to retain the original look.

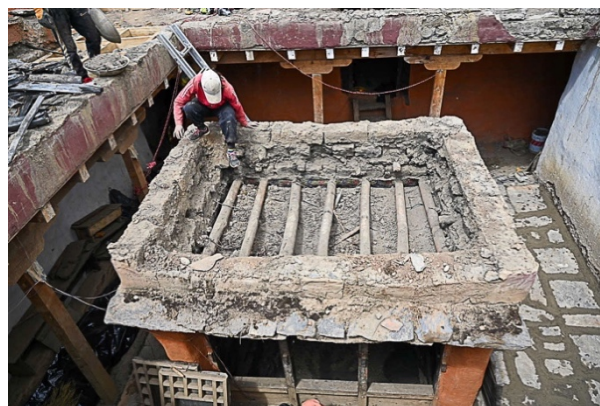
*Figure 41: The lantern with the clay removed from the roof.*

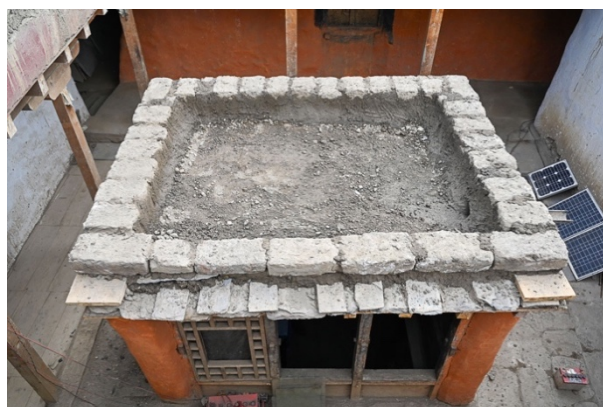
*Figure 42: The lantern with the new roof and the lower parapet.*

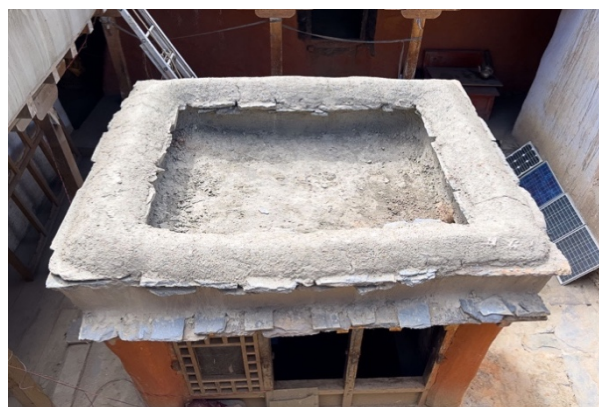
*Figure 43: The parapet of the lantern finished.*

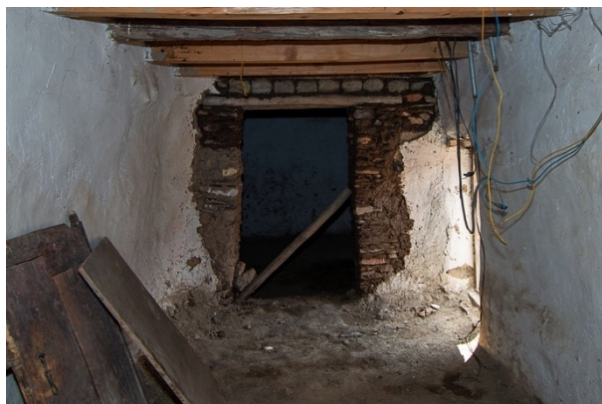
*Figure 44: View at the expended door between the two panel rooms, the Avalokiteśvara chapel in the back.*

To enable their usage as temple rooms, the entrance between the two rooms had to be widened and reinforced with round joists. This happened in April 2022. For these rooms, it was not necessary to remove the floor in its entirety, as it was relatively thin and the construction underneath, in the protectors' chapel and the room with the payer wheels, was stable. Thus, only a few inches of mud were removed before the frame for the new wooden floor was installed. To accommodate the joists of the frame, trenches were dug into the remaining mud floor. Then floorboards were screwed over the prepared frames. A new skylight was built over the roof of the corner room (U05) which had no natural light source.

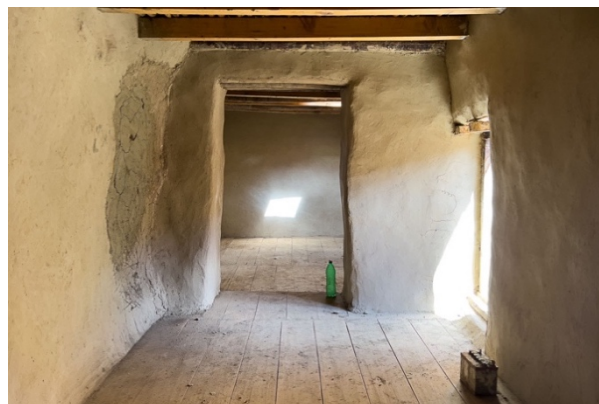
*Figure 45: View of the restored room after flooring and plastering, a skylight lighting the back room.*

Late in June 2022, the plastering of the Temple rooms started. As a first step, the walls were prepared to hold the new plaster. The walls were scrapped to create a rough adhesive surface for the new fine plaster. Then the actual plastering happened in July. For the plaster a particular variety of clay that was extensively used for fine plaster works at to be brought from Upper Mustang, and the work was done by a local plaster expert from Lo Manthang. The plaster mortar was prepared with clay, saw dust and cow dung.

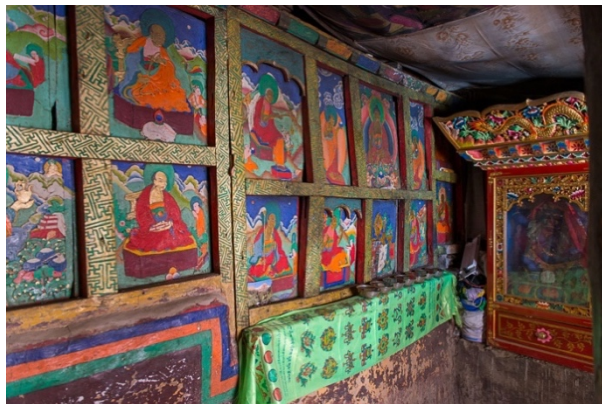
*Figure 46: The Arhat panels in their original frames in one of the front rooms of the caretaker's quarter that also houses a shrine of protective deities.*

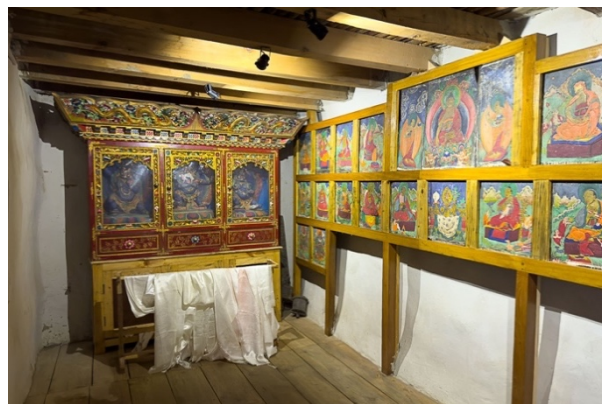
*Figure 47: The Arhat panels in the new frame after restoration. The caretaker also moved the shrine with the three protective deities into this room.*

The year 2024, was used to improve and enhance the work done in the previous years, also for the Arhat panel frames the gaps between the slates were masked. The pieces were fabricated in the field office in Jharkot and then installed later at the site. The masking pieces were prepared out of pine wood and then shellac polish was applied to create uniformity in the entire wooden frames.

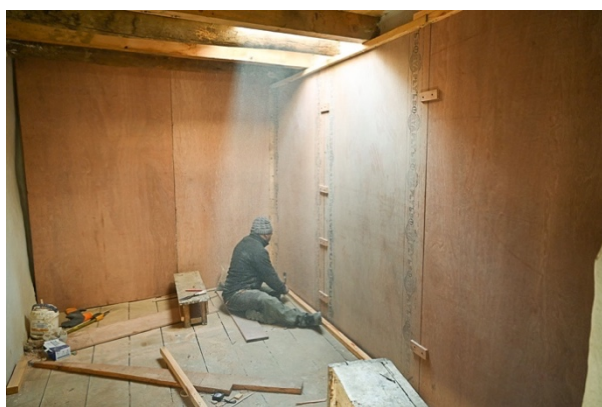
*Figure 48: Construction of the double plywood shrine to hold the Avalokiteśvara stone panels.*

Accordingly, the carpenters constructed this support structure using a double layer of waterproof plywood supported by vertical rafters. The structure further was attached to the floor and beams to increase its sturdiness. Once constructed, the surface was sanded, and several layers of shellac polish were applied.

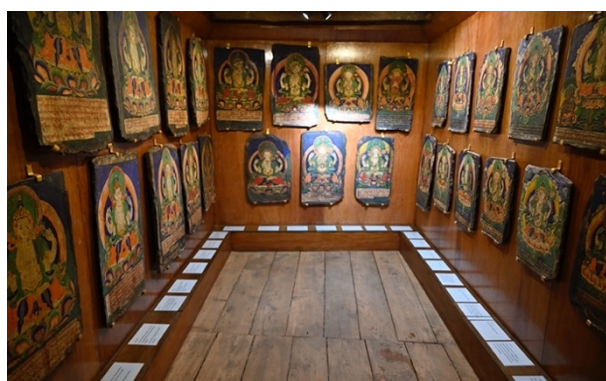
*Figure 50: The labels in the Chenrézik Lhakhang are now protected by glass.*

In 2024 glass pieces were cut into desired sizes in Kathmandu and transported to Lo Gekar to hold the labels for the Avalokiteśvara panels in place and protect them.

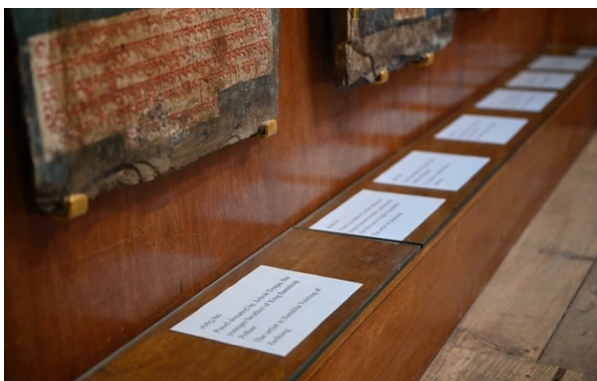
*Figure 51: Detail showing the glass cover for the printed descriptive labels.*

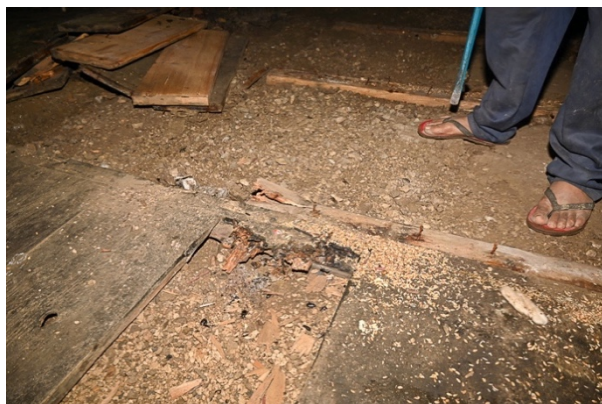
The wooden floor in the main shrine which looked acceptable from the surface was rotten and eaten by woodworms from the bottom and needed replacement. Moreover, the purlins were also rotten, and wormholes were observed (Figure 52). A few of the boards around the entry could be reused while the rest were completely replaced (Figure 53). Wood glue was used at the joints to prevent warping and then nailed to the purlins (Figure 54). The installed floorboards were sanded, and two coats of linseed oil were applied to finish off the pine board floor (Figure 55). This work was done in August 2023.

*Figure 52: The dismantling of the wooden floor in the sanctum revealed rotten areas.*

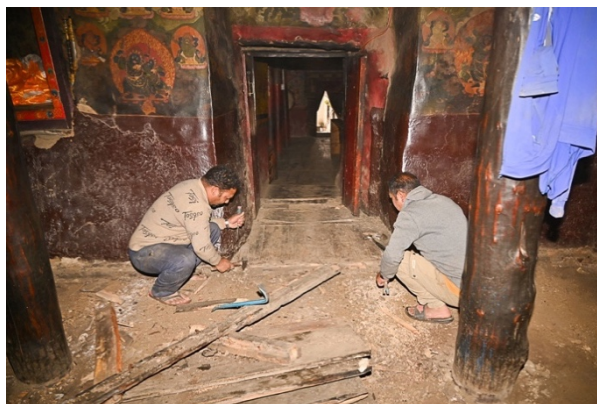
*Figure 53: Dismantling of the wooden floor of the sanctum's entry area.*

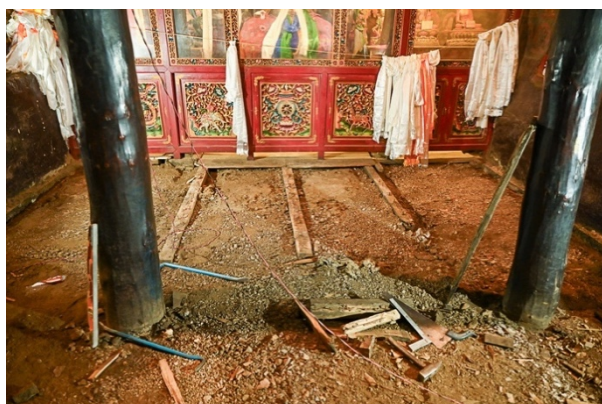
*Figure 54: The previous floor of the sanctum removed.*

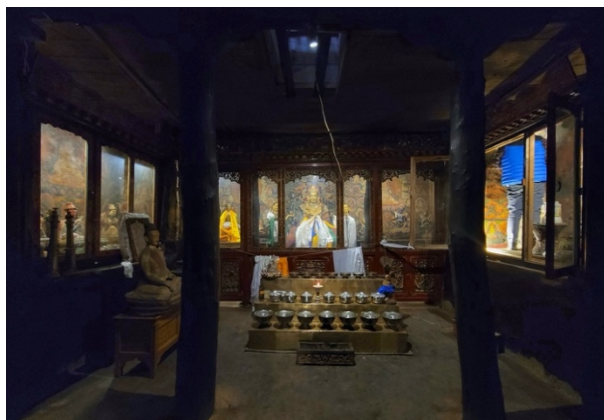
Figure 56: The main sculpture of Guru Rinpoche and other statues in the main shrine lit with the new spotlights.

The main statue of Guru Rinpoche in the main shrine was lit with five spotlights placed at angles to minimize shadows. The white light bulbs in the offering area were also removed and replaced by spotlights. Similarly, the sculptures of the eight manifestations of Guru Rinpoche along the main and side walls of the main shrine were also lit by spotlights. Then existing white PVC wire casings were removed and replaced with black double insulated PVC cables. Further, the white power switches were also replaced with darker ones to make the less conspicuous.

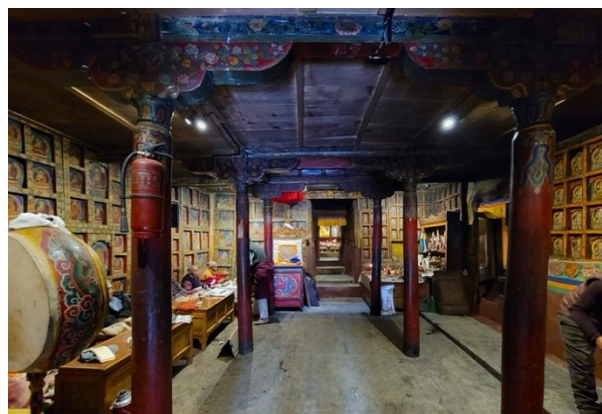
Figure 57: Local tantric practitioners (ngakpa) preparing for the annual Trenda Tsechu (? tshes bcu) under the newly installed warm spotlights in the Assembly Hall.

In the Assembly Hall, the former bright flood lights and white light bulbs were removed completely. Then, the entire lighting was replaced with new spotlights. Along the sides two spotlights were placed jointly, one to light the stone panels along the walls and the second pointing downwards as reading light for the tantric practitioners (*ngakpa - sngags pa*) and monks during the many religious rituals observed at Lo Gekar.

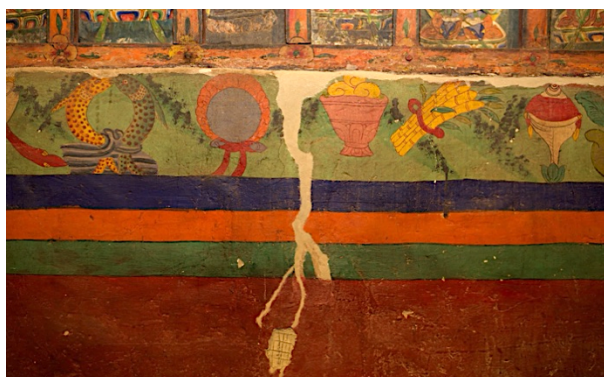
Figure 58: A major crack underneath the stone panels filled and prepared for retouching.

The extension of the project into the year 2024, was used to enhance the aesthetics in the temple and the surrounding. The long stretch of cracks in the Assembly Hall were fixed. To achieve this task, a skilled plaster expert, Tashi Angyal Gurung Lo Manthang, was hired. Then these fixed surfaces were painted to imitate the former one. The lower part of the walls below the mural which had holes and cracks were also fixed by the expert plaster man. An even surface was then prepared to apply a new paint layer.

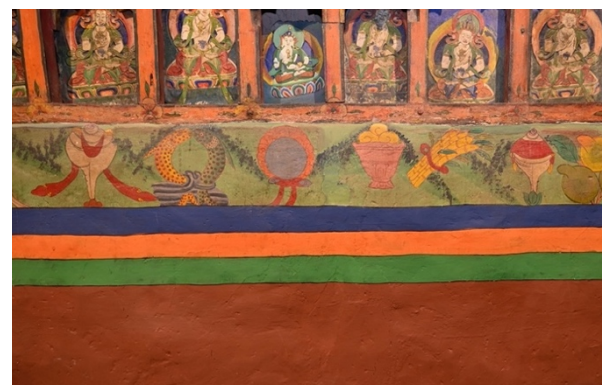
Figure 59: The same area as in Figure 58 after retouching and painting.

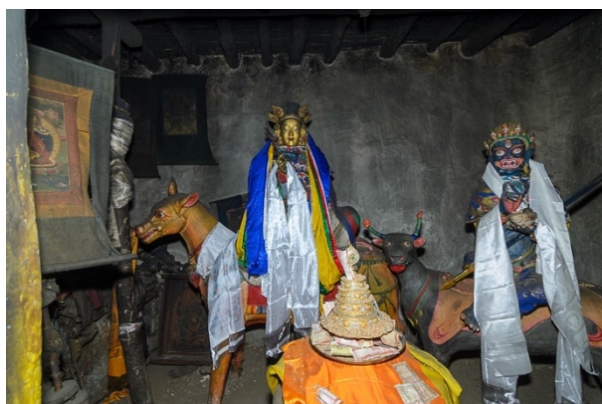
The Gönkhang, the protector deities' room located to the right of the Assembly Hall, underwent a comprehensive cleaning and the walls were given a fresh whitewash. Years of soot accumulation marred the walls, and the mud floor was riddled with rat holes. All soot and spider webs were cleared away, and the walls were coated with a chalk wash. To address the rat holes, the mud floor was compacted with aggregates and mud mortar, while the area in front of the room where the caretaker offers butter lamps was finished with flagstones. The remaining floor was plastered with mud mortar.

*Figure 60: View of the Gönkhang before restoration.*

During the floor plastering, it became evident that oil and butter residue from years of butter lamp offerings had formed a waterproof barrier on the surface, preventing the mud plaster from adhering properly. The project's 2024 extension also targeted enhancements to the Gönkhang to address this. The foreman installed flat stones on the entire floors with mud mortar, and the walls were repainted while decorative banners were added. Lighting was also installed in the protector's chapel.

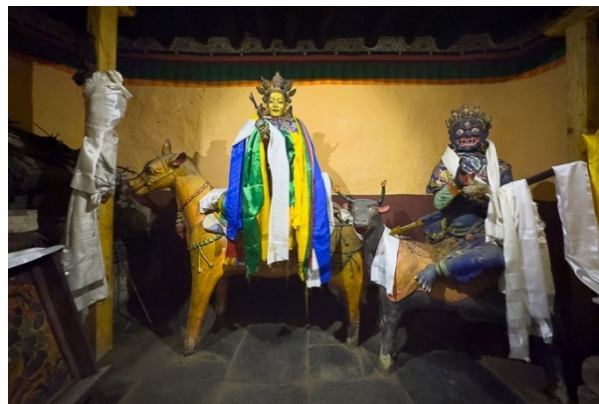
*Figure 61: View of the Gönkhang after flooring and painting of the walls and with lighting installed.*

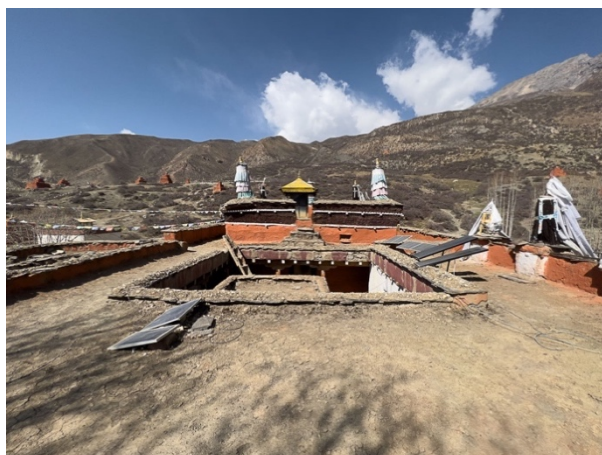
*Figure 62: The temple roof before restoration in April 2022.*

The entire roof of the temple was modified to ensure it was waterproof by applying a bituminous waterproof membrane and creating a significant slope towards the new drainage spouts. The existing mud layer on the roofs was removed until reaching the previously installed plastic sheet layer. Wooden frames were then installed, ensuring that the waterproof plywood laid on them sloped towards the drainage spouts. Further, the plywood was covered by a bitumen membrane using bituminous paint and a blow torch, adding a second layer of water proofing. Finally, the roof was finished with a layer of local

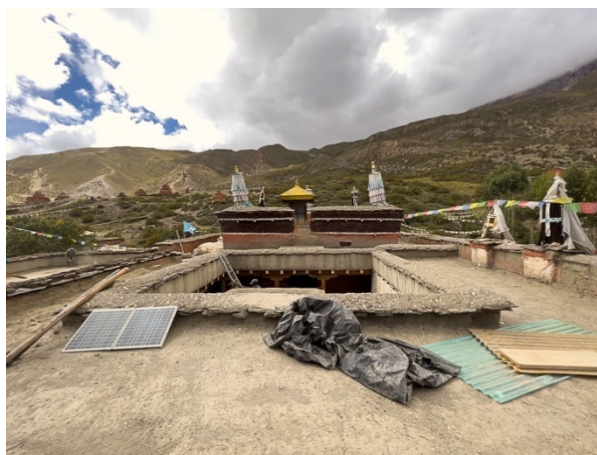
*Figure 63: The temple roof at the end of the restoration in September 2022.*

clay mixed with fine clay sourced from Kagbeni, and the mud layer was compacted using a wooden tamper.

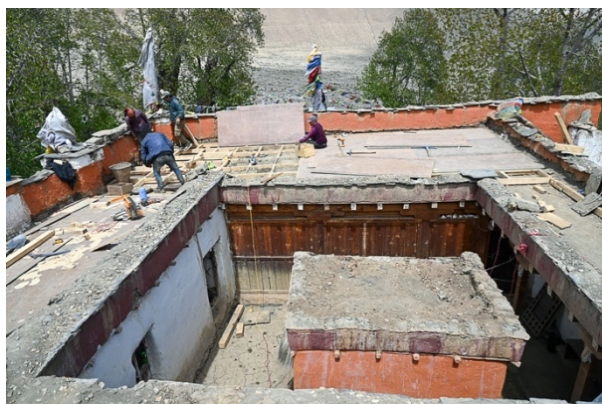
*Figure 64: Constructing sloping wooden frames and installing the waterproof plywood sheets on them in May 2022.*

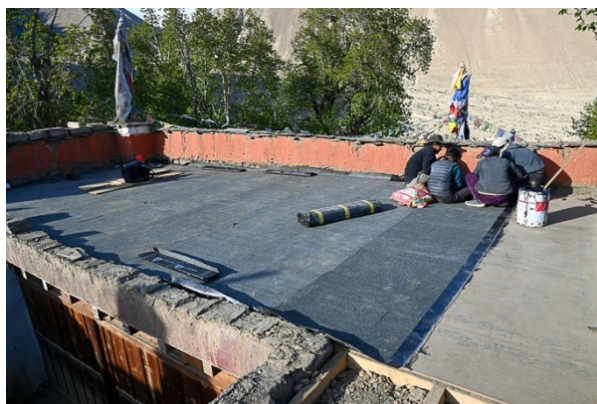
*Figure 65: Applying bitumen sheets above the plywood layer in late May 2022.*

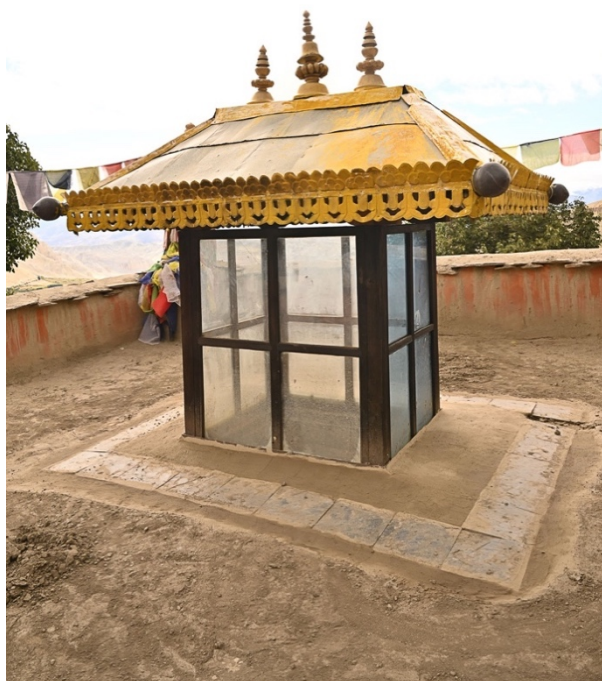
*Figure 66: The previous tin sheet lantern room painted in yellow.*

The former painted tin roof covering the lantern above the sanctum was replaced with thick copper sheets in the end of September 2023. The tin sheets built over the wooden frames were dismantled completely. The top of the wooden frame was reinforced with the addition of a new board and the rest of the former frame was kept original.

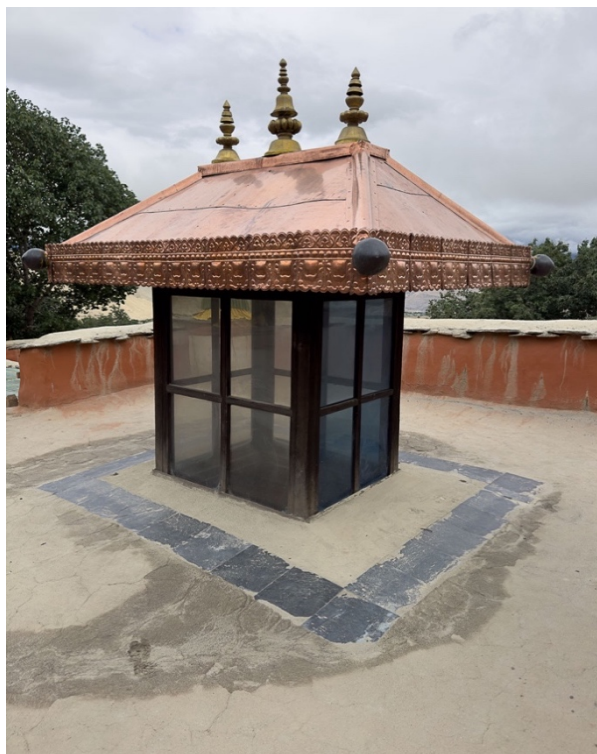
*Figure 67: The current copper sheet lantern roof.*

Several rolls of copper sheets were brought from Kathmandu. Custom pieces were cut and assembled to the frame using screws. The entire fabrication of the copper roof was done by a skilled craftsman from Helambu who has been working in restoration and reconstruction projects at Muktinath temple.

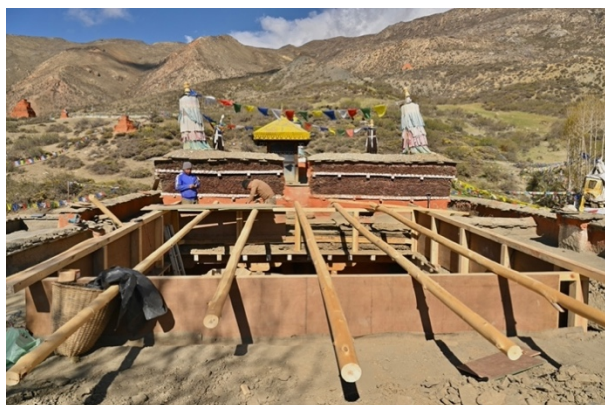
*Figure 68: The construction of the frame for the roofing of the courtyard.*

Despite the work in the previous year in making the floor of the courtyard above the Assembly Hall as waterproof and usable under adverse weather conditions, the small existing drainage pipe could not be expanded due to the Kanjur Lhakhang being built over it. Accordingly, the drainage of this area still represented a risk, and it was decided to cover the entire courtyard with a wooden framework holding transparent sheets. Thomas Schrom proposed a design for such a lightweight skylight covering the courtyard, which was constructed this quarter.

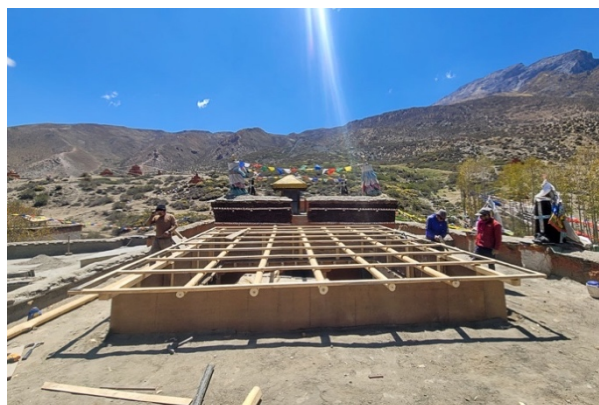
*Figure 69: The finished frame for the courtyard roof.*

Accordingly, the adobe parapets around the courtyard were dismantled and a main supporting frame was built of wood above the existing timber structure. Round poplar beams were purchased from Sakre and were connected to the square frame to provide the support for the rafters and the fiber sheets (Figure 68). Rectangular rafters were then screwed onto the poplar beams (Figure 69), and the corrugated fiber sheets were screwed to the rafters to complete the skylight (Figure 70). Pine boards were installed over the prepared frames on the internal side while waterproof plyboards were used for the exterior surface. Similarly, bitumen sheets were extended on the ply board surface as a

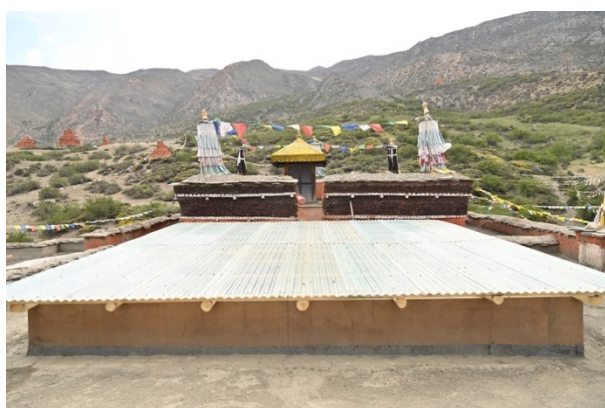
*Figure 70: The roofing of the courtyard largely completed.*

waterproofing measure and also for the durability of the exterior wooden surfaces from natural wear and tear.

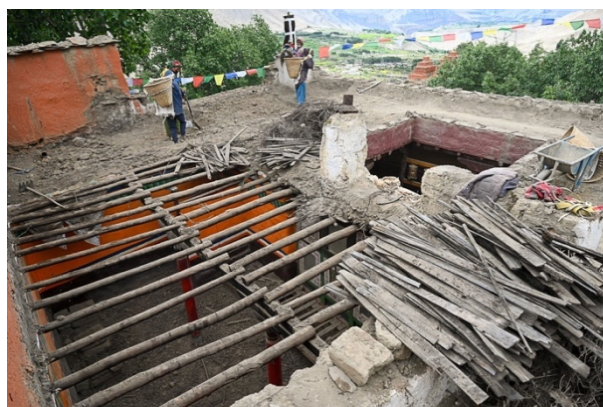
During the removal of the roof layer down to the joists, a two-foot-thick mud layer was uncovered, which had accumulated over the years to prevent seepage. This layer significantly increased the weight on the walls and main beams, causing some mud bricks beneath the main beams to become compressed and develop cracks. The cracks were evident due to the absence of wall plates under the beams and the joists. Once this layer was exposed, it was entirely removed to allow access to the floor beneath, which was also taken out as necessary for reconstruction.

*Figure 72: Removing the roof above the VIP room with the original joists exposed.*

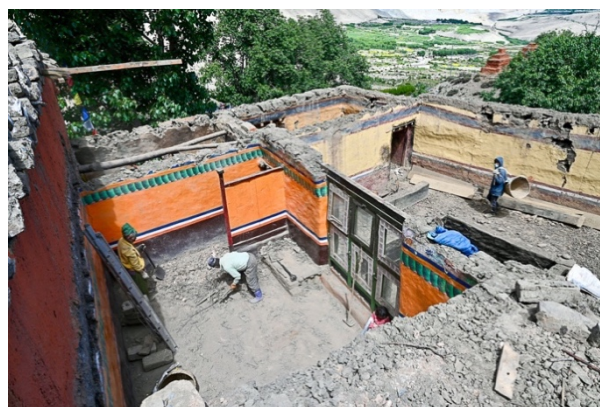
*Figure 73: The roof of the entire front section removed completely.*

The reconstruction followed the original floor plans. To alleviate stress, the main beams were supported with wall plates to distribute the weight horizontally across the walls. Additionally, the cracked rammed earth walls were reinforced with the insertion of

horizontal plates, and the damaged mud bricks were replaced with new ones. When damaged, the old round joists on the ground floor were substituted with salvaged joists from the upper floor. The construction was further strengthened by reducing the gaps between the joists with additional round joists.

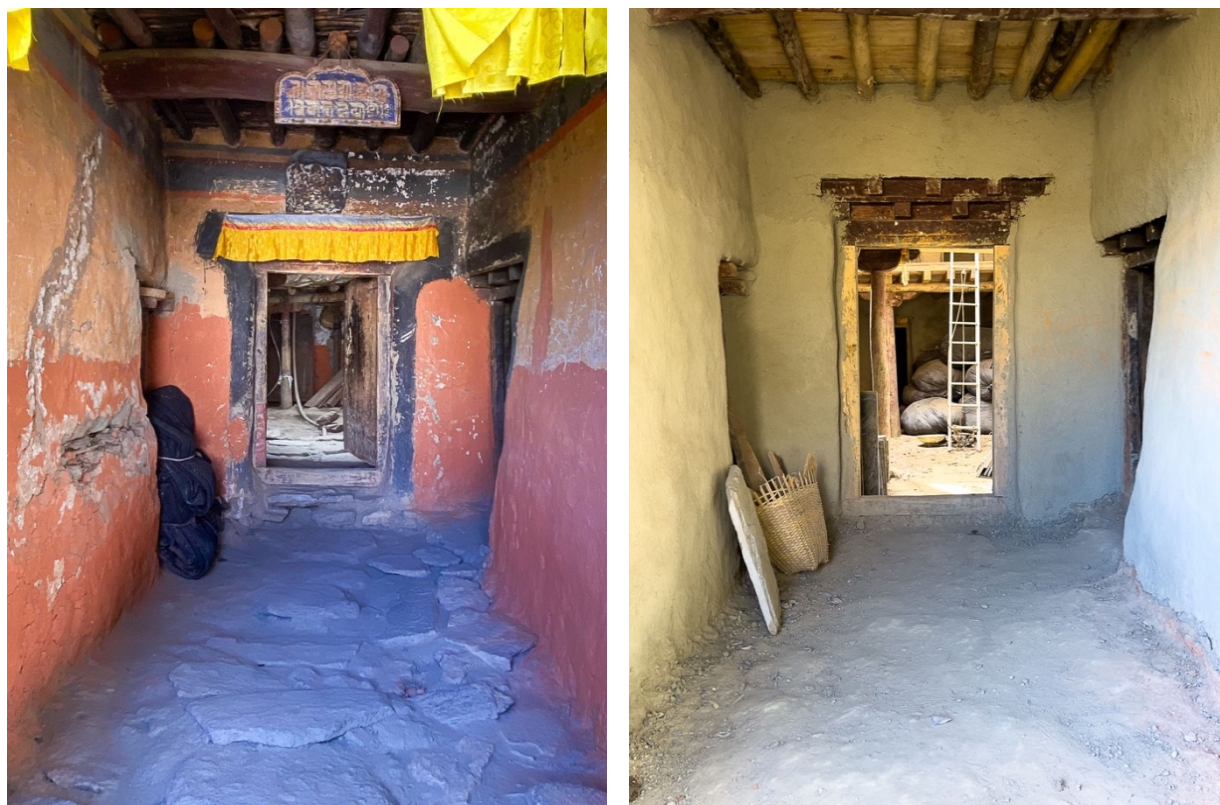
The entrance to the caretaker's residence required reinforcement to support the superstructure above. The walls beneath the main beam exhibited significant stress cracks, which were addressed by adding slates and replacing the damaged sections with new mud brick walls.

Figure 74: The entrance to the caretaker's quarter before restoration.

The door to the storage area on the left was straightened and reinforced from the inside to accommodate the visitor's toilet. The original door was preserved to maintain its historical appearance. To enhance accessibility for visitors and pilgrims, the vertical columns of the entry door were replaced with longer ones, increasing the door's height. Other components of the door were retained and restored.

Lastly, the floor of the entrance area was leveled, and a flat stone pavement was installed for easier maintenance, with the paving completed in September 2022.
