# Seismic Strengthening and Restoration of Lo Gekar

U.S. Ambassadors Fund for Cultural Preservation, Award No. SNP40020GR0042

## Final Project Report, 2021–2024

### Norbusum Foundation (NGO)

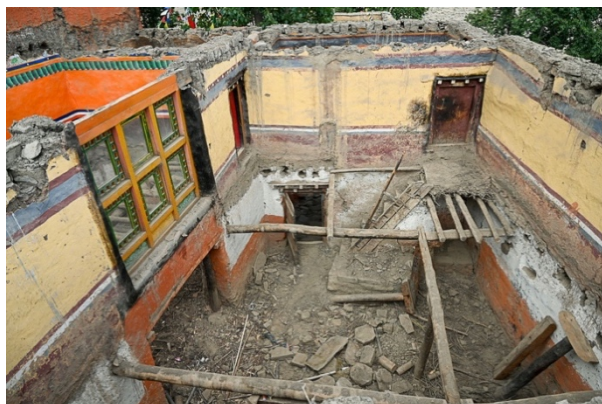
*Figure 76: Deconstructing the atrium to ground floor level.*

The entire wooden structure of the atrium was dismantled and reconstructed with new wooden joists. The height of the lower floor atrium was initially too low, prompting a decision to lower its floor level to match that of the entrance area. This required the removal of the stone pavement and excavation of the floor to that level, revealing accumulated animal waste from its previous use as a horse shed for local pilgrims and visitors.

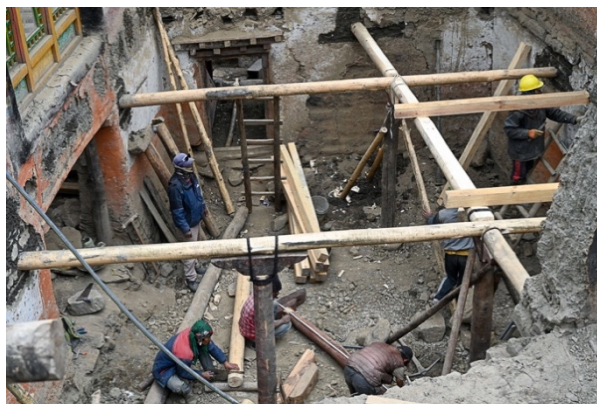
*Figure 77: Reconstruction of the timber structure in the atrium after lowering its floor level.*

The deteriorated columns and capitals were replaced with sturdier salvaged ones, while new round main beams were installed. The flooring was revamped with flat stones sourced from Marpha. Additionally, the old staircase was taken out to eliminate the narrow passage to the VIP room on the upper floor. A new staircase with a wooden rail was then constructed from the main entryway leading up to the upper floor kitchen.

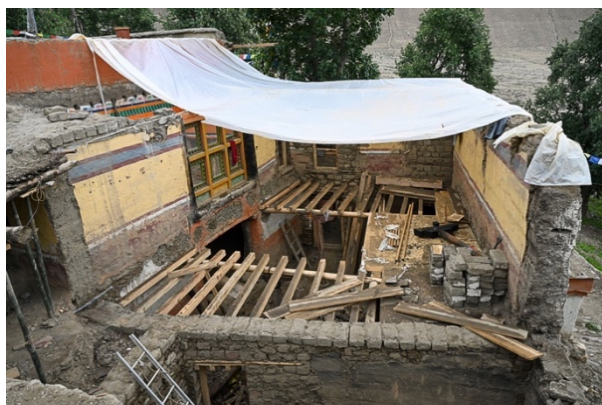
*Figure 78: Reconstructing the timber structure of the atrium on the lower floor.*

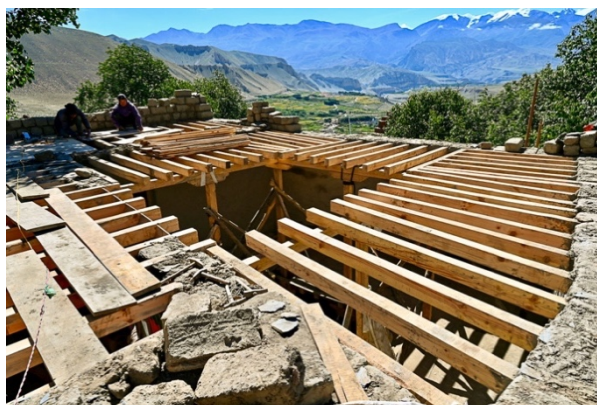
*Figure 79: Reconstructing the timber structure of the atrium on roof level.*

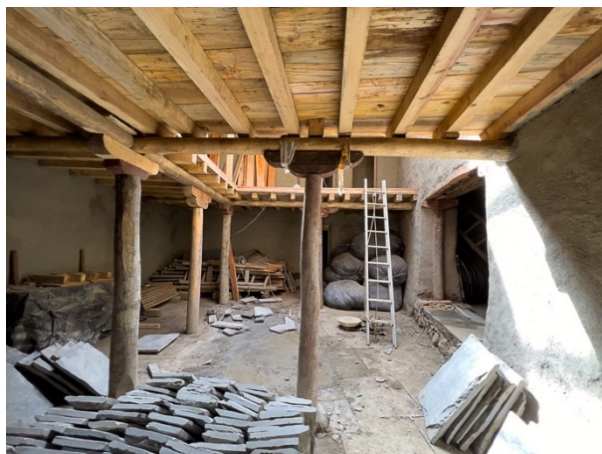
Figure 80: Ground floor of the atrium with the new stone pavement used as a storage during restoration.

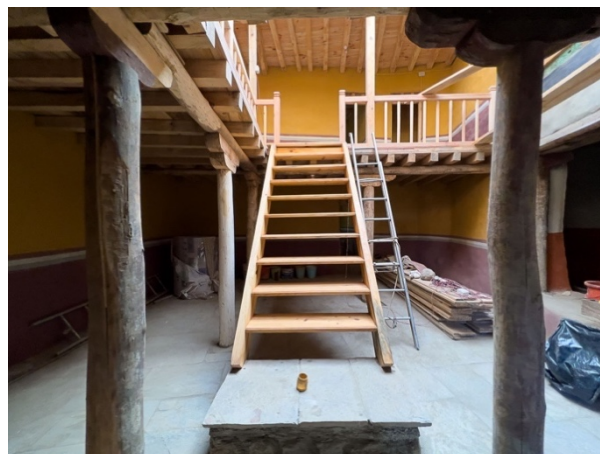
Figure 81: Ground floor of the atrium with the new stairs installed.

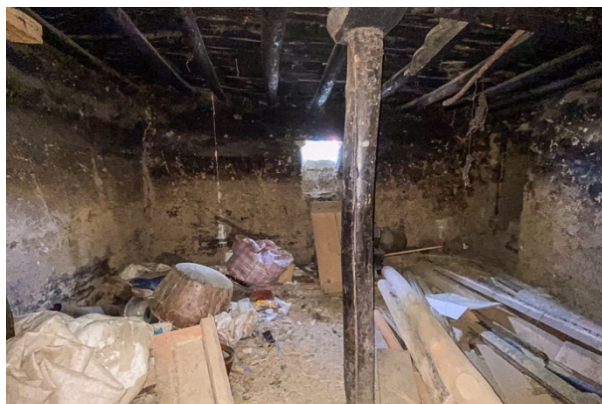
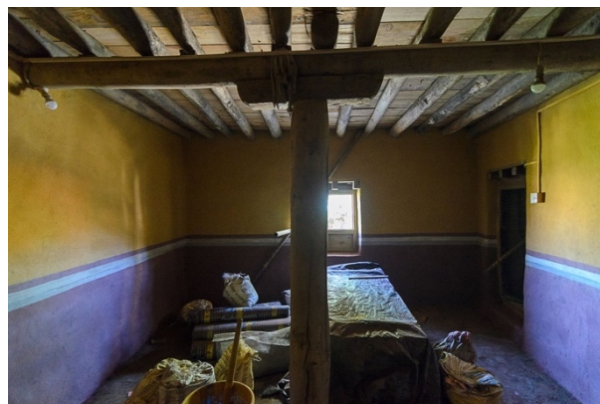
*Figure 86: Room L11 used as a storage before restoration.*

Upon closer examination of the architecture, it was discovered that this room contained a hollow space underneath. To address this, the hollow space was filled with rubble to create a sturdy floor, and the wooden components such as joists and round sticks were removed. Additionally, the floor level of the room was lowered to increase the ceiling height and align it with the adjacent atrium.

To enhance the structural integrity of the room, the columns, beams, and joists were replaced with locally sourced new ones. The walls received necessary repairs, and the floor was paved with flat stones to facilitate easy maintenance. Moreover, an existing small opening on the east side was upgraded to a proper window, allowing natural light to brighten the space.

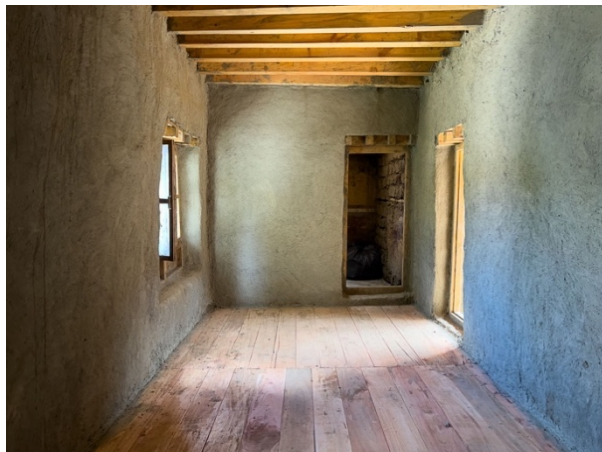
*Figure 88: The new guestroom with attached bathroom during restoration.*

The area of the bathroom was walled, and a new entrance created. For the bathroom a small vent was constructed to allow for natural light and to provide sufficient ventilation. A square frame was constructed on the floor and then filled with clay before covering it with floorboards.

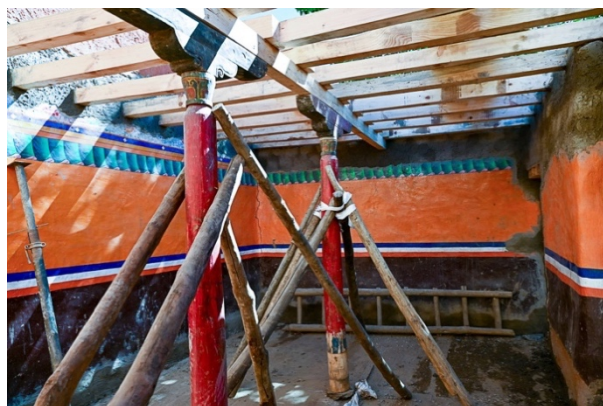
Figure 91: The new timber structure for the ceiling of the VIP room.

In the room that has mainly been used to accommodate VIP guests—hence its name—the damaged round beam and the joists were completely replaced with square ones, while the carved and painted columns and capitals were reused. The door was replaced with a larger one. As usual, a frame was constructed to support the floorboards and filled with clay. The clay was leveled and then floorboards were installed to complete the floor. The painting of this room was retained and repaired at the end of the restoration; the window was newly painted.

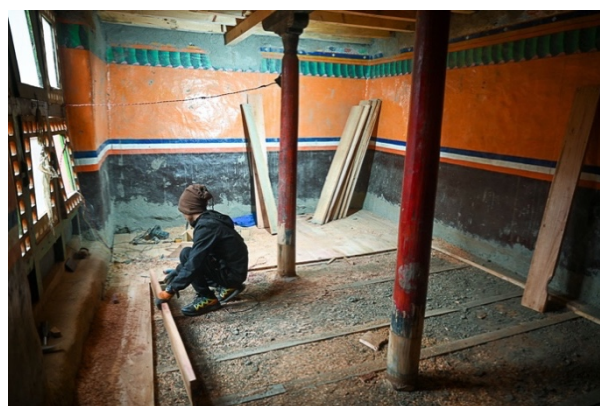
Figure 92: Installing the floor boards in the VIP room.

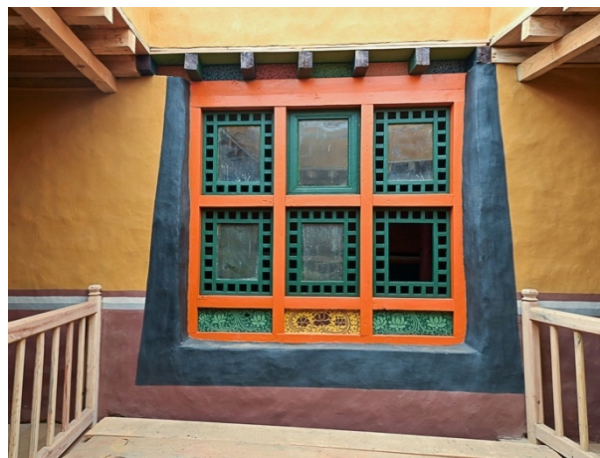
Figure 94: The window of the VIP room after repainting.

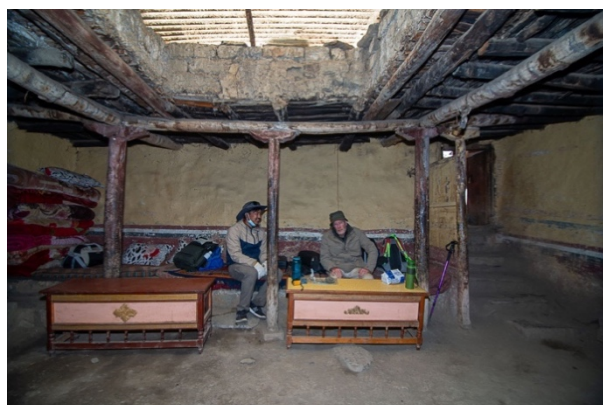
*Figure 95: The back guest room before restoration.*

Due to their weight, the raised mud brick platforms along the walls on which the mattresses were placed were removed. The old columns, beams, and joists have been replaced with new square ones. The walls on the entry side, which did not reach up to the ceiling level, were increased in height with mud bricks, and an entrance was built in the middle of the wall. These walls now support beams and joists.

The large skylight has been reduced in size to retain more indoor heat during winter days. It has been built on a mud brick parapet with wooden frames and transparent poly sheets.

The mud floor was replaced by a wooden one. To enable this, channels had to be dug into the mud floor to accommodate the wooden frames. The gaps were compacted well before finishing the floor with floorboards.

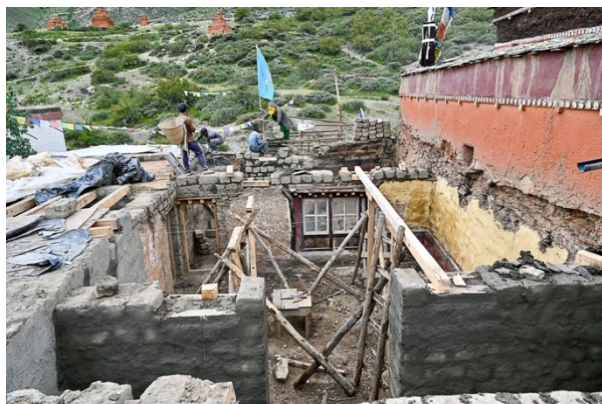
Figure 97: View of the back guest room after dismantling the roof. Note the new walls in the foreground.

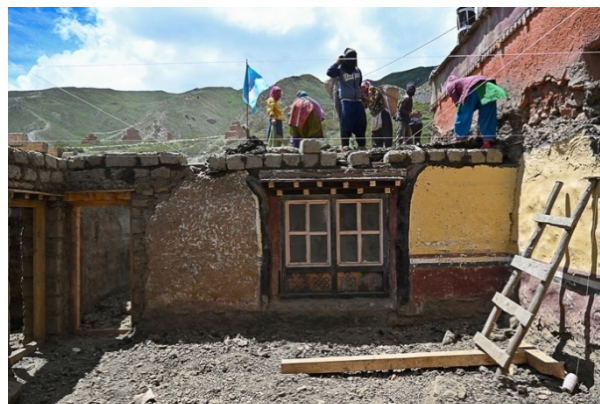
Figure 98: The back guest room during reconstruction.

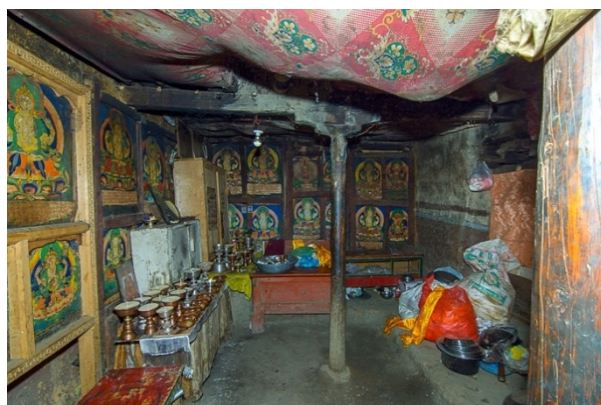
*Figure 101: The former Avalokiteśvara chapel behind the back guest room.*

Behind the back guest room, and connected to it through a door and a large painted window, is the room that originally housed the Avalokiteśvara stone panels. This room used to receive little daylight from an inadequately constructed skylight made of mud bricks and covered with a chicken mesh along with pieces of corrugated fiber sheets. Since the panels of this room have been relocated to a room on the temple side, this room now serves as a retreat room.

The west side of the wall had cracks at several sections, some of which were see-through. These cracked sections were demolished and rebuilt with new mud bricks and reinforced with horizontal wooden plates. The damaged round beams, joists, and columns were completely replaced with new square ones. A new skylight replaced the old one, and now enough natural light can enter the room. Again, the skylight was constructed as a square wooden frame covered by a transparent sheet.

The mud floor was leveled, and channels were dug to accommodate the wooden frames to which the floorboards were nailed. Similarly, the low door was replaced by a new larger one for safe and convenient access for visitors and the caretaker.

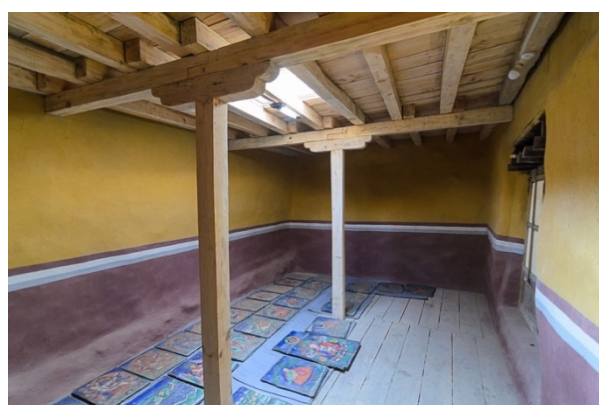
*Figure 102: The same room after restoration used as a temporary storage for the stone panels of the upper sanctum.*

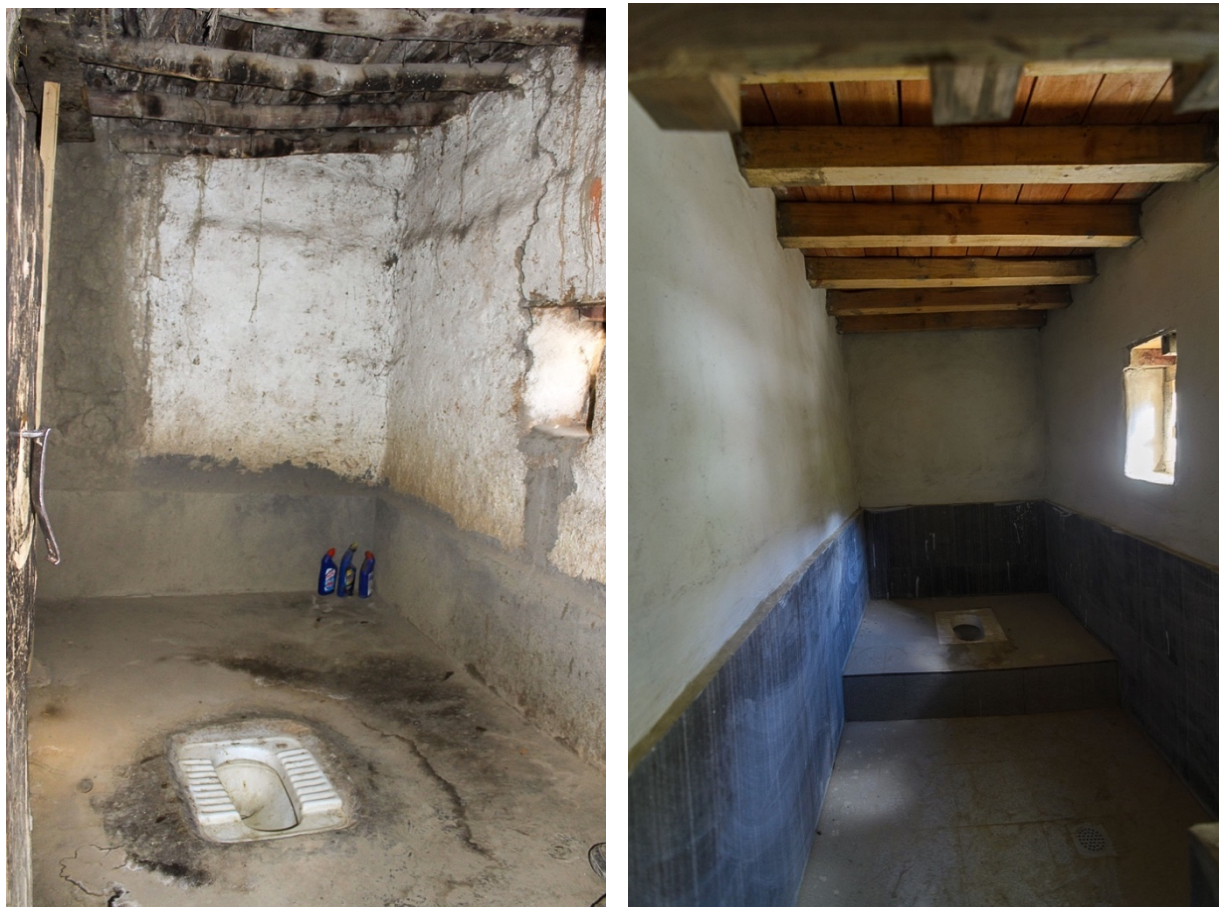
*Figure 103: The toilet before and after restoration.*

The two doors leading to the toilet were replaced with new larger ones. The old concrete floor was demolished to inspect the joists underneath and to accommodate the drainage pipes. Some of the joists were rotten and needed to be replaced with new ones. New ceiling boards were installed on the joists and then the floor was remade in concrete with iron rod reinforcements underneath. The waste pipe was installed on the concrete connecting the old waste pipe from the cess pit.

The toilet is equipped with tiles on walls and floors with water taps. The entry area to the toilet has been equipped with hand wash sink.

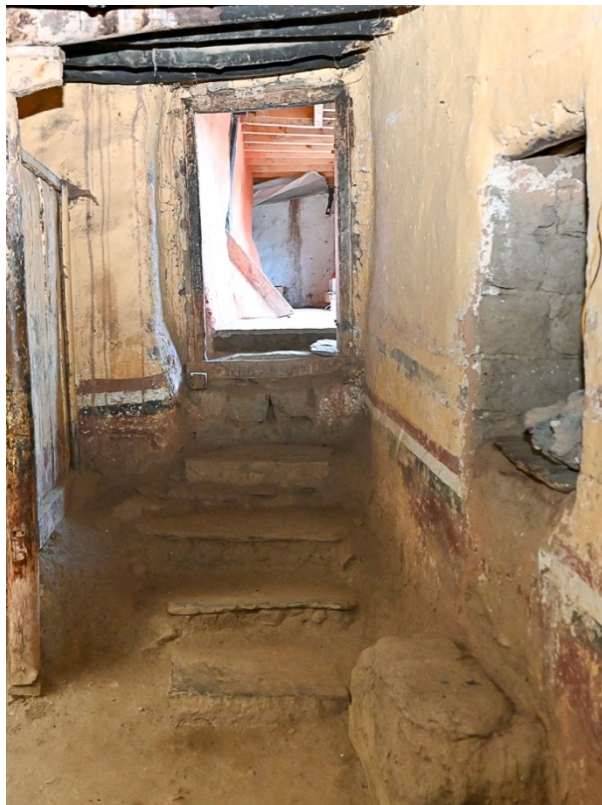
*Figure 104: The passage to the temple courtyard before restoration in June 2022.*

The passage leading to the temple courtyard has also been redone with flat stone pavement on the mud floor. The steps were also repaired with wide flat stones. Likewise, for safe and convenient mobility, the low door was also replaced with by a higher one.

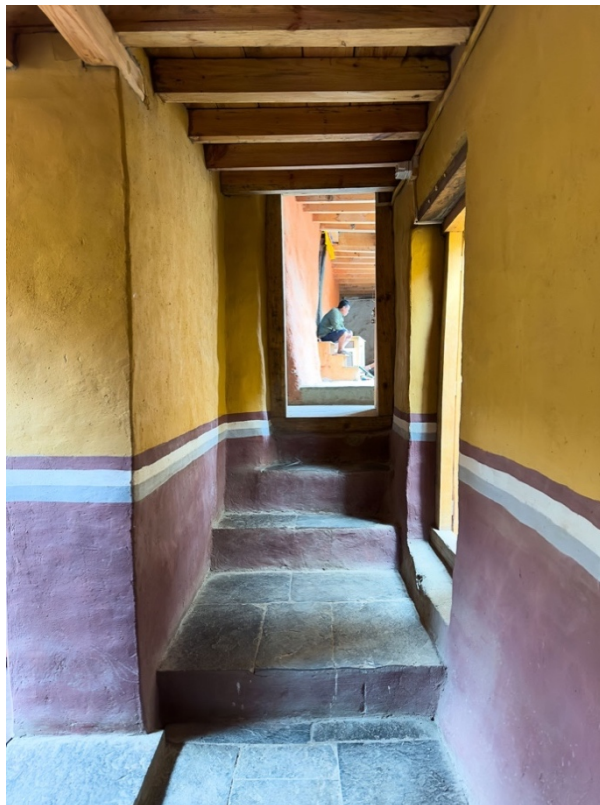
*Figure 105: The passage to the temple courtyard after restoration in July 2024, the door to the right leads to the roof.*

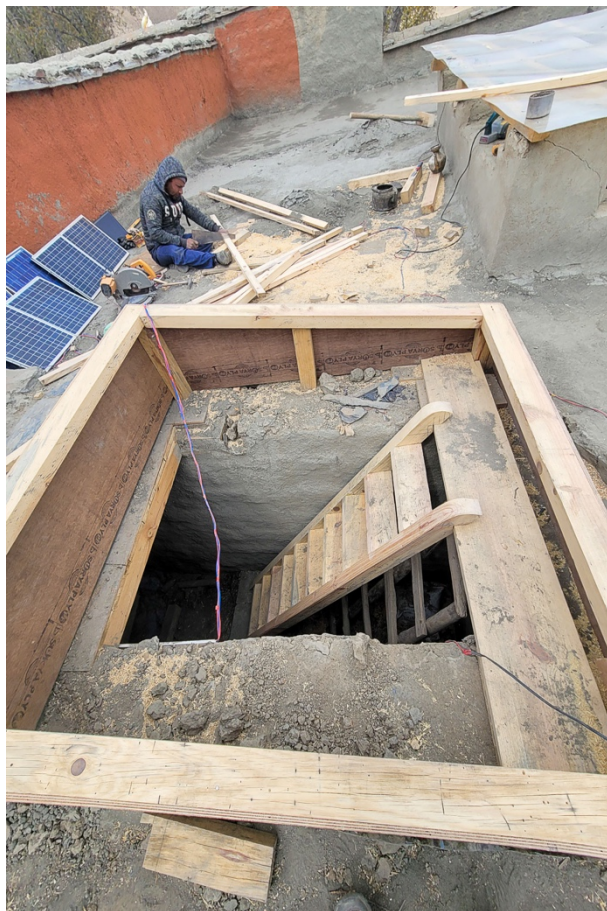
*Figure 106: Roof access opening during construction.*

The roof is now accessed through a small room located between the passage and the VIP room through a steep flight of stairs.

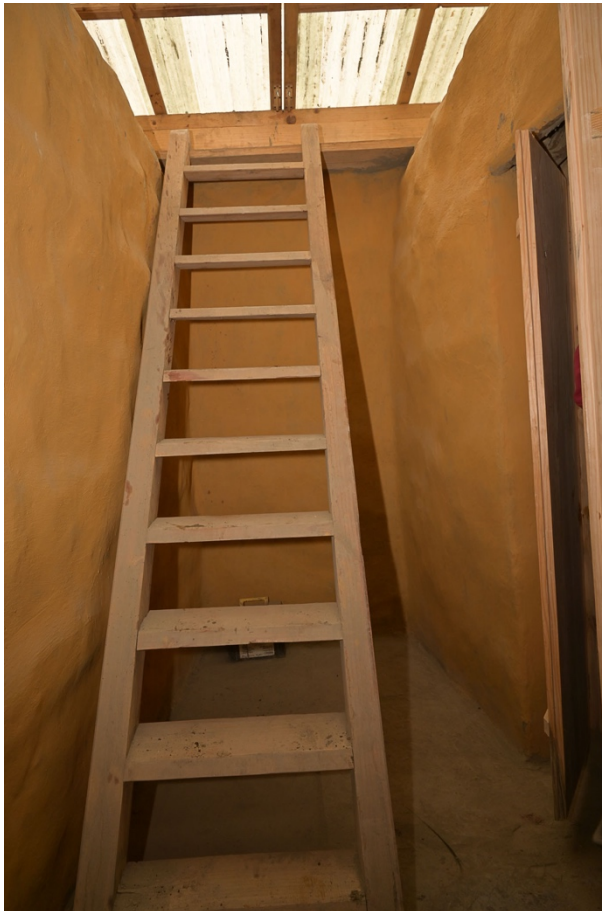
*Figure 107: Roof access with its opening covered by a corrugated sheet skylight that can be opened.*

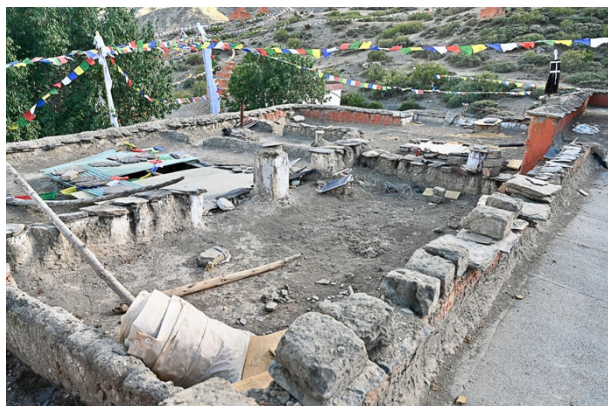
*Figure 108: The roof of the caretaker's mansion before the restoration, the east section in the foreground.*

Mostly importantly, the restoration enabled the replacement of the roof of the entire mansion in a uniform format mirroring that of the temple. The construction of this roof is the same as the one above the temple, a wooden frame constructed at an angle supports a plywood and bitumen layer and is covered by clay. Two spouts drain this roof on the south side. All skylights are framed in wood and covered with transparent sheets. Originally flat sheets were used for the cover, but they warped within a year and needed to be replaced by corrugated ones.

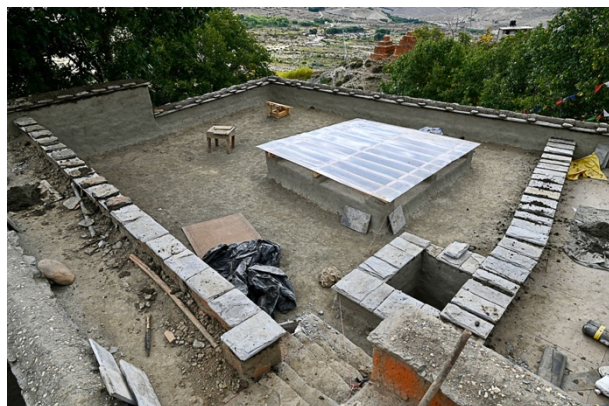
*Figure 109: The roof of the east section of the caretaker's mansion after reconstruction.*

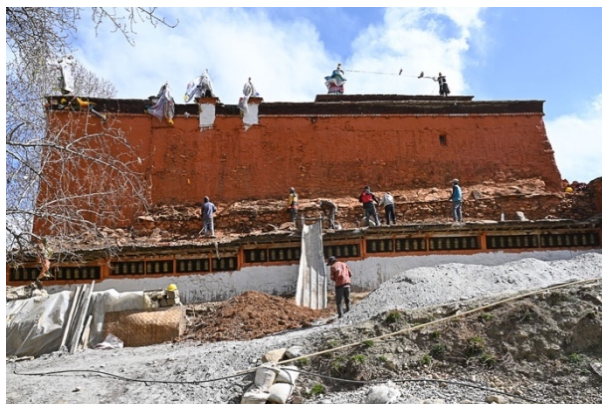
Continuous lines of mani wheels surround the temple structure on three sides, with stupas at the four corners. The structure holding the mani wheels along the north wall was in poor condition. Thus, a group of workers were employed to restore this section.

There is a two-layered construction with mani stones and prayer wheels running along the entire wall, which was covered with mud and grass. The prayer wheels have been pushed outwards by the weight of the construction, and parts were damaged by the exposure to water from the roof. Further, there were indications that occasionally humidity reached the murals inside the sanctum on this side of the wall, leading to damages. Therefore, it was decided to restore this part in its entirety.

*Figure 110: Beginning of the restoration of the mani wheel wall on the north side in April 2022.*

In the first step, it was made sure that the stones of the upper layer were placed correctly, and mud plaster covered the areas in between the stones. The supporting wall was also consolidated. Then the entire superstructure of the prayer wheels was taken off, the prayer wheel construction pushed back into an upright position, and its roof was newly laid. Wooden sections supporting the roofing were replaced and a plastic sheet was introduced underneath the mud layer to protect the wooden construction underneath. Finally, the area behind the prayer wheels was newly plastered.

Special attention was paid to those areas that receive the water from the roof via its drainage spouts. These were covered with additional superimposed stone panels forming a stepped construction. Finally, the wall was repainted with the traditional colors.

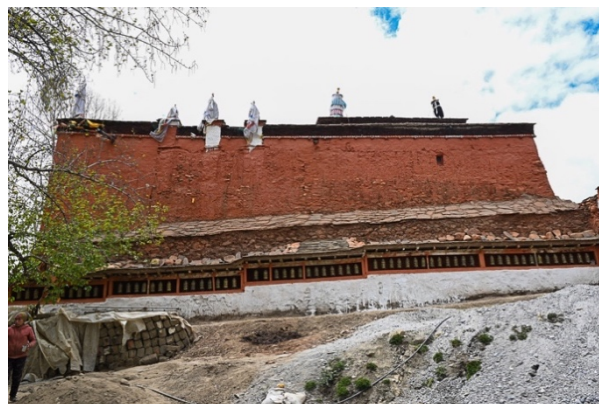
*Figure 111: The mani wheel wall on the north side after the restoration in May 2022.*

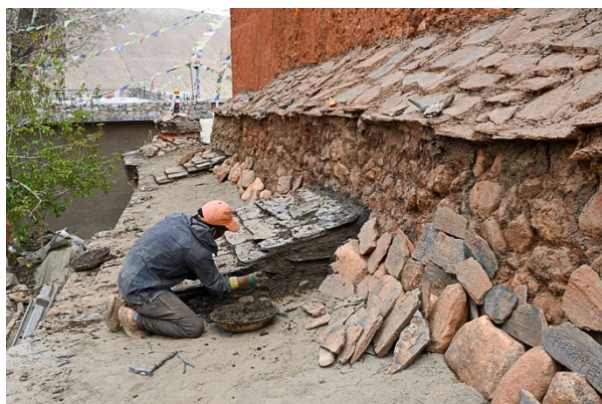
During the restoration period, it became clear that the traditional stone roofing reconstructed on the north side of the temple in the first year of the project was not watertight enough to protect the mani wheels for a longer period. Further, it was observed that weeds had grown on the mani wheel roofs that were repaired in 2022.

*Figure 112: The roof of the mani wheel wall towards the end of the initial restoration in May 2022.*

Therefore, it was decided to cover all mani wheels around the temple by the flat stones acquired in Kathmandu. The new roofing with thin flat stones projecting the edges will make sure that the rainwater will drop to the ground without running over the wooden purlins and the wooden frames supporting the mani wheels. They also enable an overlap that prevents the mud on the roofs from eroding during rainfall. Likewise, the plastic sheets used as a waterproof layer did not help much to stop water penetrating from the edges to the walls underneath.

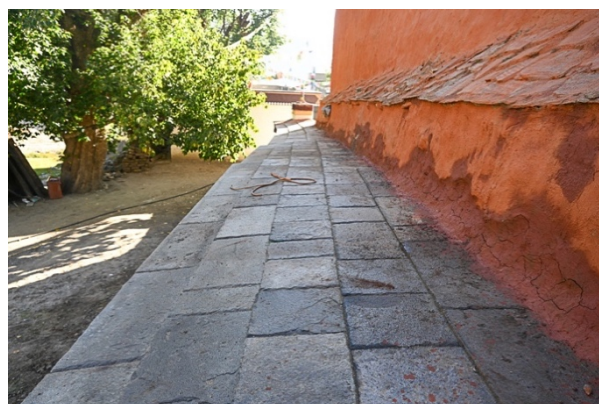
*Figure 113: The same roof section of the mani wheel wall after laying stone panels in October 2023.*

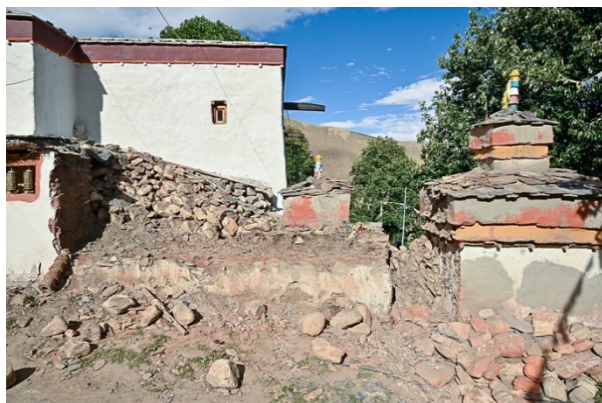
*Figure 114: Uncovering the existing platform to build encasing for the prayer wheels.*

A set of eight prayer wheels from the caretaker's former atrium had been stored since 2022 after they were dismantled to restore the caretaker's residence. Later after the internal works had been completed, the same prayer wheels could not be restored at the former location due to the construction of the staircase in a different spot and an installation at another place would not allow the turning of the wheels clockwise as is done traditionally. Further, this space is being used for groups now and installing the prayer wheels there would not be appropriate.

A picture published by David Snellgrove documents the existence of a set of prayer wheels at a location in the back of the temple that more recently only had mani stones. Thus, after consultation with the caretaker it was decided that these prayer wheels are to be installed in this position, where the previous mani wall platform could still be observed. Accordingly, a supporting wall was constructed over the existing platform, and the prayer wheels were installed in two compartments. They now complete the row of prayer wheels along the back of the temple. The mani stones (maldangs) last located in this place were moved further west on a flat land and arranged to imitate a stupa as requested by the caretaker.

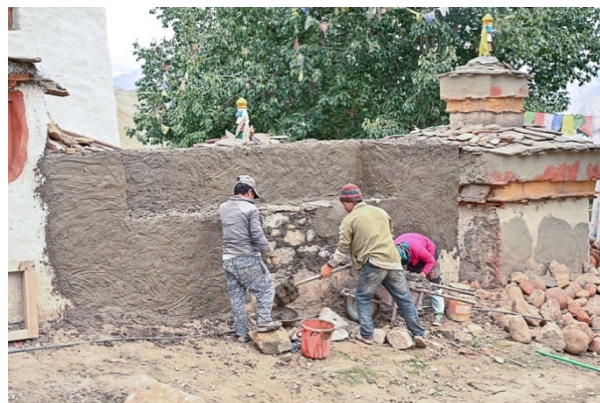
*Figure 115: Constructing the new encasing.*

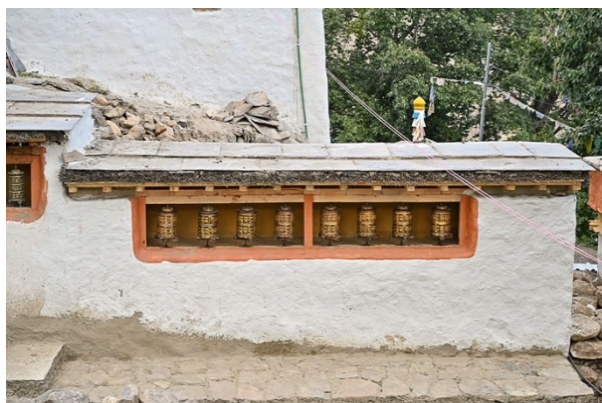
*Figure 116: The mani wheels installed in place.*

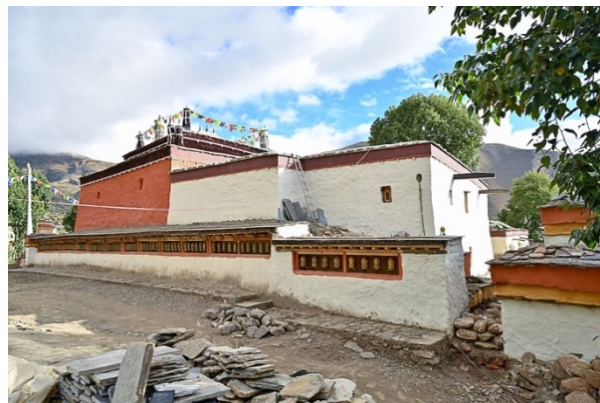
*Figure 117: View of the west wall after the installation of the restored mani wheels.*

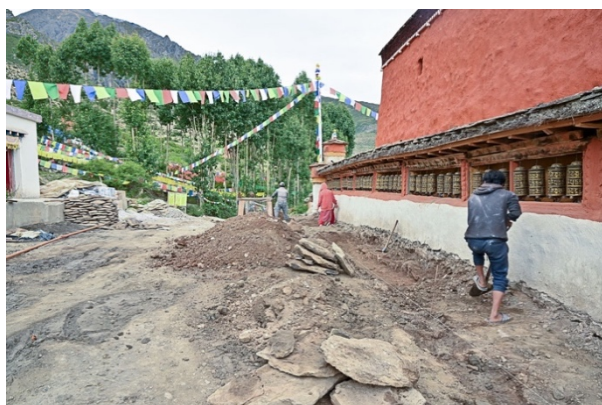
In mid-September 2023, Thomas Schrom visited the project site and provided recommendations for using the existing flagstones to even out the circumambulation path, as the existing path was uneven and low in some places. Thomas Schrom prepared a drawing for the new pavement and provided instructions to achieve an even path.

*Figure 118: Work on the circumambulation path on the west side.*

Accordingly, the old flagstones were all dismantled and the ground was leveled, which involved plenty of digging. A stone masonry wall was constructed along the ends to reinforce the flagstones which rested on it. The gap was then filled with stones to provide a sturdy platform for the flagstones. This also prevented the installed flagstones from moving outward in the future at the same time sinking during the wet seasons. The areas where the water from the drainage spout hit, were installed using cement mortar and the grouting was also done using the same to keep the flagstones intact.

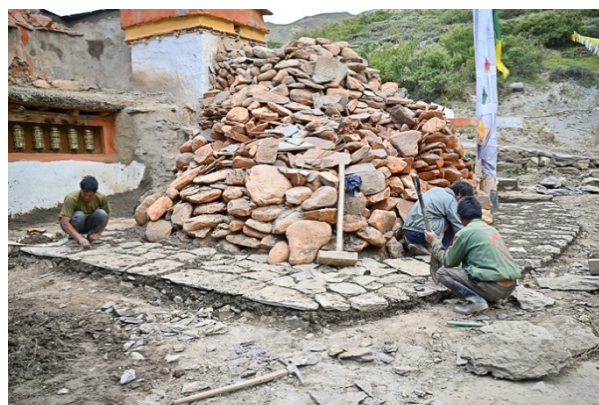
*Figure 119: Work on the circumambulation path around mani stones in the northwest corner of the temple.*

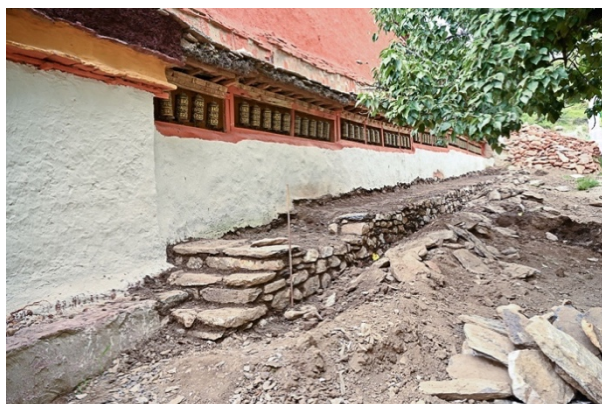
*Figure 120: Improving the circumambulation path on the north side.*

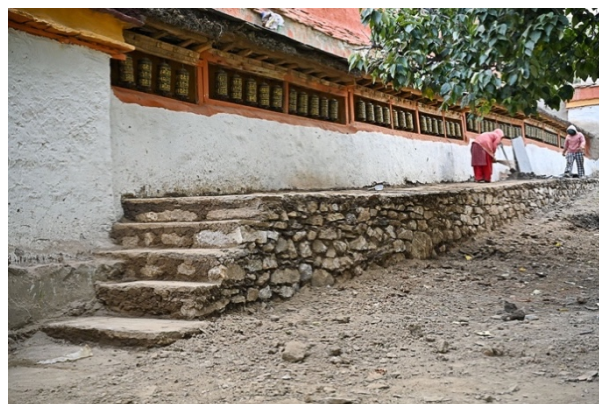
*Figure 121: The newly constructed circumambulation path on the north side.*

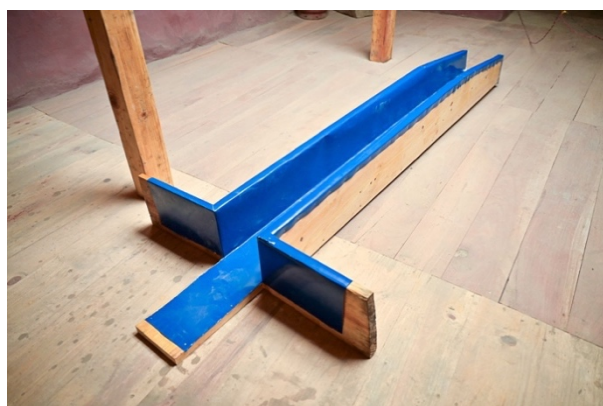
When completing the roofs in the year 2022, PVC pipes were used to ensure their drainage. However, it was widely felt that it would be better to improve these spouts with more solidly anchored ones. Thus, in June 2023 Thomas Schrom designed spouts that could be anchored more securely and fitted the structure and its technology better.

*Figure 122: A new drainage spout ready for installation.*

Hence, all four spouts; two on the temple side and two on the caretaker's mansion side were replaced. The skilled carpenters from Kathmandu constructed the new wooden drainage spouts according to the plans using pine boards. The inner surface was covered with galvanized metal sheets for durability. An opening was bored into the adobe parapet below the purlins and the spouts were inserted. The spouts were then nailed onto underlying joists to hold them in place. Then Bitumen membrane was extended over the spouts' surface and on the sides. The wooden spouts were sanded, and black paint was applied. A final coat of linseed was applied to provide a waterproof layer.

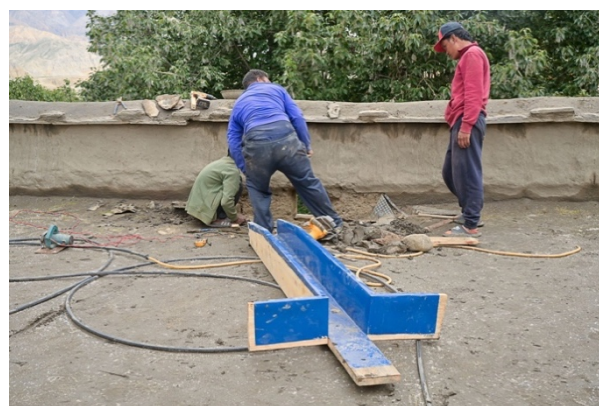
*Figure 123: Installation of a new spout on the south side.*

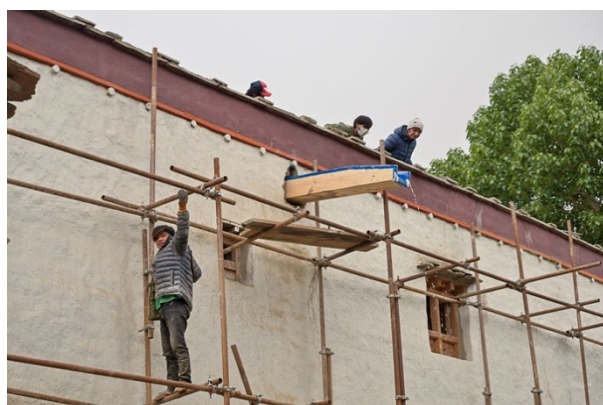
*Figure 124: Testing the water flow of the freshly installed spout.*

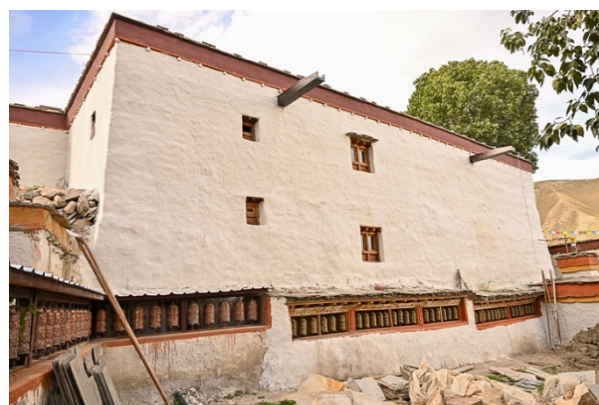
*Figure 125: The south side with two newly installed spouts.*

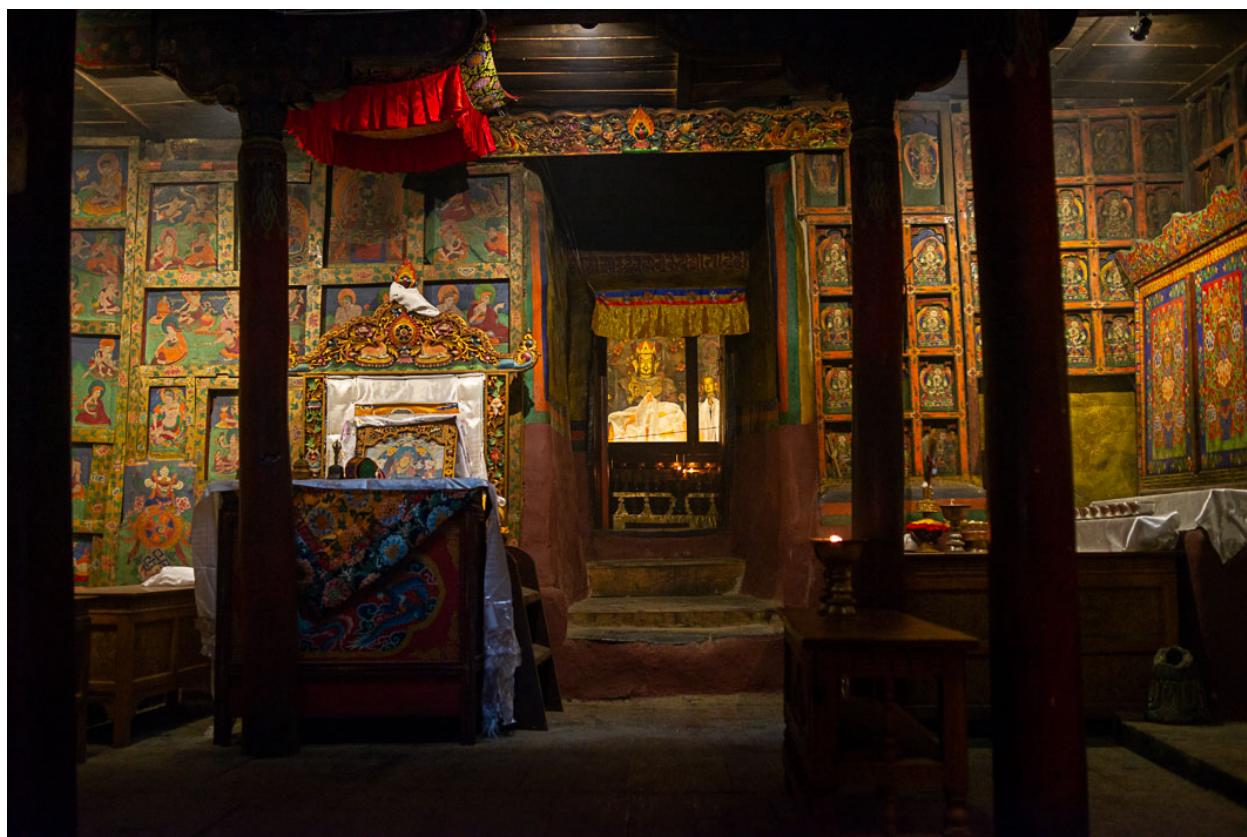
*Figure 126: The Assembly hall and the sanctum with the new lighting installed.*

In the Assembly Hall, the former bright flood lights and white light bulbs were removed completely. Then, the entire lighting was replaced with new spotlights. Along the sides two spotlights were placed jointly, one to light the stone panels along the walls and the second pointing downwards as reading light for the tantric practitioners (*ngakpa - sngags pa*) and monks during the many religious rituals observed at Lo Gekar.

The entire lighting of the temple and the caretaker's residence were improved during the project. The entire facility has been equipped with a battery backup that is charged two ways, electricity and solar. The cluttered wires were replaced in the temple while a completely new wiring was installed in the caretaker's side. To minimize the occurrence of fire hazard due to short circuit, a miniature circuit breaker (MCB) was added in every rooms.

Later in year 2024, the bright flood lights in the main shrine, Assembly Hall and both Upper Guru Lhakhang and Chénrezik panel rooms, were enhanced by replacing the old bulbs with warm spotlights. Likewise, the bright PVC housing for wires were replaced with black double insulated PVC cables.
