# Architectural Restoration and Seismic Strengthening of Gönpa Gang

U.S. Ambassadors Fund for Cultural Preservation, Award No. SNP40022GR0039

**Final Project Report, April 2025**

**Norbusum Foundation (NGO)**

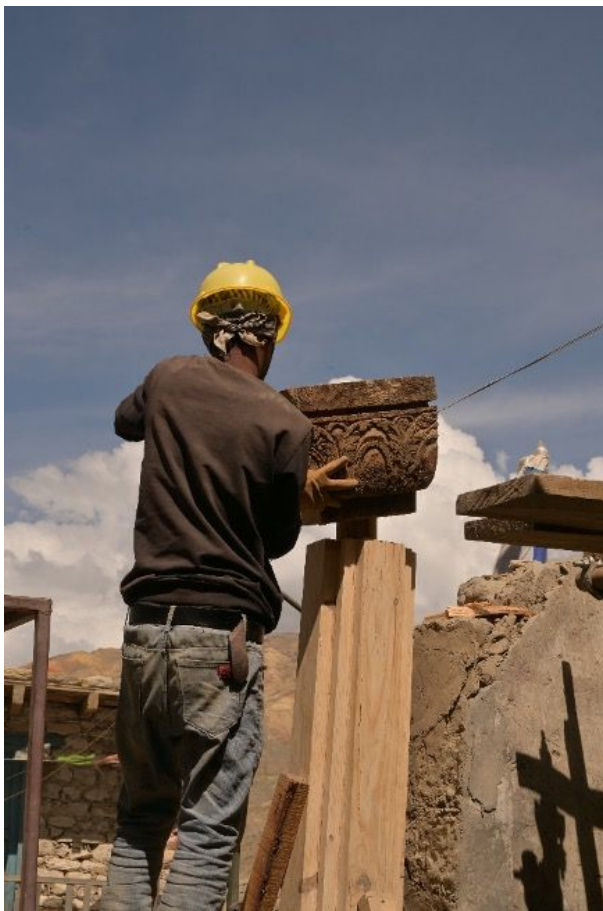
Figure 95: Connecting the old capital base to the new column.

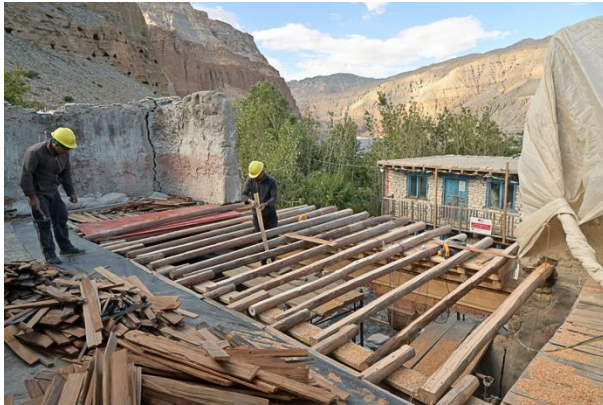
Figure 100: Arranging the original joist of the Entry Hall.

Once the front gate beam was set up, the Entry Hall was completed by first carefully placing the joists onto the beams and into previous suspension holes in the walls. Then the old wood splits were screwed onto them. In this way, all the wooden members were gradually assembled to prepare for the mud flooring and wooden flooring planks on top of mud floor with wooden batten.

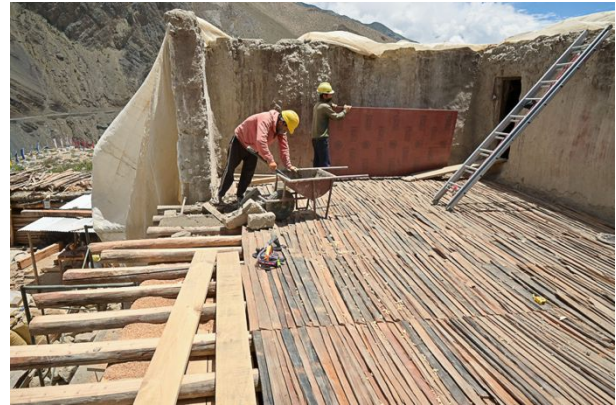
Figure 101: The old wood splits were screwed to the joists and retain the previous appearance of the Entry Hall ceiling.

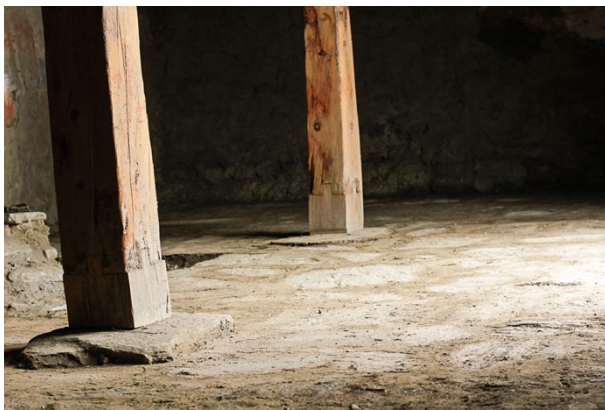
*Figure 109: View of the Entry Hall's floor after completion, the base stone supporting the pillars slightly projecting from it.*

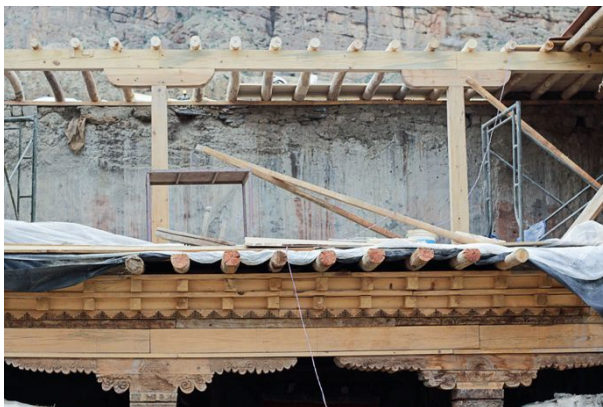
Figure 114: Detail of the partial reconstruction with the back joists in place.

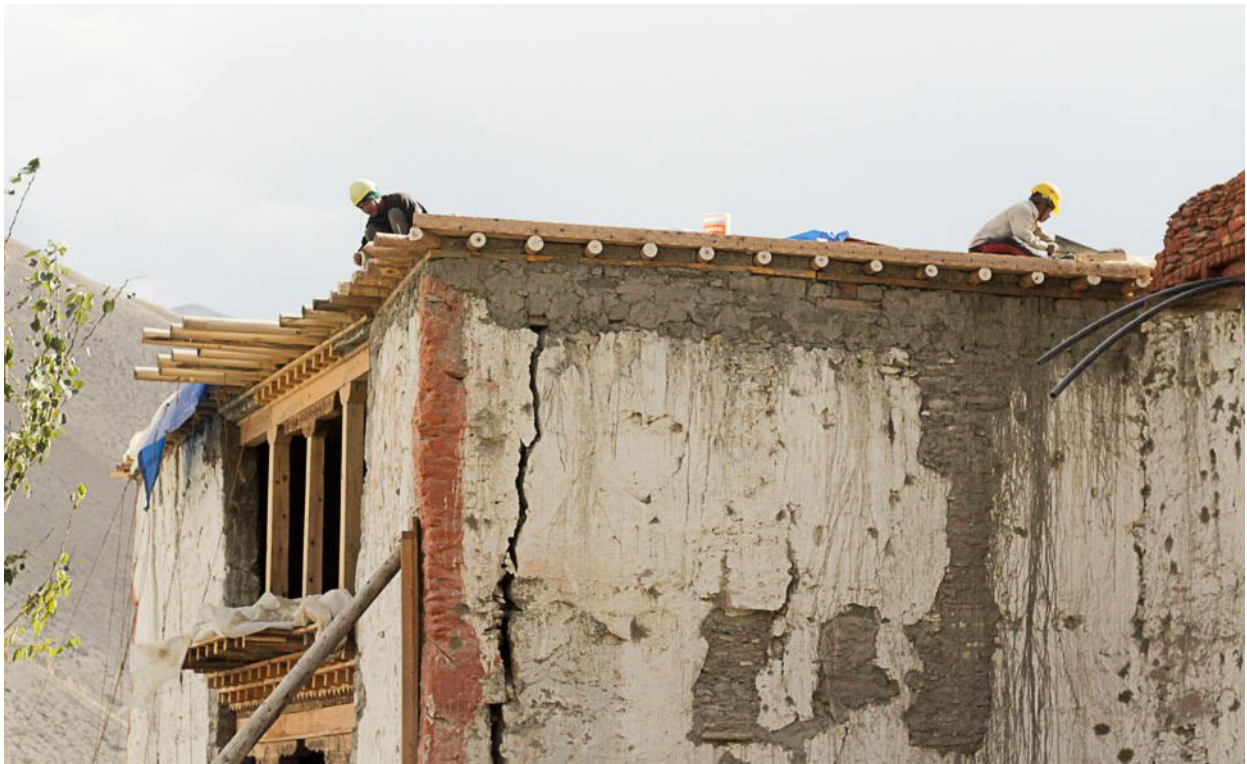
*Figure 118: Placing the wooden members with circle design along the top of the wall to support the parapet.*

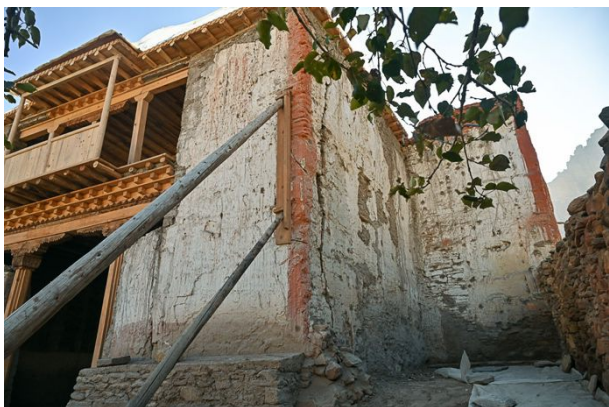
An issue remaining from the first year's work was a major crack in the northeast corner of the Entry Hall. Since the crack appeared to have expanded during the restoration, more than just a repair was needed to tackle this issue. On the ground floor the inner walls are covered with murals, these walls therefore could not be touched. Instead, it was decided to take down a larger section of the corner of the balcony room above and rebuild it in a way that ties the two corner walls together, and in this way prevents the crack on the lower floor to widen.

*Figure 121: The severe crack at the northeast corner of the Entry Hall in October 2023.*

First, the walls at the corner had to be taken down, which was started on March 19, 2024. Then the walls were reconstructed using wooden ties with rammed earth to connect them across the corner. This work was finished by March 22.

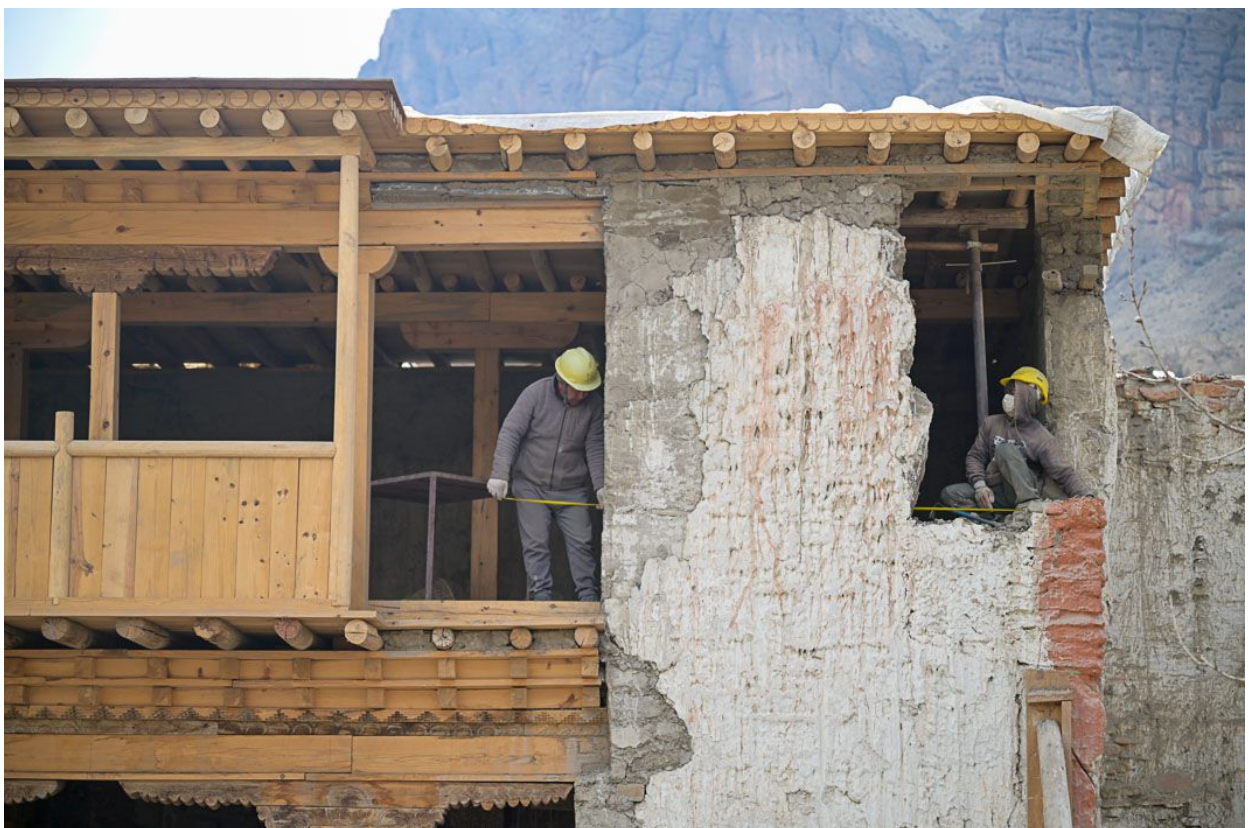
Figure 124: The upper part of the northeast corner after dismantling.

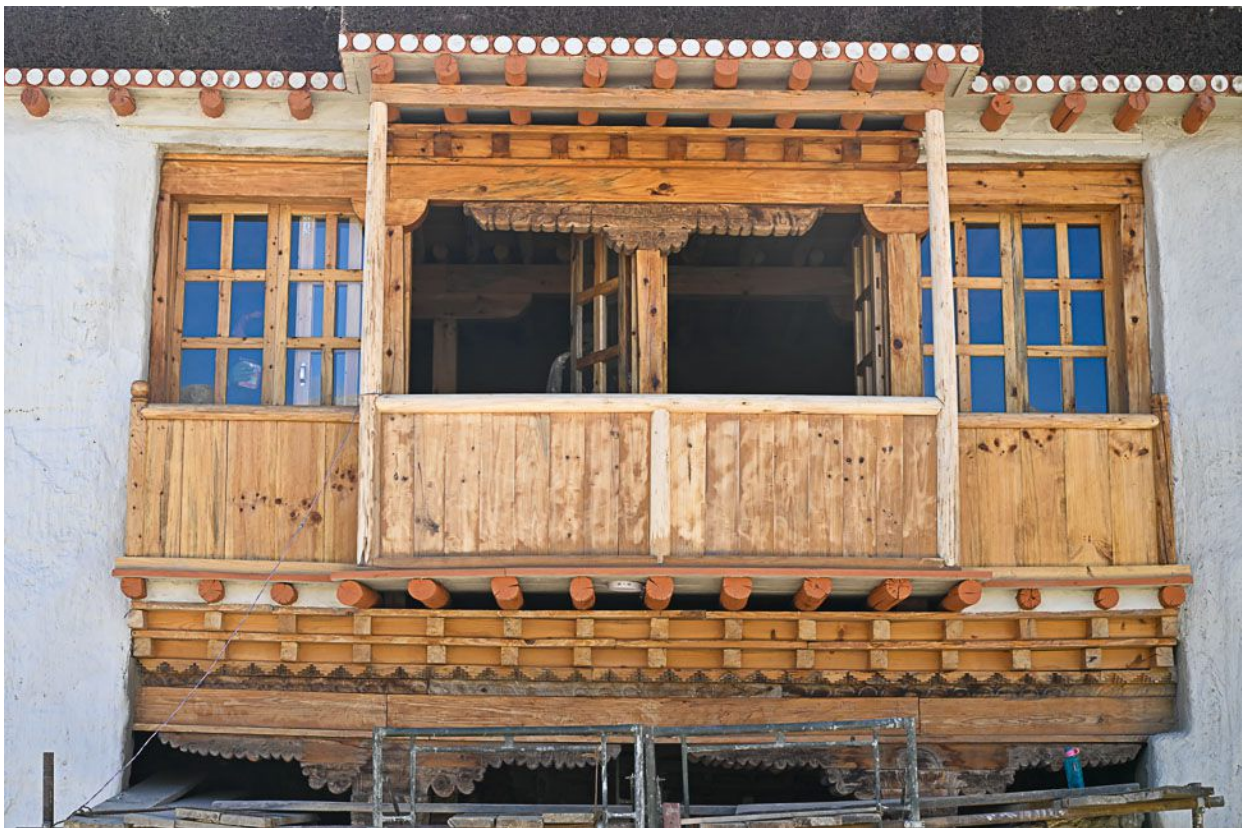
Figure 132: View of the balcony with the doors installed but opened in the central area. Note also the screens added at the sides to give the balcony a uniform appearance.

In May 2024, another community meeting was organized to discuss the plans for the installation of glass windows and sliding doors on the balcony designed by Thomas Schrom. The villagers agreed to this plan documented the result of the meeting. However, summer was too busy to get back to this work, it thus needed to be finished in the projects final phase. Also mud plaster was only applied in early October.

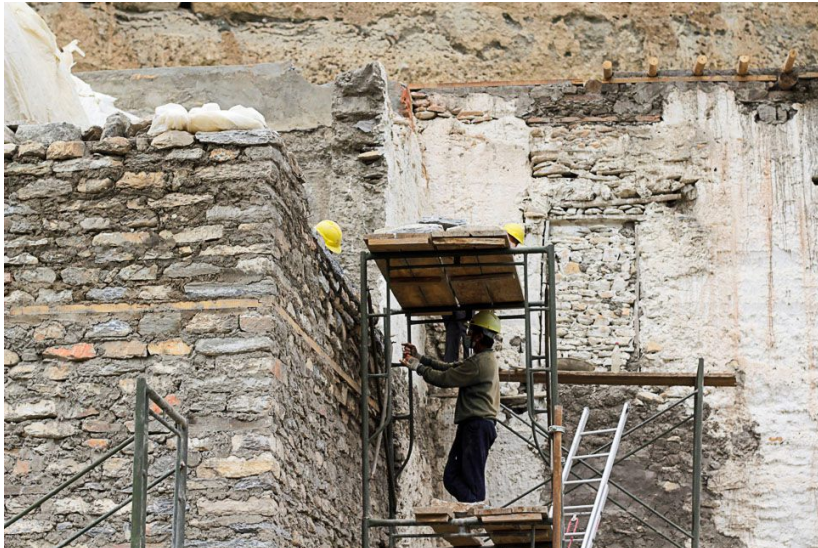
Figure 157: Continuing the construction of the southeast corner wall.

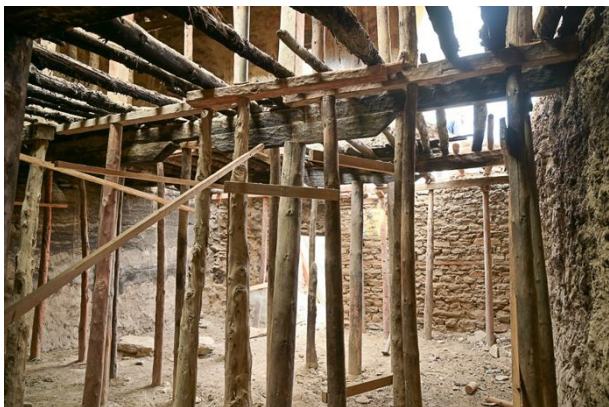
*Figure 169: Installing temporary supports for the wooden members of the upper floor before dismantling.*

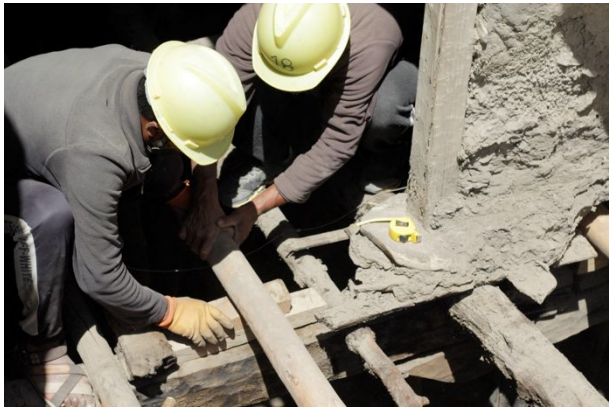
Figure 170: Replacing the old joist with new one maintaining the level.

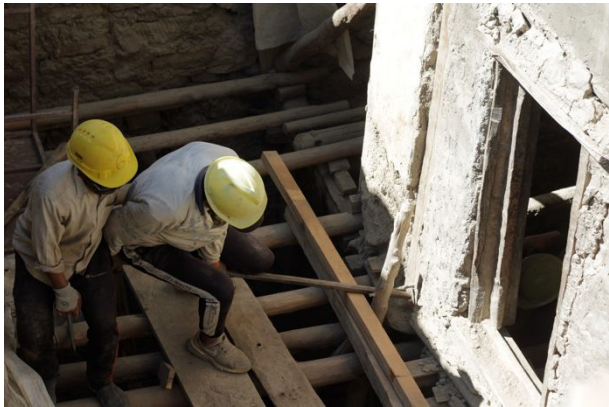
Figure 172: Placing another joist under the partition wall.

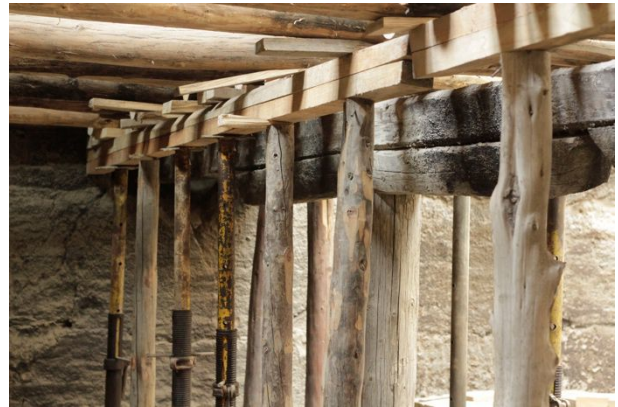
Figure 173: Supports were installed to preserve the painted partition wall above during reconstruction.

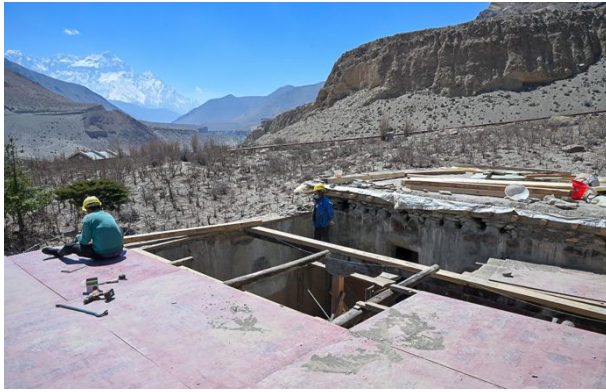
Figure 179: Removing the temporary roof of the south wing.

In 2024, first the temporary roof needed to be dismantled then we started to add the joists that were prepared when work began in March. After adding the joists, planking was installed above them. Then the batten work to finish the floor of the painted room was done. In this process we also integrated an electrical pipe before the mud and floor finish, then we prepared the planks for the floor. Also, the decorative wooden band to finish the roof of the southeast part was done.

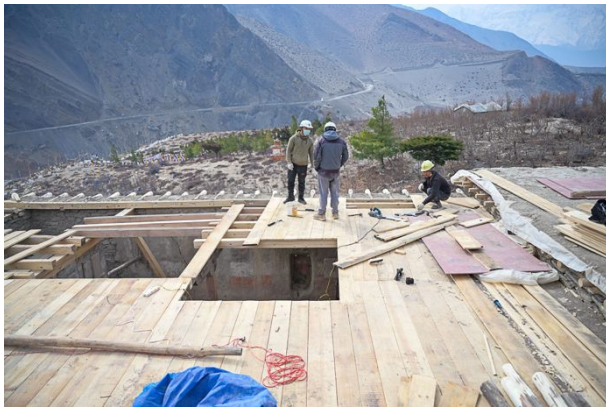
Figure 181: Adding the planking to the roof of the south wing.

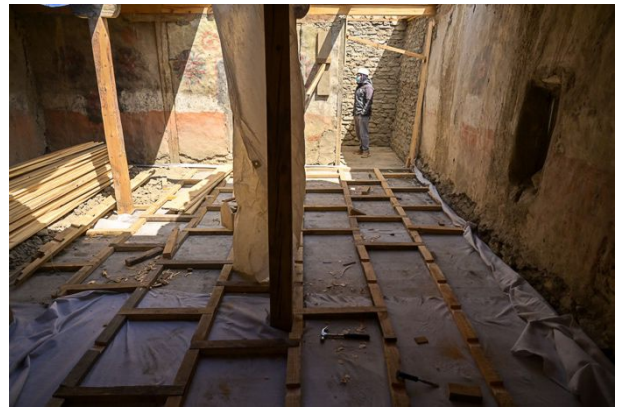
Figure 182: Preparing the wooden floor for the painted room of the south wing.

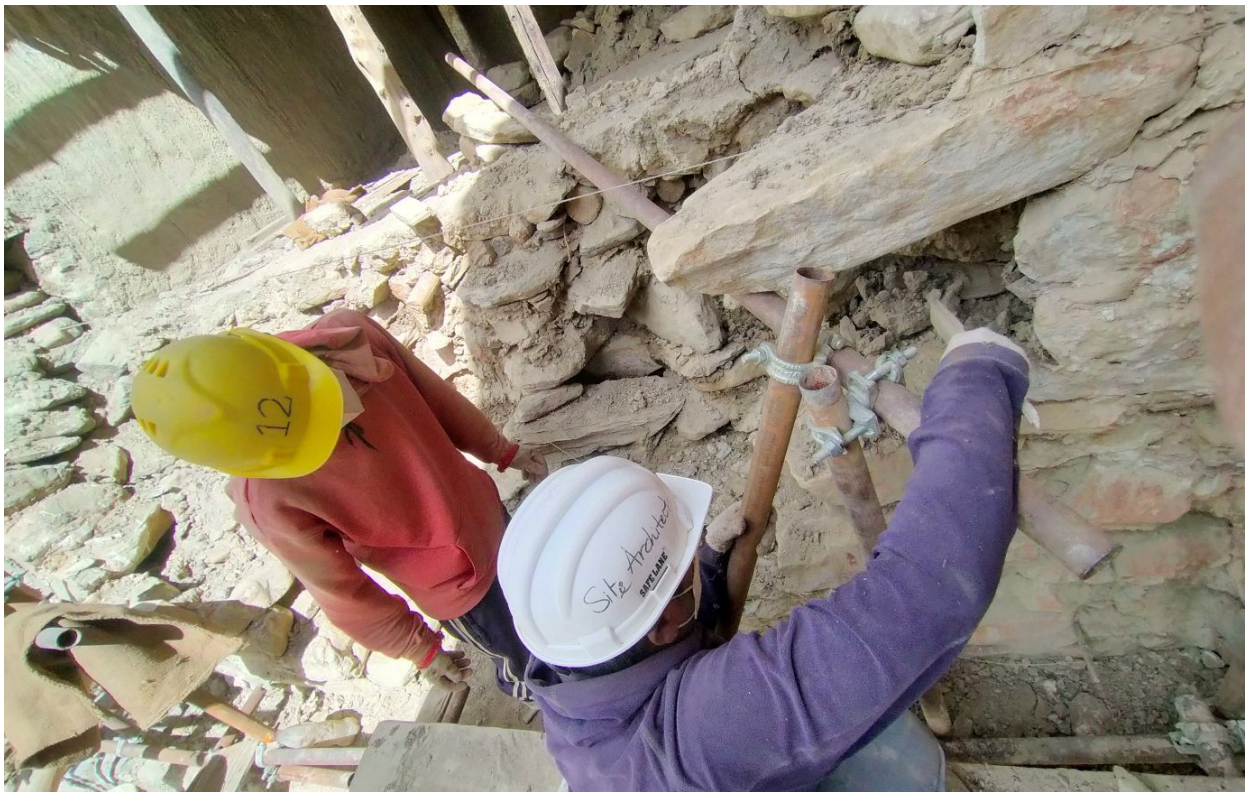
Figure 195: Supporting a large stone from the original wall that can act as connector between the old and new walls.

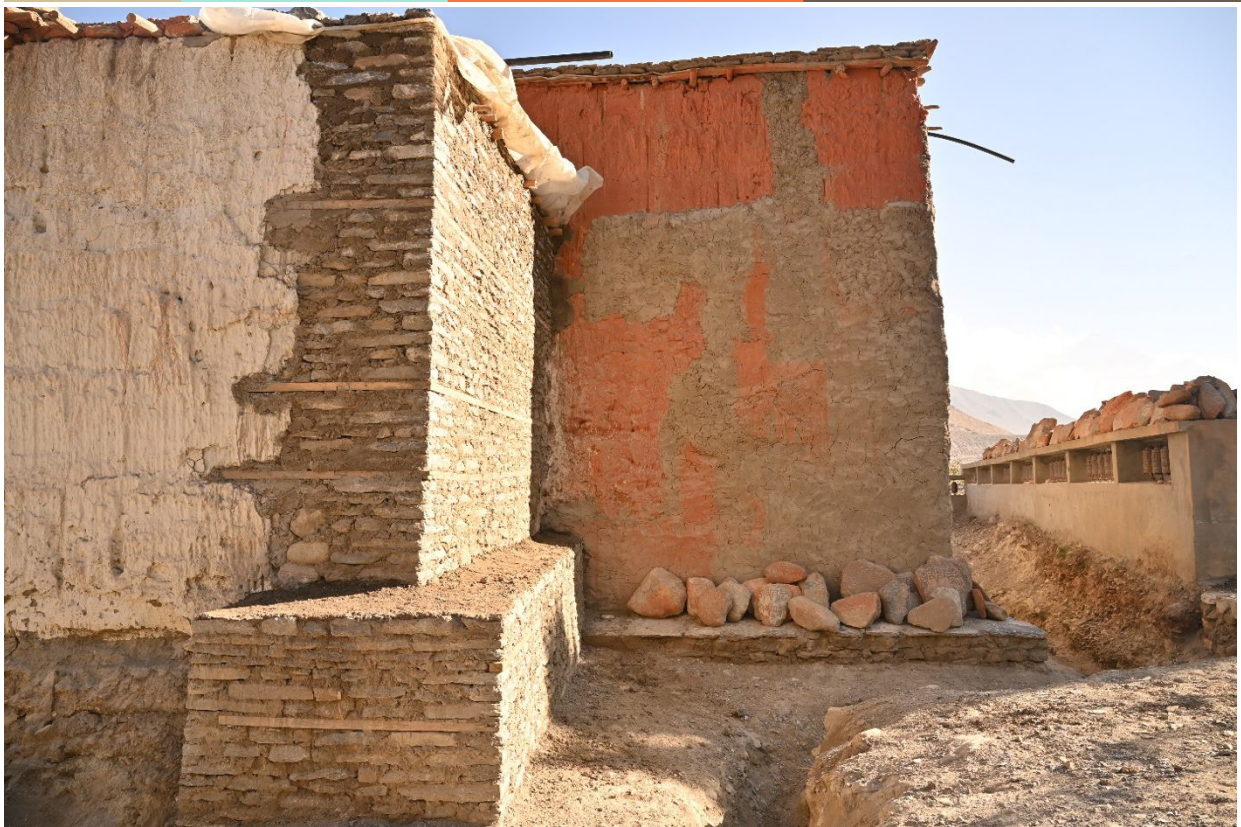
*Figure 202: Northwest corner wall after completion.*

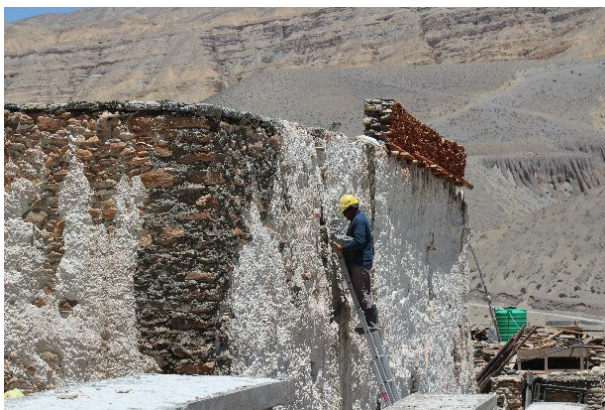
*Figure 203: This worker undertakes repairs along the south wall of the monument. The southwestern corner in the foreground had to be repaired extensively.*

Both on the exterior and interior walls of the building needed to be repaired to cover cracks and areas of losses over time. For this purpose, stones were relayed as needed and the gaps between them filled with mud mixed in the traditional way.

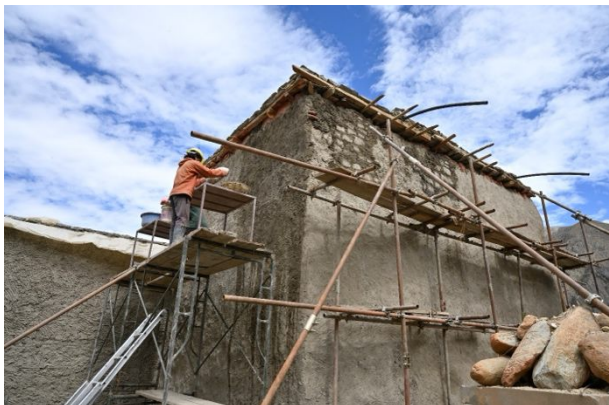
*Figure 209: Wall repairs and plastering on the exterior of the temple.*

As with the South Wing all exterior walls of the temple were repaired and covered with two layers of plaster. Then the whitewash was applied to its surface. While some areas of the wall had to be repaired with mudbricks, others were repaired using plaster mortars only.

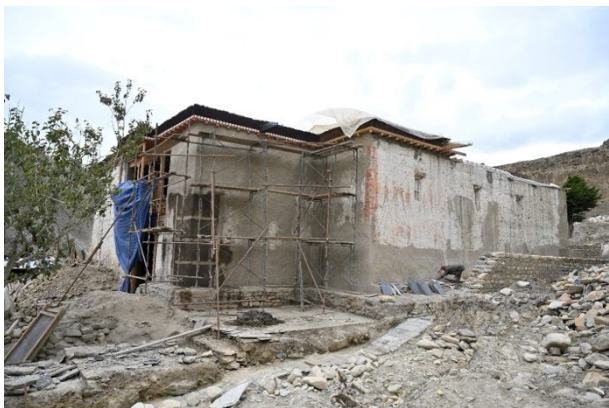
Figure 213: The repaired northeast corner of the Entry Hall after plastering.

Also a big crack of about 2.5 inches in the northeast corner of Entry Hall was repaired. It was tied with 3 x 4 inch wooden members both vertically and horizontally. A base wall for the corner and wooden members was also built. Further, the south wall of staircase area was also repaired with wooden ties and stone, and then plastered and colored.

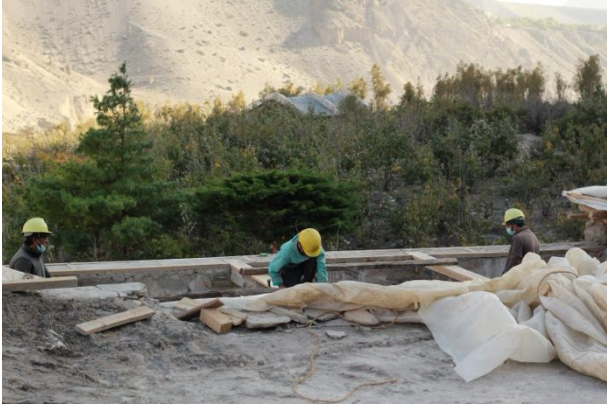
*Figure 216: Installing the temporary roof above the south wing.*

In the south wing area, which was a focus of the work in 2023, a temporary roof needed to be installed for the winter. It was made sure that the roof is properly supported from the inside to enable it to bear heavy snowfall.

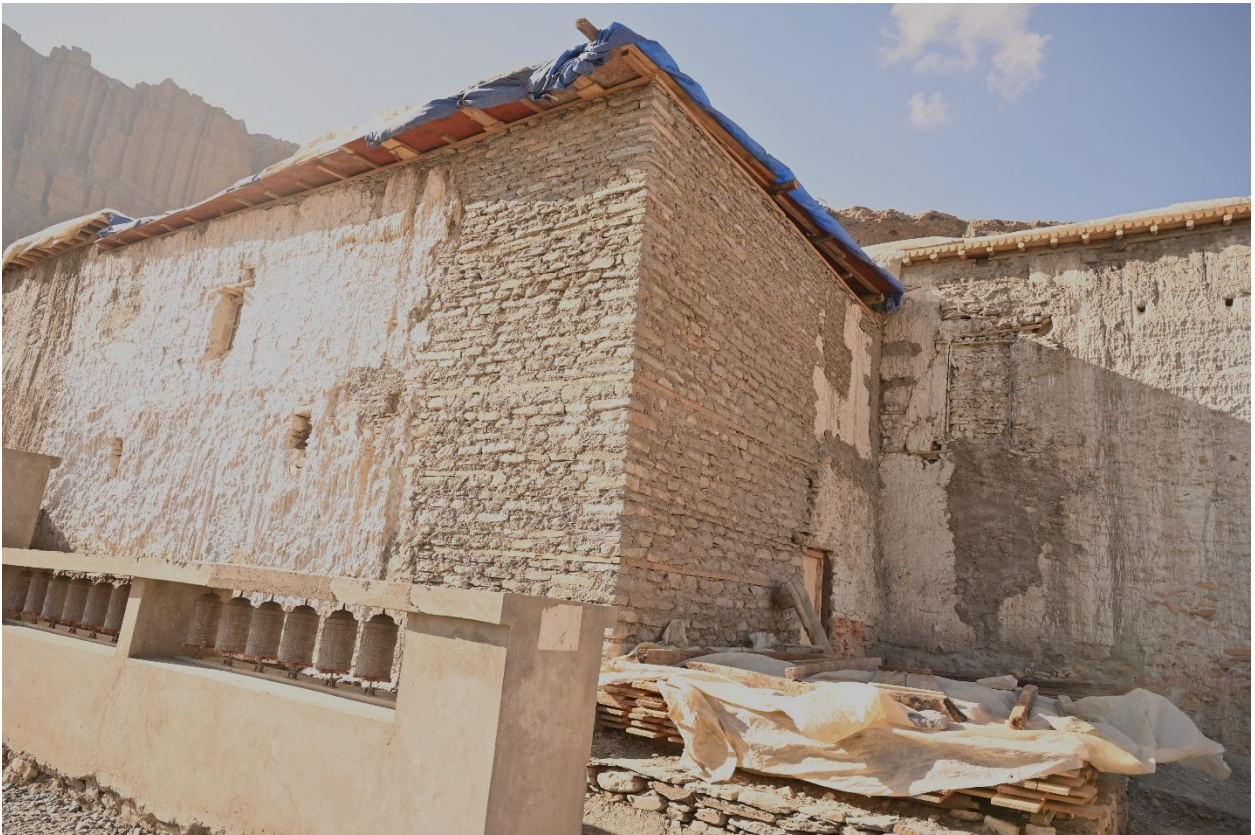
*Figure 218: The temporary roof after completion late in 2023.*

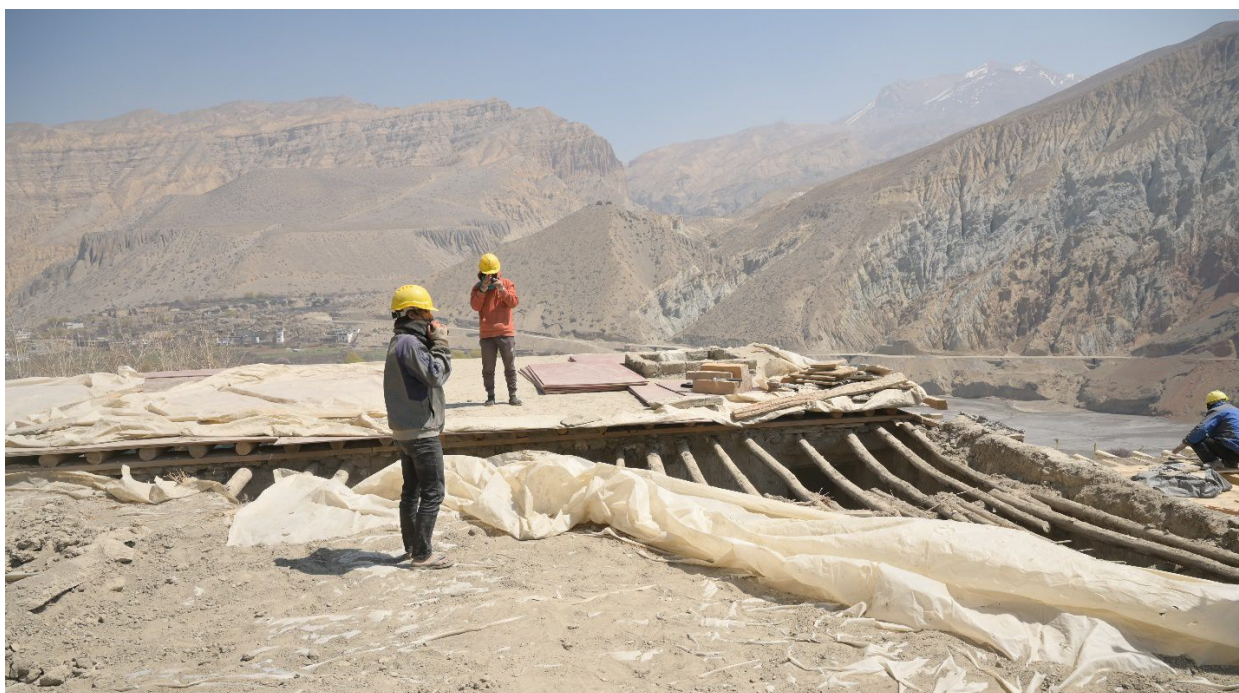
Figure 244: Removal of the roof above the Assembly Hall, including the plastic sheets added in an earlier village restoration.

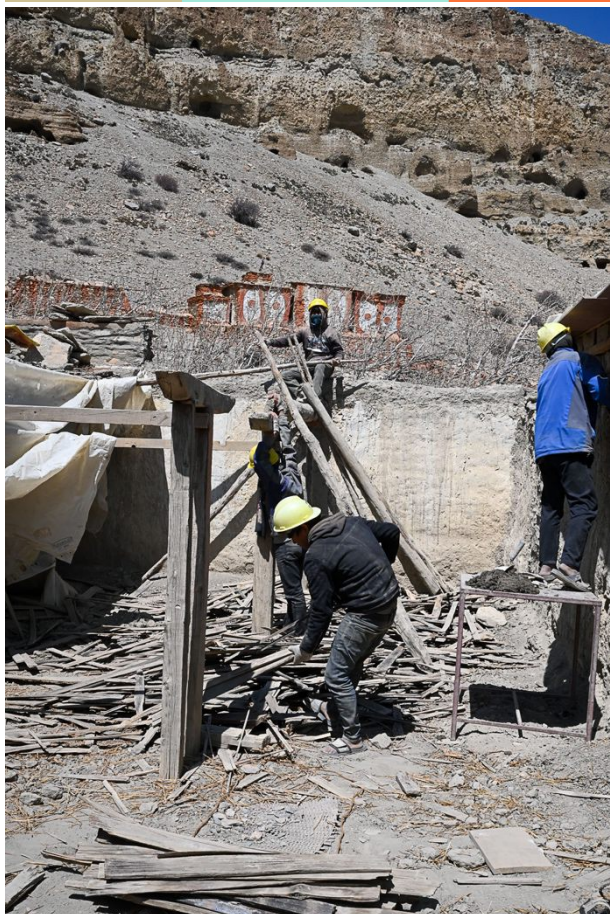
Figure 245: Dismantling the support structure on the upper level.

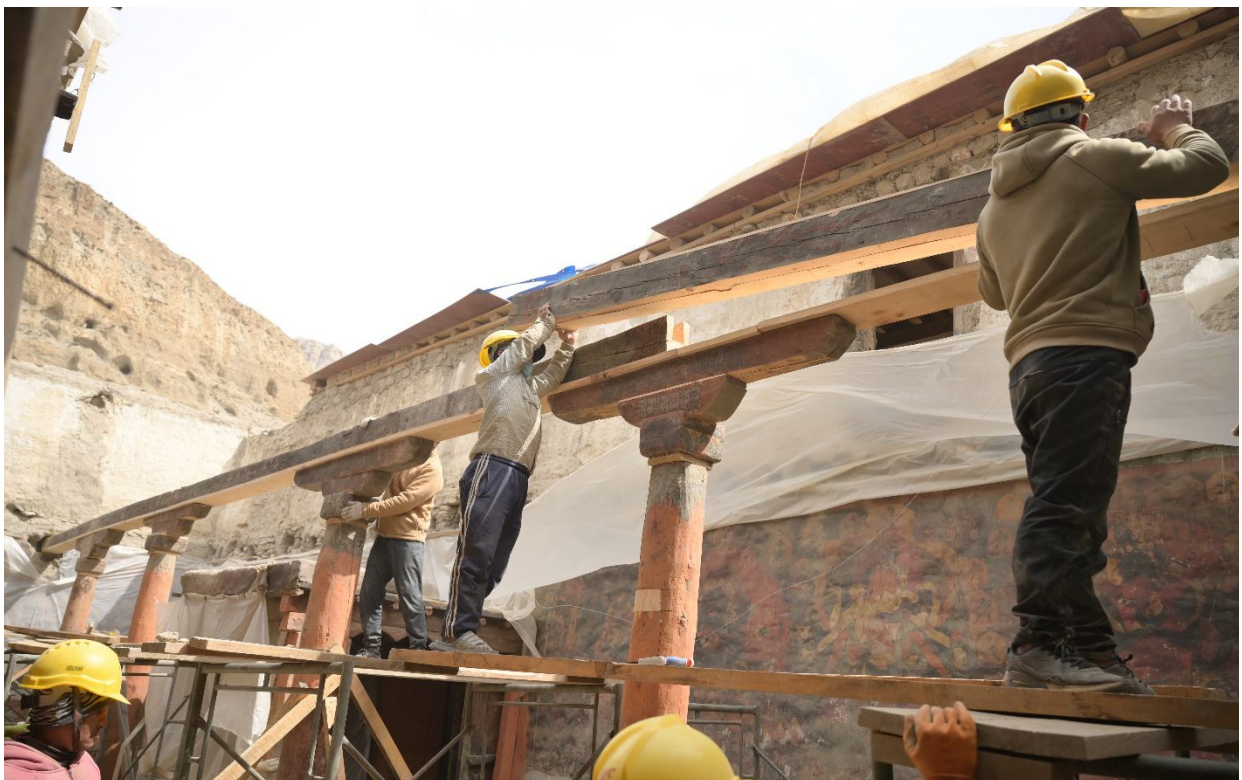
Figure 256: Reassembling the first row of pillars inside the Assembly Hall.

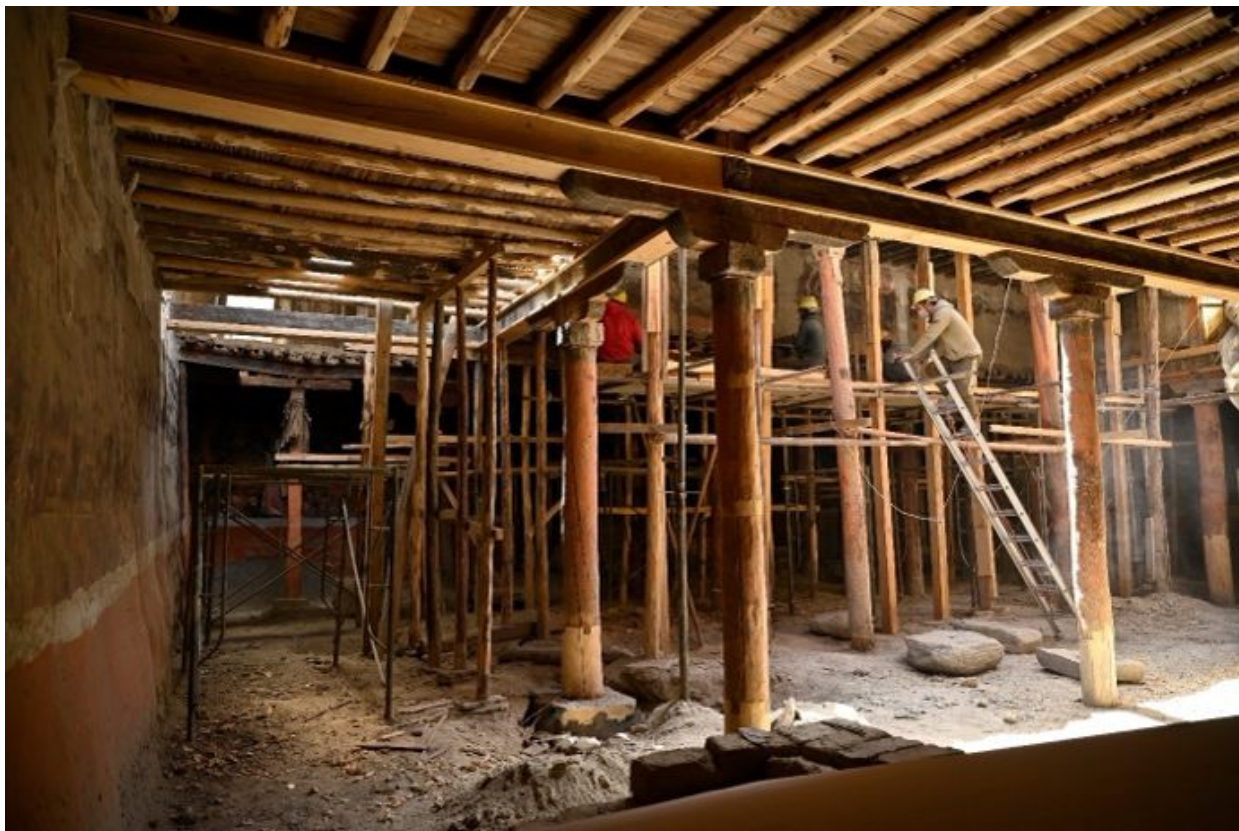
*Figure 286: View from the restored section towards the fourth and fifth rows of pillars. On the right work commenced on replacing the support of the painted wall, while the broken beam in the last row and its support can be seen on the left.*

A particular challenge was the structural repair underneath the painted wall above the fourth row of pillars. It took until mid-July to restore the pillars under this wall in a Final Report, April 2025

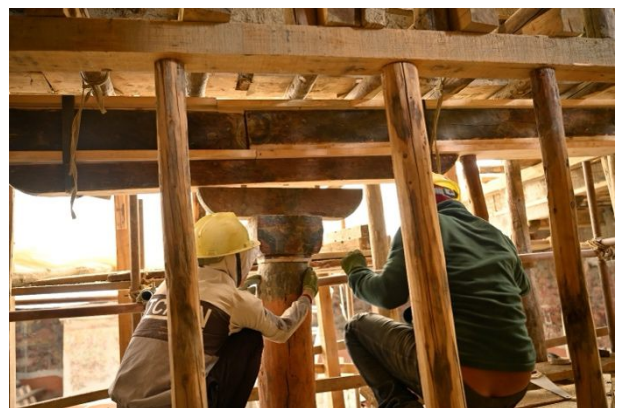
*Figure 296: Placing the pillar in its original place, now supported by a solid foundation and connected across all parts.*

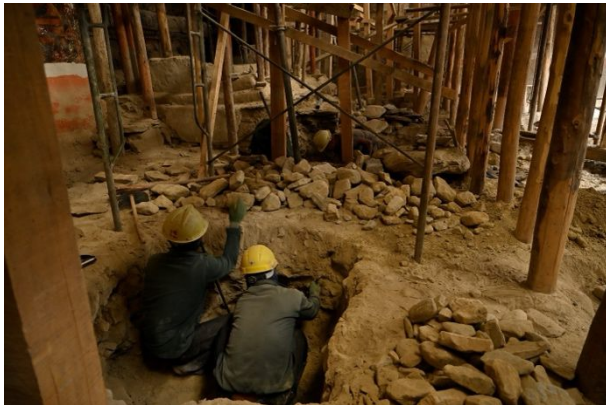
*Figure 309: Excavating the pillar foundations after dismantling while the fourth-row pillars are still in place.*

At the same time, we started to dismantle the ground floor of the fifth and last row of pillars, supporting the ceiling with many temporary supports. Unlike previously, we also had to keep a part of the original roof in place to avoid damage during rain. The pillars

were restored as usual with new foundations in concrete supporting a massive stone and the connections between all its members.

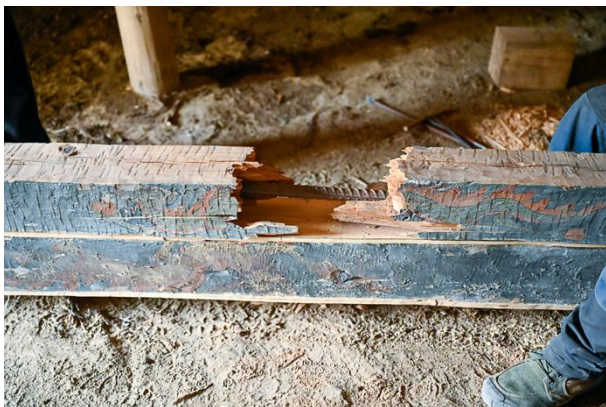
Between the pillars of row five the beam on the south side was cracked in the middle and supported from below. As this break was complete, we had to join the two parts of the pillar with a 2 cm steel rod inserted to the middle of each of the pieces. The depth for the steel rod was 18 inches on each side. Then after putting the steel rod at center depth of beam, it was joined with glue. Then 5 mm metal plates were put at the top and bottom of the beam and connected by 12 mm bolts. The metal plates were placed within a carved out central section of the beam to preserve its original size. This also made it easy to level the joist and planks above it. The structural restoration of all pillars and beams on the ground floor of the Assembly Hall was completed by August 11, 2025.

*Figure 310: Reassembling the broken beam with an iron rod.*

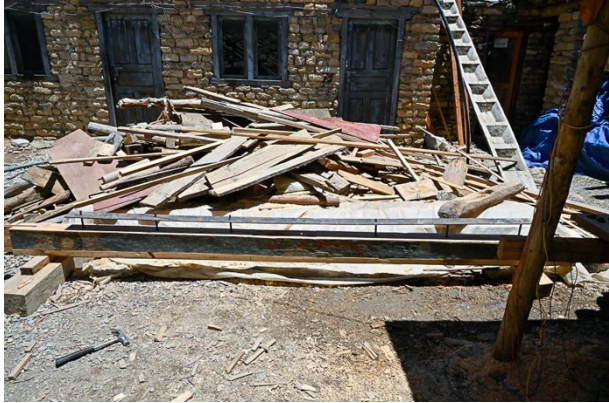
*Figure 312: Placing iron plates on both sides of the broken beam.*

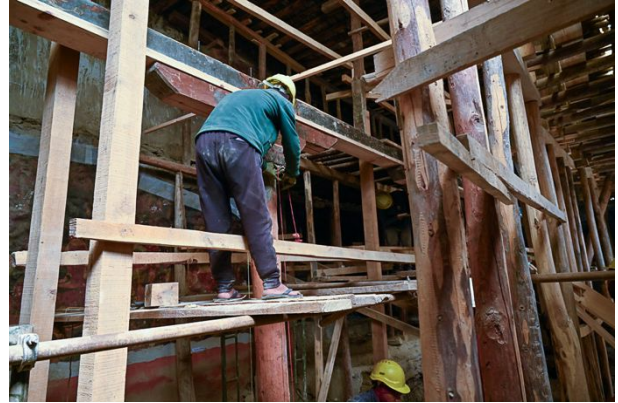
*Figure 313: Reinstalling the repaired and strengthened beam in its original place.*

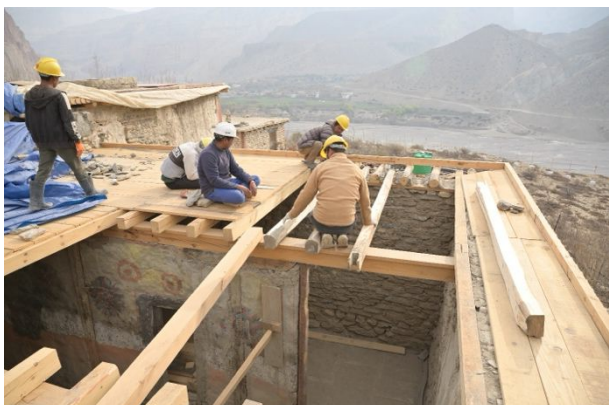
Figure 324: Finishing the roof above the painted room of the South Wing.

The main work remaining for the South Wing was the completion of its roof and the finishing of their interior. First, the remaining parts of the ceiling were completed with joists and planking. Then, the decorative wooden band that marks the bottom of the parapet was fitted. We also needed to replace some of the damaged planks that were used the previous year to install a temporary roof.

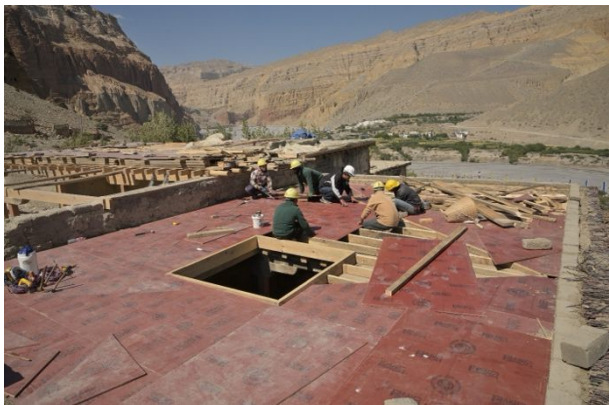
Figure 328: Constructing the wooden frame around the skylight.

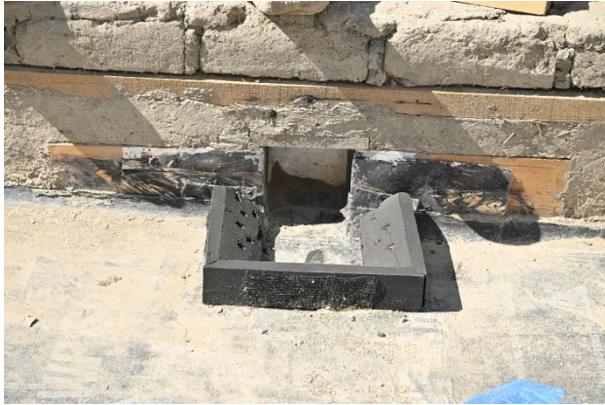
*Figure 332: Wooden barrier around the waterspout.*

After laying the bitumen sheets and the construction of parapet wall on roof, an aluminum sheet band was added to the parapet to cover the edge of bitumen sheet once it is installed. This makes sure that also in very adverse weather conditions no water can penetrate inside the wall. This procedure was then followed in all areas of the parapet wall. Further, Sabin Shreshta decided to install wooden barriers at the collection points of the waterspout to avoid mud running off the roof, a measure that is to be reversed.

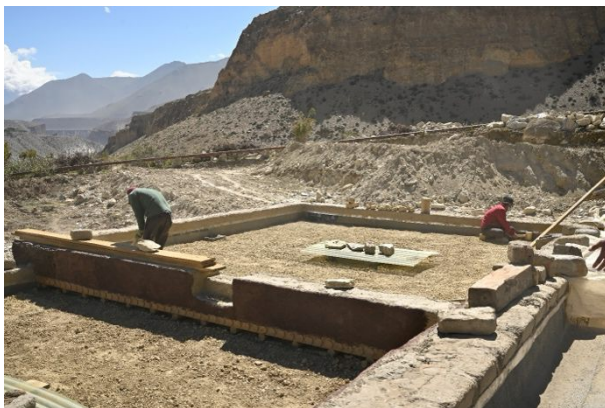
*Figure 334: Laying the lower layer of mud on the roof of the South Wing.*

Then, layers of mud were laid on top of bitumen sheets; first pure yellowish clay was laid at a thickness of one inch, then a second layer of fine mud filtered in 1/8-inch net and at a thickness of 1.5 inches. Volunteers from Chuksang village carried the mud to the roof of the temple.

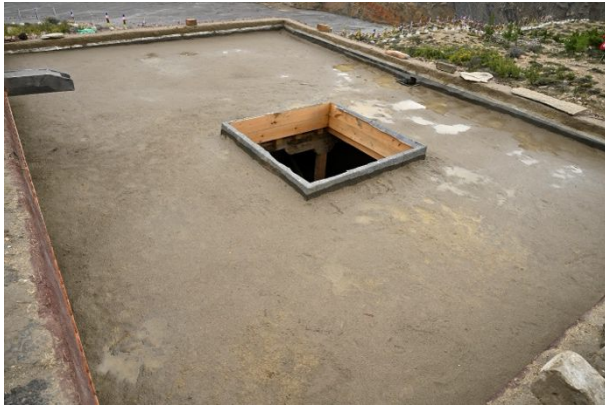
*Figure 336: Part of the South Wing with two mud layers after two days of heavy rain. There was no leakage but the water did not run off completely either.*

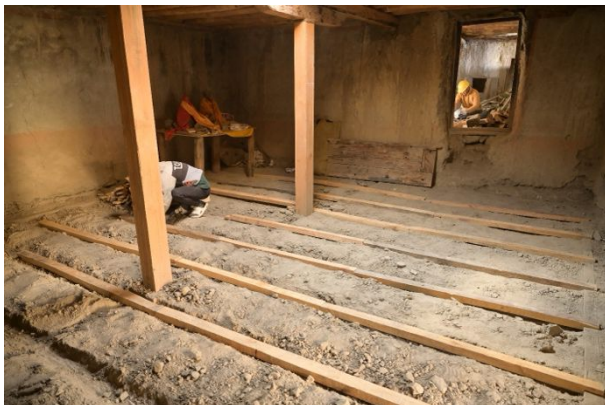
*Figure 337: Preparing the frame for blanking in the South Wing rooms.*

On the first-floor interior of the south wing, mud was filled in the areas after the batten work. Then the wooden planking of the floor was done within the month of April 2024. However, the area where two broken statues remained in the room could not be finished at this stage.

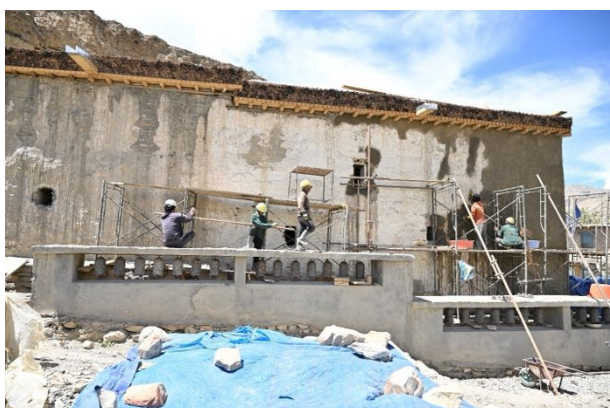
*Figure 344: Repairing and plastering the outside wall of the South Wing.*

On the outside, also the area of the newly constructed wall was plastered and damaged plaster areas were patched. Then fine paster was applied. The wall was then whitewashed while the projecting wooden members were painted red. A dark maroon color was used to paint the brushwood, the so-called *perma* frieze, of the parapet wall. These are traditional colors sourced and produced locally.

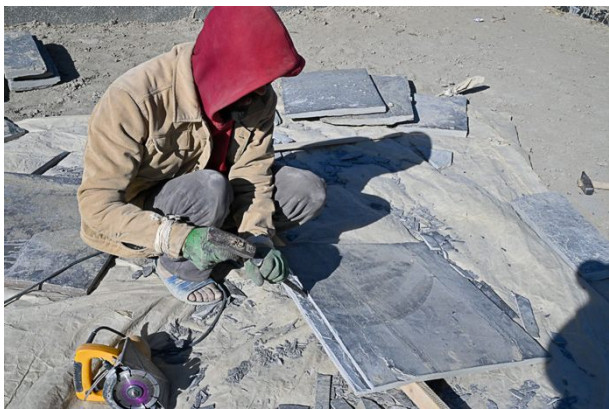
As the previous installation of the stone slates above the parapet turned out to be insufficient, a specialist was hired to improve on these by adding an overlap between the sheets and sealing the gaps. This parapet improvement was started on October 18 and finished by November 26.

Figure 367: Cutting an overlap into the edge of the stone slate.

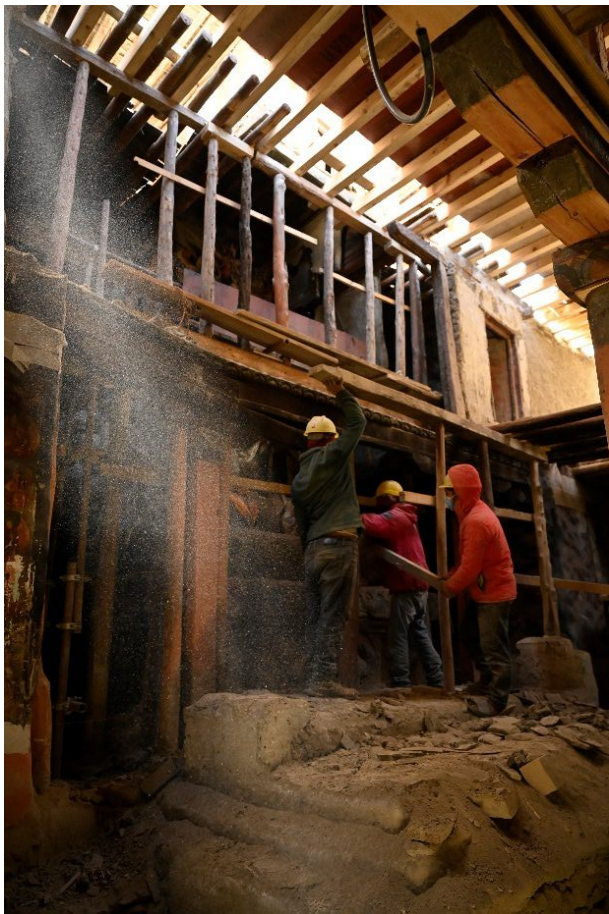
*Figure 369: Mounting the supports in front of the main image.*

Work in this section was complicated by the elaborate and throne structure around the easily damaged clay image and major structural problems that had developed there over the centuries. On the ground floor, the area to the left of the main image was particularly challenging, as here the pillar supporting the beam has sagged considerably. Thus, once the beam was removed a 2 foot x 16 inches foundation stone was placed underneath it to support it properly.

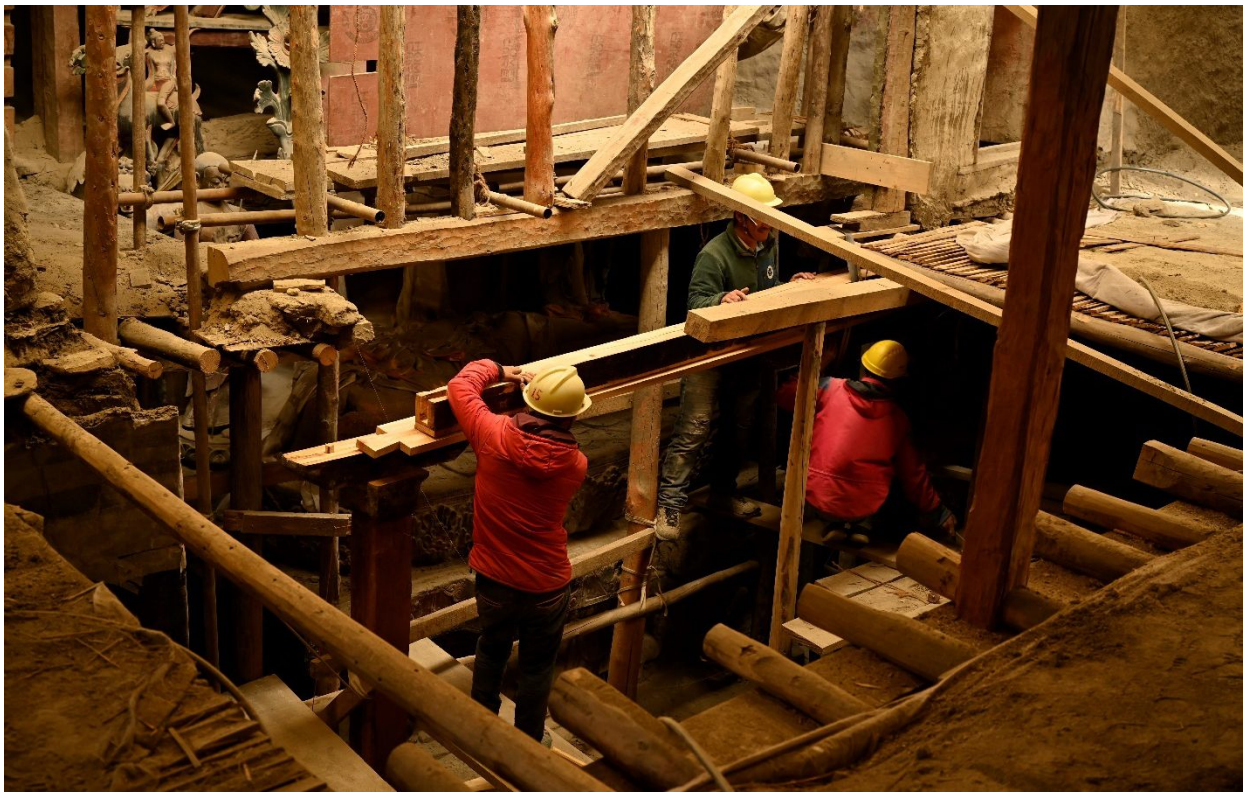
*Figure 371: Reassembling the beam in front of the main sculpture after restoration; note the joints.*

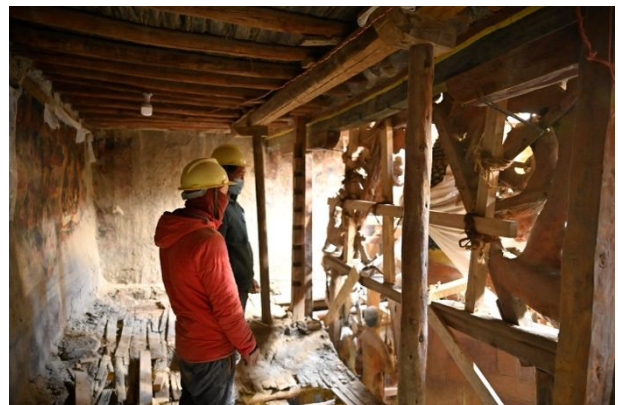
*Figure 379: Placing additional supports to the back of the main sculpture to enable the restoration of the broken beam.*

To avoid damage to the main image and assist planning the restoration, the wooden frame around it was removed to be reassembled after the restoration. It fully revealed the damage to the beam in this area that required additional support.
