# Architectural Restoration and Seismic Strengthening of Gönpa Gang

U.S. Ambassadors Fund for Cultural Preservation, Award No. SNP40022GR0039

**Final Project Report, April 2025**

**Norbusum Foundation (NGO)**

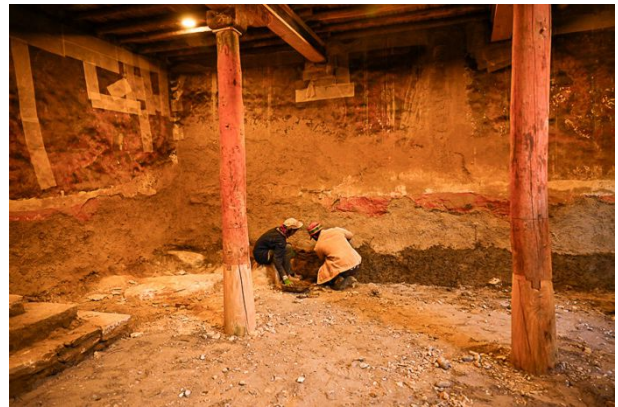
support of villagers. In the northwest corner of the Assembly Hall, where a big stone boulder was covered by a clay platform, the floor could not be leveled due to the stone. To cover it a new platform was erected with clay bricks. Flooring then started in the Ambulatory around the main image with the installation of its support frame and moved from there towards the entrance to the Assembly Hall. Also the altar and the platform in the southwest corner were covered by wood.

*Figure 414: Workers applying rough plaster along the bottom of the wall in the southwest corner of the Assembly Hall. Note the stone bolder projecting in this area.*

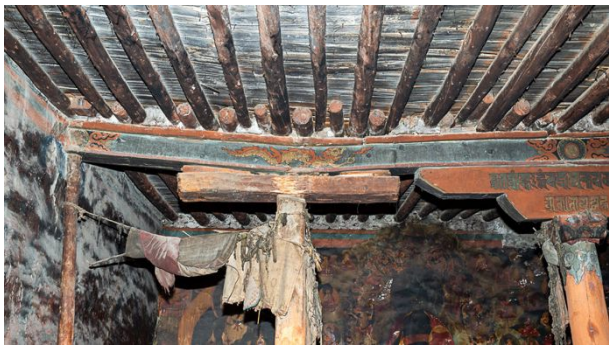
Figure 456: The broken beam with additional support before restoration.

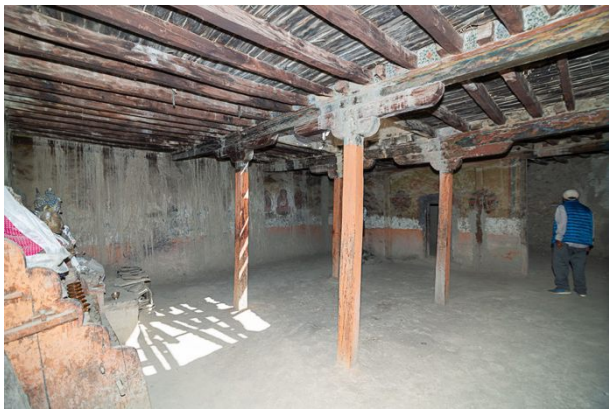
Figure 474: View of the painted room before restoration.
