# Seismic Strengthening and Restoration of Lo Gekhar

U.S. Ambassadors Fund for Cultural Preservation, Award No. SNP40020GR0042

**Project Report, Second Year, Fourth Quarter – July to September 2022**

**Norbusum Foundation (NGO)**

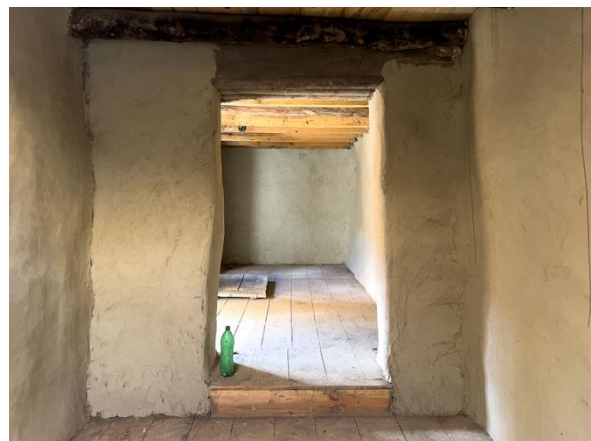
*Figure 5: View from the one plastered panel room to the other.*

Equally, the upper panel rooms, rooms U04 and U05, have been plastered late June to August (Figure 5), again after an extensive preparation of the existing walls as recorded in the previous report. Also here the construction of the frames for the panels awaits a skilful carpenter.

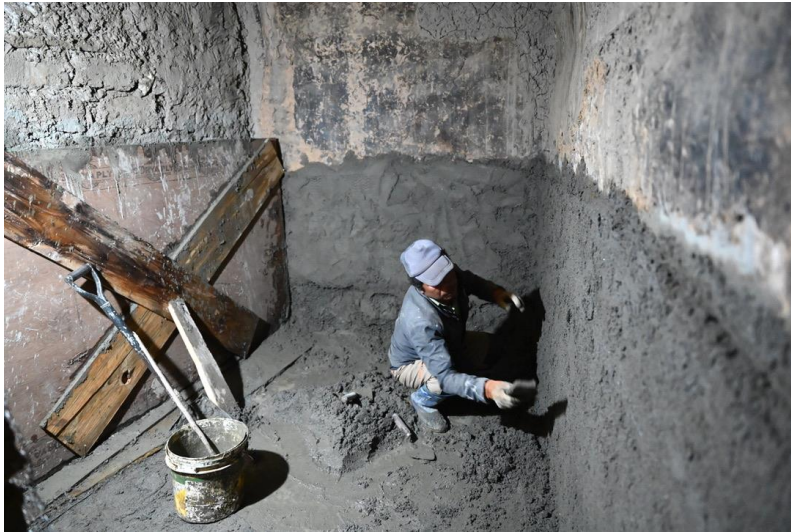
*Figure 10: Rough concrete plaster applied to the lower parts of the walls of the new visitor's toilet.*

In this room, the floor was levelled, and stone soling work was done. Then a mesh of iron rods was placed (Figure 11) and finally the floor of the room was plastered with concrete. Also, the lower parts of the walls were covered with a rough plaster using chicken mesh as support to properly attach the plaster to the wall (Figure 10).

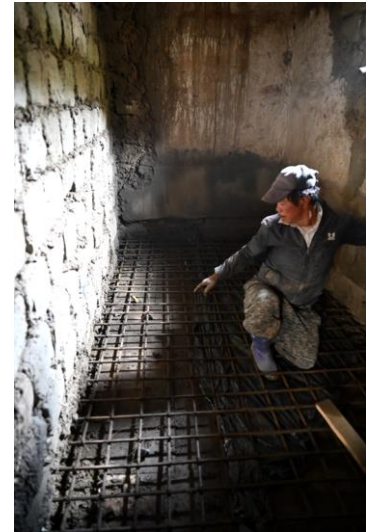
*Figure 11: Iron rod mesh used in the new toilet.*

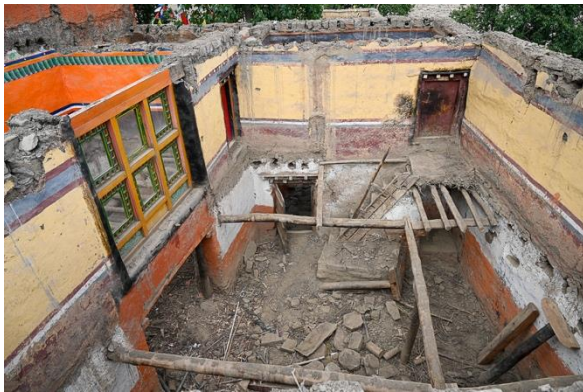
*Figure 12: The atrium in the process of dismanteling.*

The wooden construction of the atrium has been taken down completely (Figure 12) and rebuilt with new wooden joists (Figure 13).

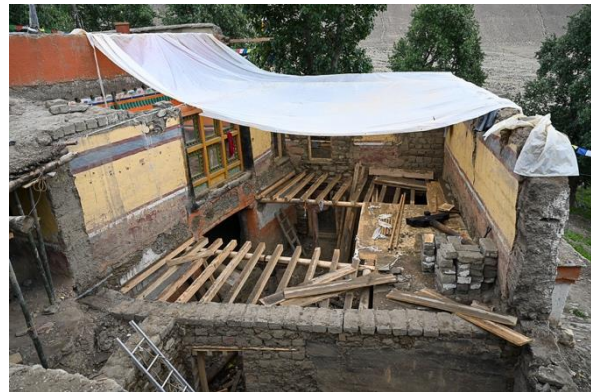
*Figure 13: The atrium in the process of reconstruction.*

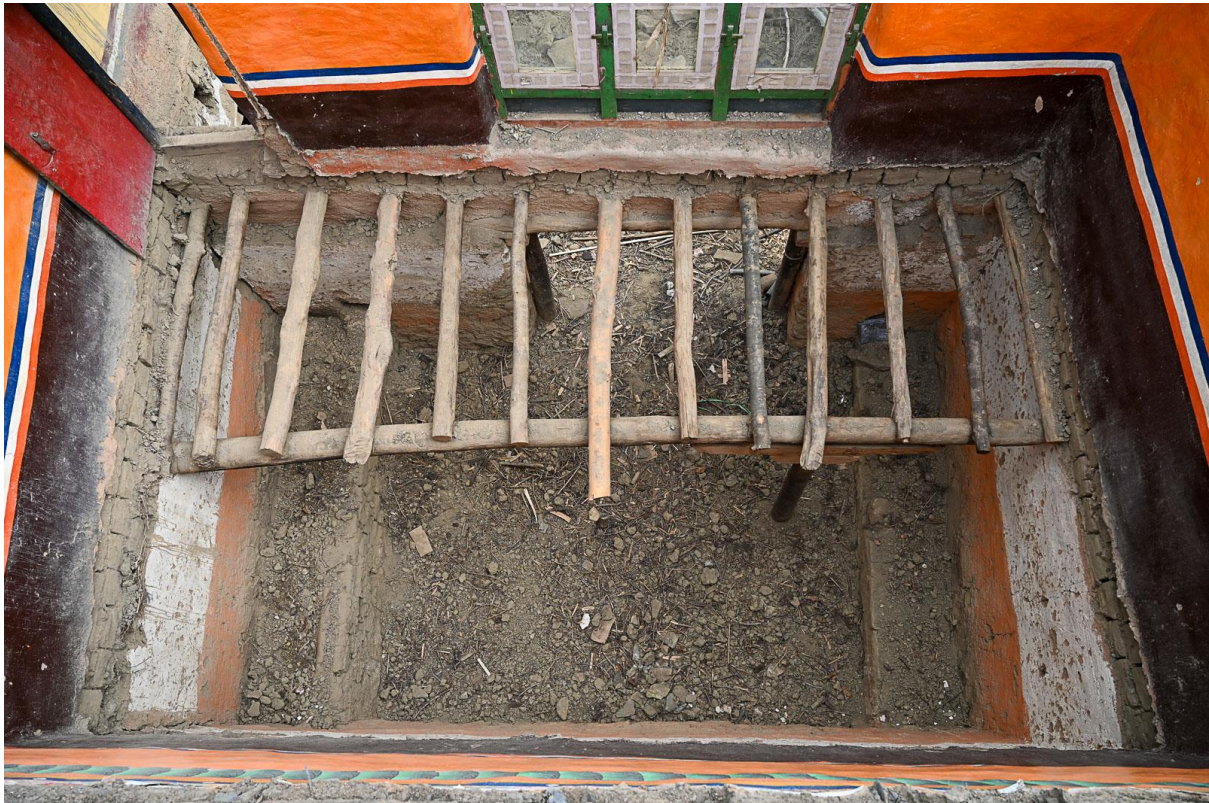
This room, on the temple side of the atrium and underneath the VIP room, was formerly used by the caretaker to store firewood (Figure 16). This space had to be repurposed as

*Figure 16: The former storage room underneath the VIP room seen from above during restoration.*

The wall underneath the main beam had stress cracks which were reinforced by installing stone slates inside the wall. The damaged columns and capitals were replaced. The joists had earlier been placed at considerable distances, which were reduced overall by the addition of several new joists (compare Figure 17 with Figure 18).

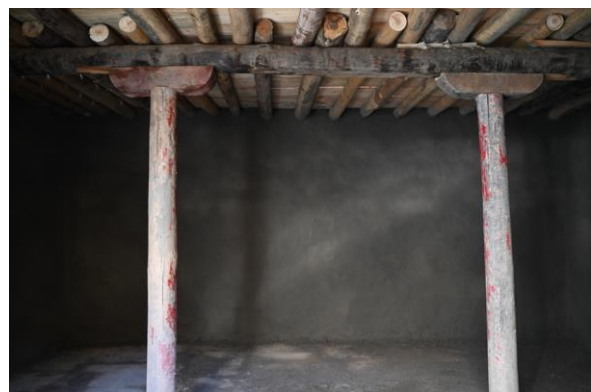
*Figure 18: The storage room after restoration and plastering.*

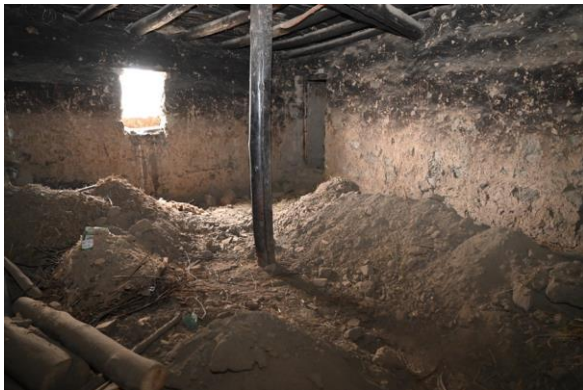
This room, previously referred to as storage and little used, in the planning stage has been repurposed as a kitchen for pilgrims and visitors which will be using the lower atrium. When surveying the architecture, it turned out that this room had a hollow space underneath. This space was now filled with rubble to create a solid and strong floor, while its wooden parts, joists and round sticks laid between them were removed. The floor level of this room was also lowered to increase the room height and level it with the atrium in front of it.

Figure 19: The future visitor's kitchen before the restoration.

The columns, beams and joists in this room were replaced with new ones sourced locally. The walls were patched, and the floor was paved with flat stones for easy maintenance. Further, the small opening on the east side was replaced by a proper window.

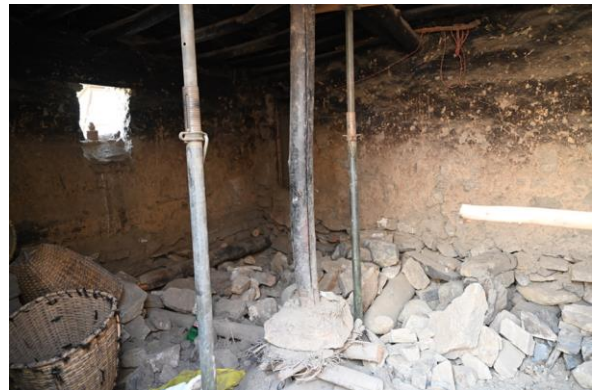
Figure 20: The future visitor's kitchen during filling of its floor.

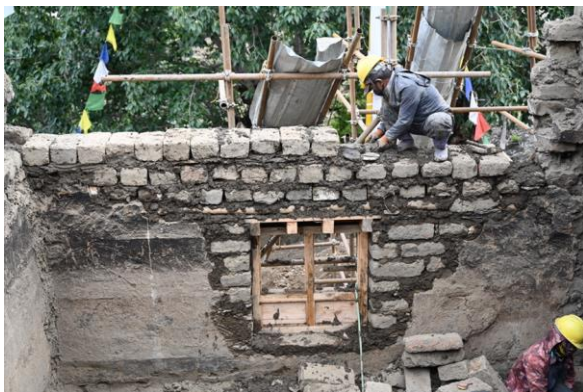
Figure 21: Introduction of the window for the visitor's kitchen.

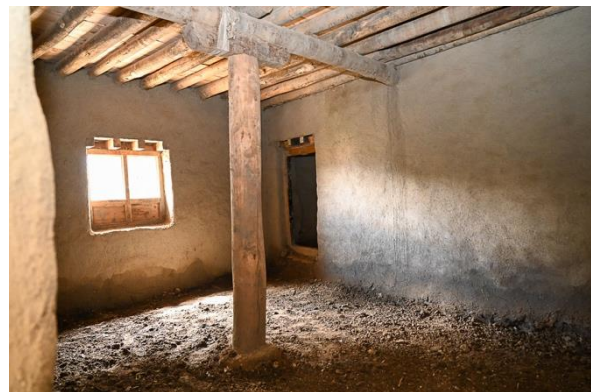
Figure 22: The plastered kitchen with the new window.

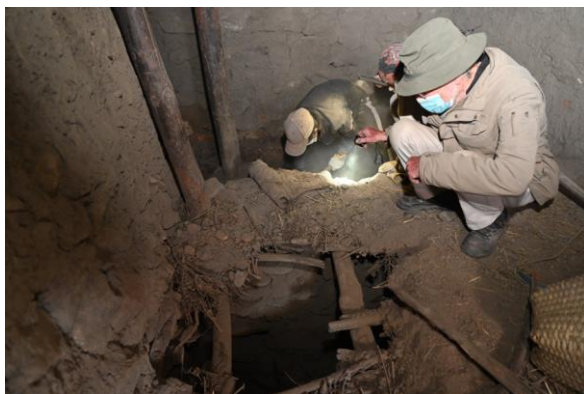
Figure 23: Surveying the space underneath the storage room.

This room referred to as storage (L12) in the proposal has been repurposed to serve as a storage for the visitor's kitchen. Like for the kitchen room itself, there was formerly a room underneath this space (**Error! Reference source not found.**) which was opened and filled to form a solid floor. A partition wall was constructed in this lower space to evenly distribute the pressure sideways (**Error! Reference source not found.**).

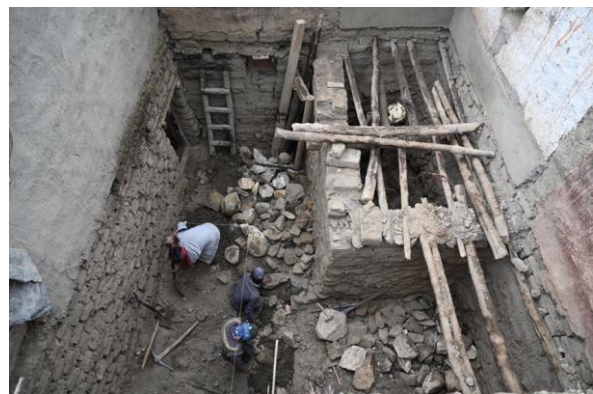
Figure 24: The storage room during restoration.

A new stone wall needed to be constructed to support one of the toilet walls on the floor above. Earlier, this wall rested on the joists only, resulting in enormous pressure on them. The tiny old window opening was replaced with a new one for more daylight to enter the room.

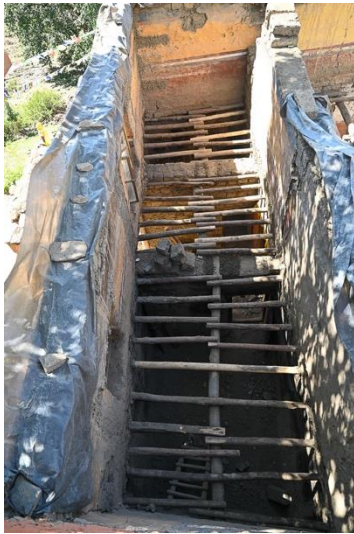
*Figure 23: View of the rooms above the main entrance.*

Of these two rooms above the main entrance U07 formerly housed a shrine of protective deities as well as the arhat stone panels, while U08 simply served as access to this room. U07 was also used by the caretaker and guests to stay in. With the arhat panels and the shrine moved, U07 was planned to become a guest room while U08 is being converted into an attached bathroom that can also be used for guests of the VIP room (Figure 25).

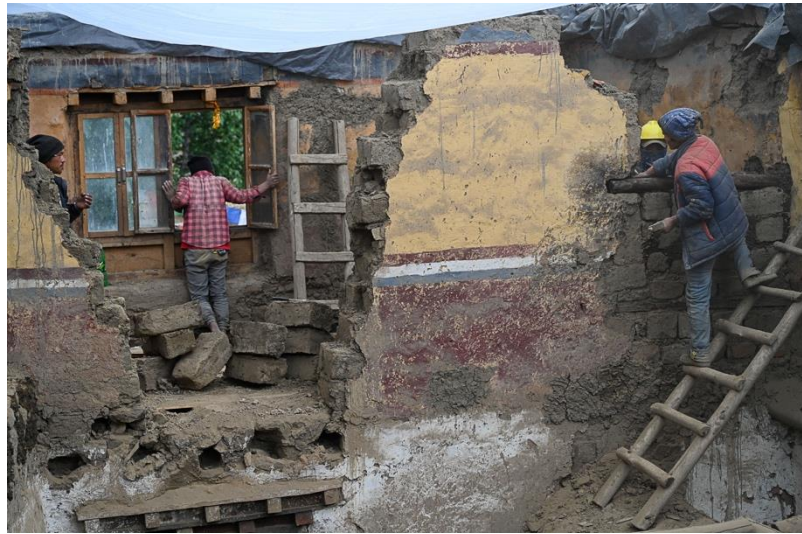
*Figure 24: The door on the right was closed and a new one constructed on the left, close to the entrance to the VIP room.*

The repurposing of the rooms necessitated the shift of the entrance from the corner of the area to the middle (Figure 26).

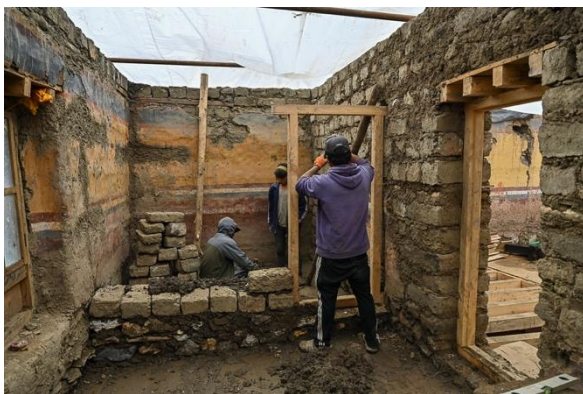
*Figure 25: Construction of the new bathroom.*

The area of the bathroom was walled, and a new entrance created (Figure 27, Figure 28). For the future bathroom a small vent was constructed for natural light and to provide sufficient ventilation. A square frame was constructed on the floor and then filled with clay before covering it with floorboards.

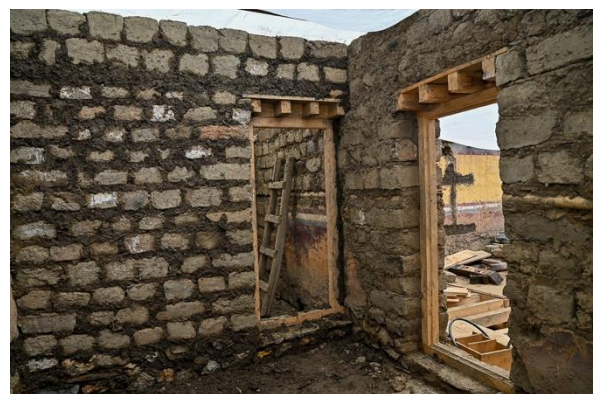
*Figure 26: The wall separating the bathroom finished.*

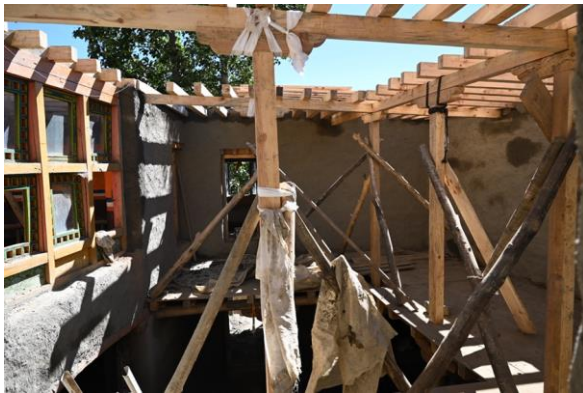
On the upper floor, the parapets around the atrium were removed, as they added immense weight resting on the beam and joists underneath. All the old columns, beams

*Figure 27: Construction of the upper part of the atrium.*

and joists were replaced with new square ones. Finally, the opening of the atrium was covered by a lantern supported by a wooden frame.

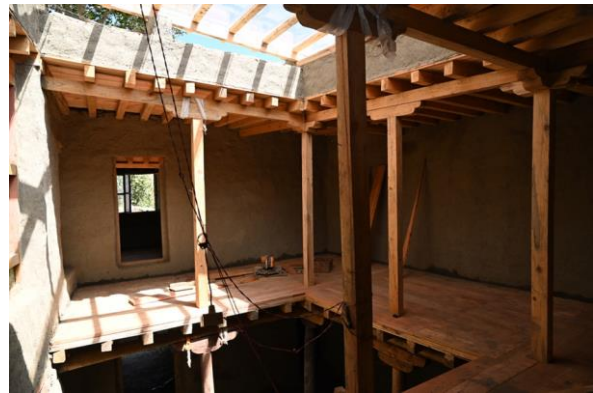
*Figure 28: The atrium finished with a lantern covering its opening.*

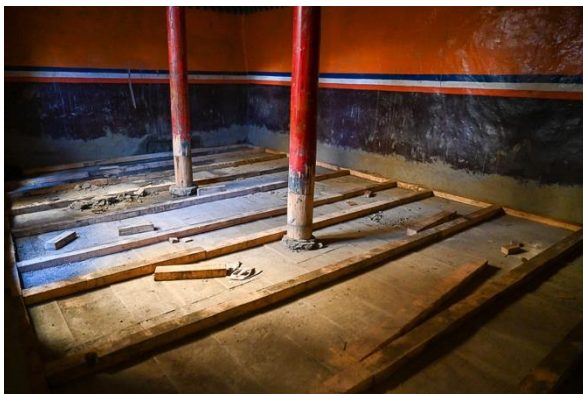
*Figure 29: The installation of wooden frames in the VIP room to support the floorboards.*

As usual, a frame was constructed to support the floorboards and filled with clay. The clay was levelled and then floorboards were installed to complete the floor.

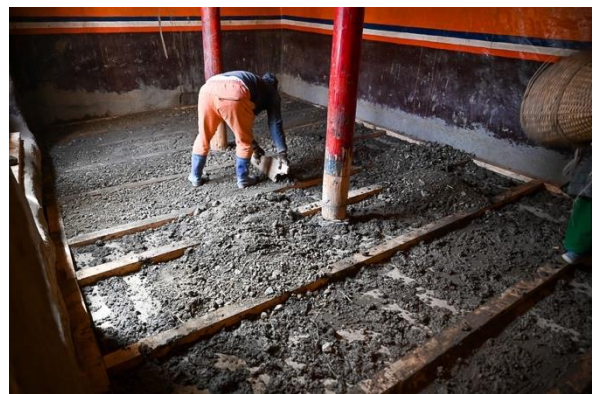
*Figure 30: The frames were filled with clay as a fire precaution.*

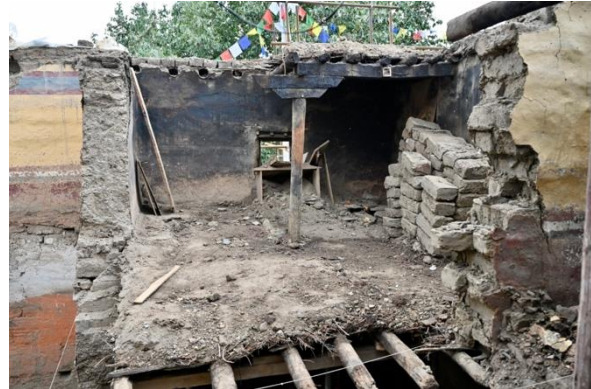
The dismantling of the roofs on the caretaker's kitchen side resumed after the front section was completed. The beam, column and joists were not reusable. So, they needed to be replaced by new ones. Accordingly, the old wooden structure was redone

*Figure 32: The caretaker's kitchen in the process of dismantling.*

with new square beams and joists. A new window with two panels now replaces the damaged old one. The mud floor has also been replaced with a wooden floor which was installed on a frame filled with clay.

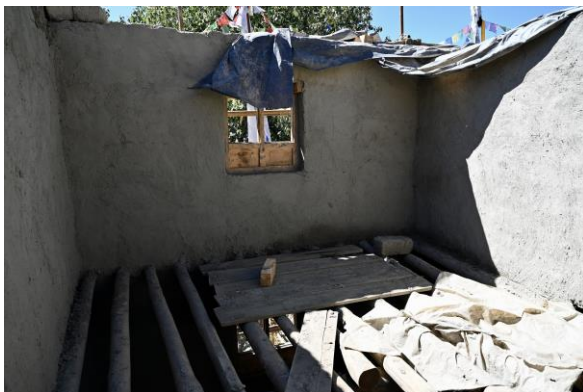
*Figure 33: The caretaker's kitchen during restoration with the new window installed.*

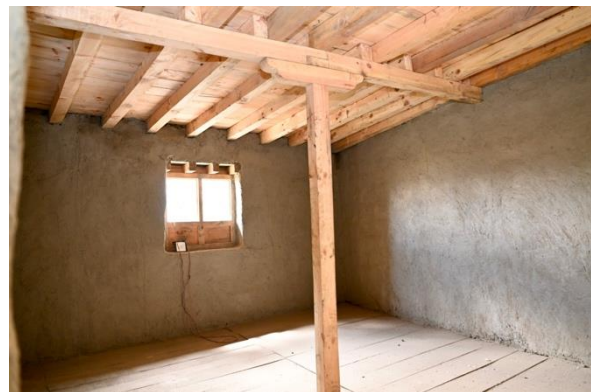
*Figure 34: The caretaker's kitchen after restoration.*

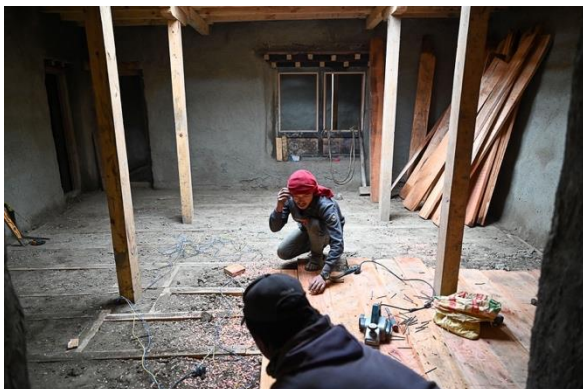
*Figure 36: Installation of the wooden floor in the visitor room.*

The mud floor was replaced by a wooden one. To enable this, channels had to be dug into the mud floor to accommodate the wooden frames (Figure 36). The gaps were compacted well before finishing the floor with thick floorboards (Figure 37).

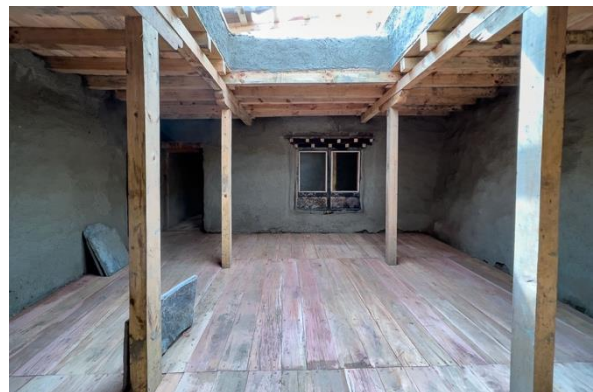
*Figure 37: The visitor room with the wooden floor installed.*

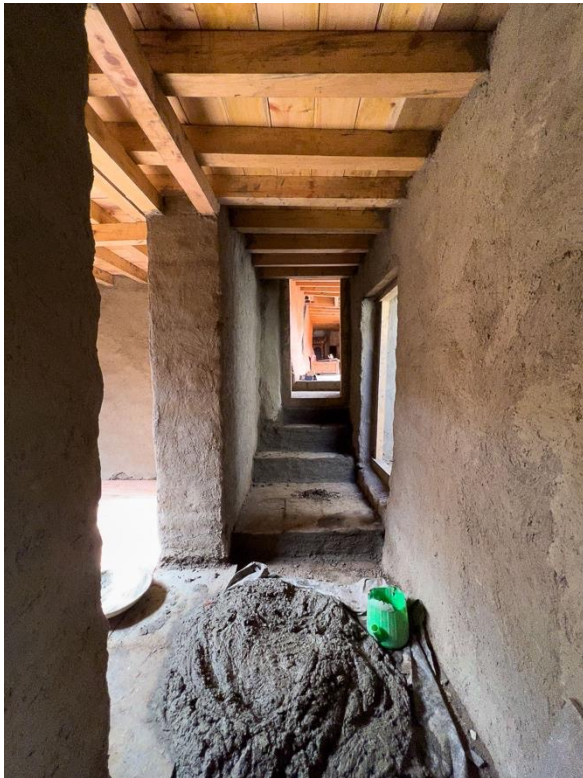
*Figure 39: View of the passage to the temple with the higher walls to the guest room on the left and the door that will provide access to the roof to the right.*

The passage leading to the temple courtyard has also been redone with flat stone pavement on the mud floor. The steps were also repaired with placement of new wide flat stones. Likewise, for safe and convenient mobility, the low clearance door was also replaced with a new one providing more height (Figure 41).

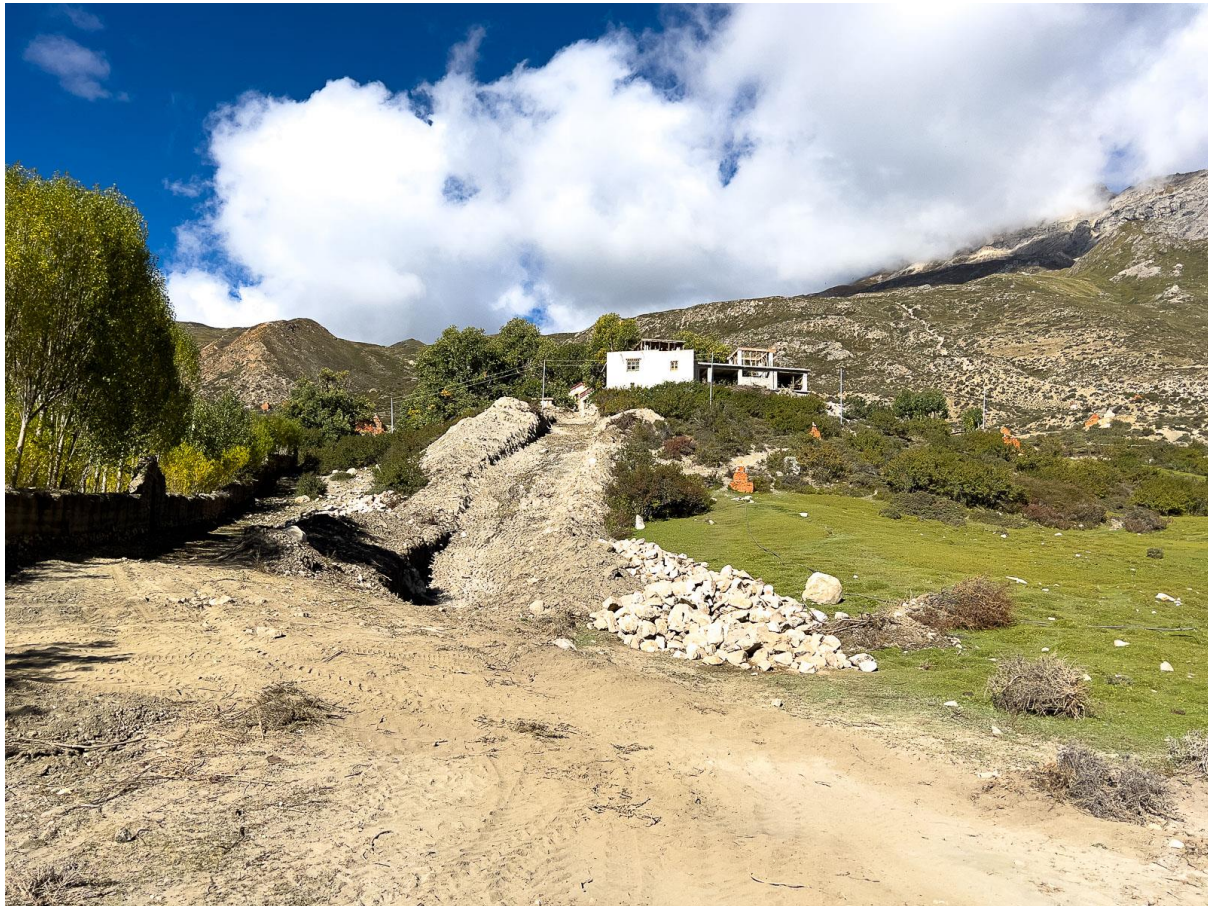
*Figure 40: View from the walking path leading up to the monastery; the trench in the foreground prepares the concrete stairway, while the new concrete construction is seen in the background behind the white building.*
