# Architectural Restoration and Seismic Strengthening of Gönpa Gang

U.S. Ambassadors Fund for Cultural Preservation, Award No. SNP40022GR0039

**Final Project Report, April 2025**

**Norbusum Foundation (NGO)**

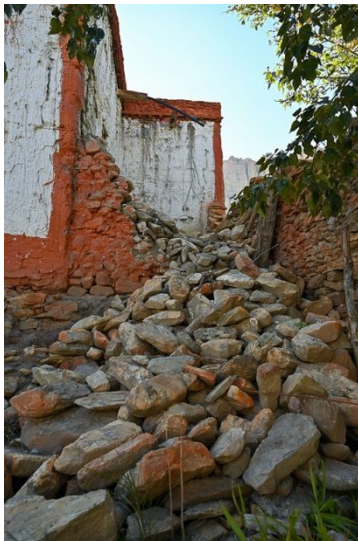
The acuteness of the project was demonstrated in early October 2022 when unusually heavy rains at the beginning of October did affect Gönpa Gang. A simple structure to the right-hand side of the building's entrance has partially collapsed (Figure 13) and it was said that the crack on this side of the wall got bigger. Further, inside the Assembly Hall, in the niche behind the big Maitreya Buddha image, water entered the interior of the building.

*Figure 13: The structure to the right of the entrance partially collapsed in recent rains.*

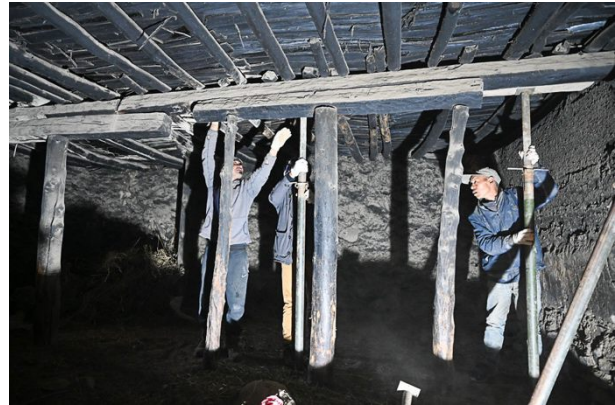
On the ground floor of the southern structure underneath the painted room columns supporting the main beam had tilted precariously and barely supported the beams. Thus, secondary columns have been installed in the room underneath to strengthen the support of the beam temporarily (Figure 16).

Figure 16: Inserting metal props as a temporary measure to secure the foundation of the southern part of the monument.

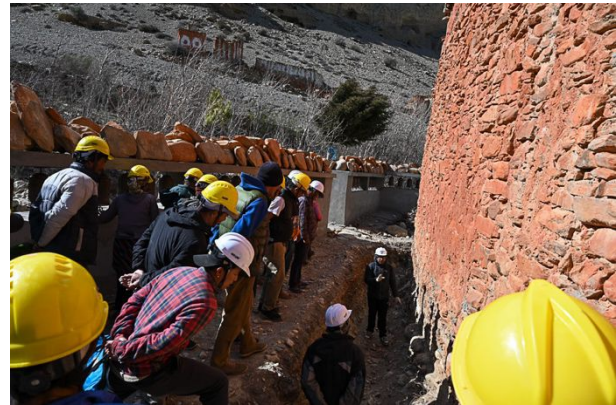
*Figure 34: Villagers looking at existing foundation's condition after a dig around the outer wall.*

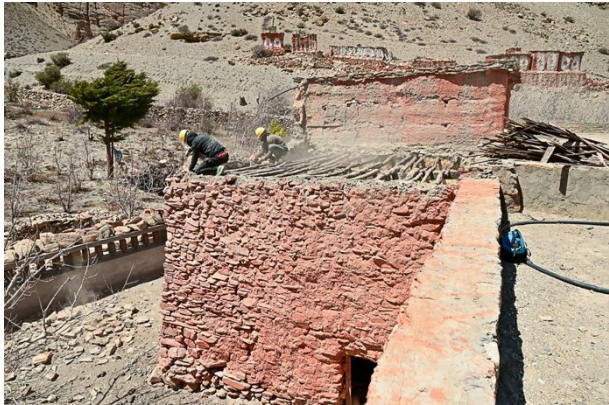
*Figure 37: The structure to the south side of the apse clearly is a later addition and poorly constructed.*

As agreed in the April 2 meeting, the poorly constructed structure on the south side of the apse was demolished in its entirety. This enabled to improve the foundations of the main temple in this area the walls of which carry murals on the inside.

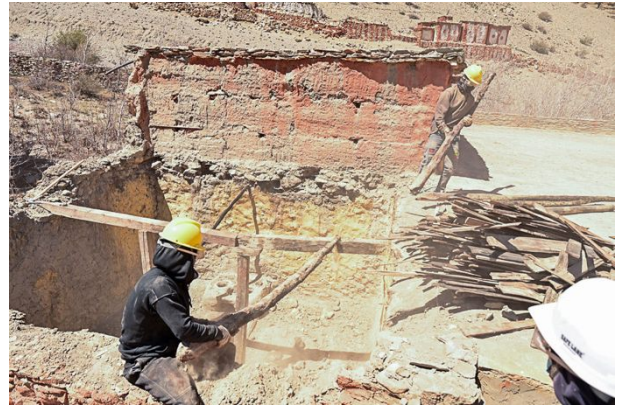
*Figure 38: Note the distortion of the small wooden members that once supported the upper floor.*

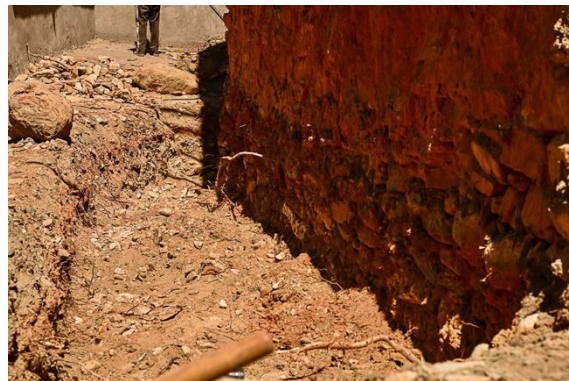
*Figure 44: Roots penetrating the foundation of the temple.*

Around the temples exterior a drainage channel needed to be dug to avoid the accumulation of moisture. The new drainage was made at a distance from the wall and its foundation support.

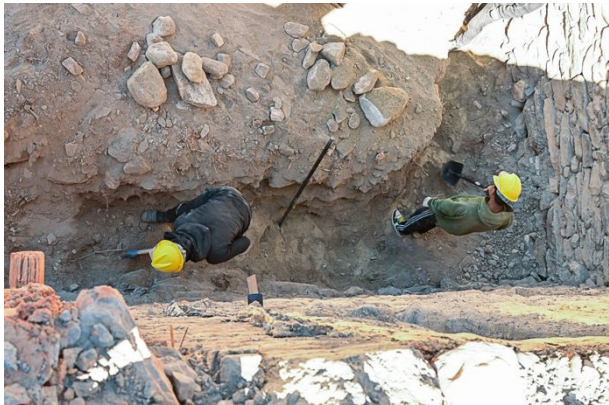
The clearing work revealed that the structure was erected with a very weak foundation, a new issue that needed to be addressed during the restoration. After analyzing the condition of the foundation around the building and identifying potential risks (damages

*Figure 59: All along the outer wall of the monument a ditch was dug for the wall strengthening the foundation.*

and distress) and weaknesses, we concluded that it is necessary to build a continuous stone wall adjacent to existing foundation to increase the stability of the walls.

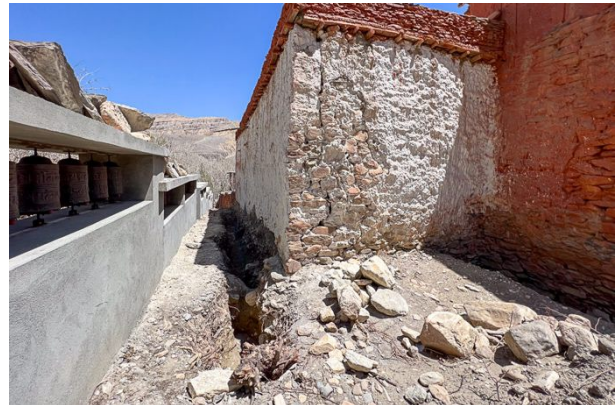
*Figure 60: The most precarious area in the northwestern corner of the building.*

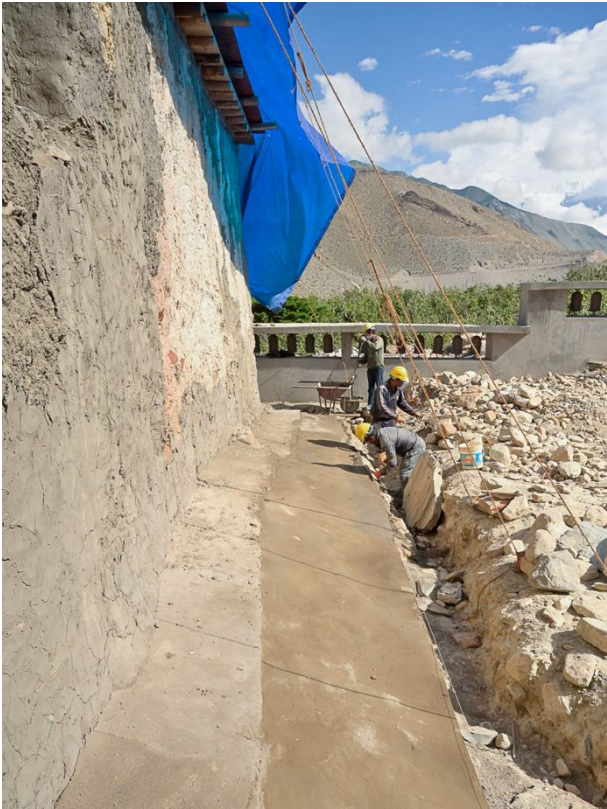
At the southwest corner of the apse a buttress stone wall needed to be constructed to consolidate the corner. The wall at this corner was rather weak with loose stones.

Figure 67: Mud was also laid between the newly constructed foundation support and the drainage.

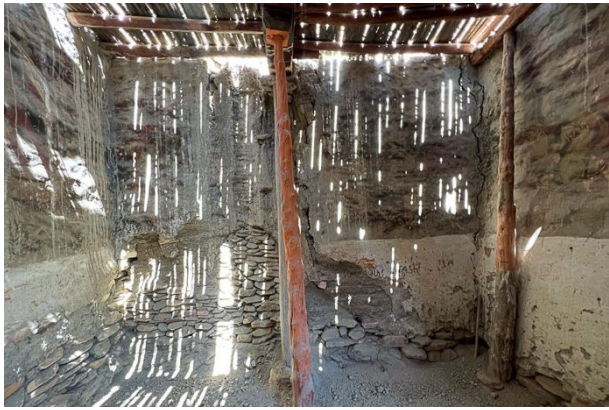
Figure 79: The severely damaged right-side wall of the Entry Hall during dismantling of the upper floor.

To be able to add a foundation underneath the pillars and to level the construction for seismic strengthening the wooden structure of the Entry Halls' interior needed to be fully dismantled. First the superstructure of the Entry Hall was dismantled from the roof to the base of ground floor. Only the walls of the hall were retained. Then all wooden elements were renovated, cleaned, leveled, and prepared for reconstruction, with rotten wooden elements replaced with new ones. To hold the rebuilt structure new bed stones were laid in the appropriate size, that is much larger than the original ones, and joints prepared by stone masons. The wooden structure was then gradually restored with connections between all its members as documented in the images below. By the end of May 2023, the first-floor level was finished including the mud, while the roof was still outstanding.

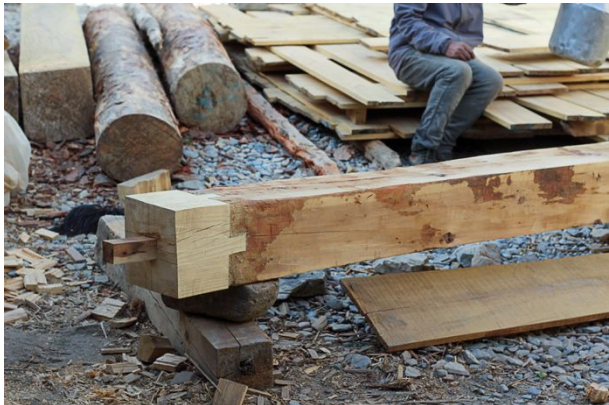
Figure 81: The original post holding the porch was lengthened by adding a new bottom section.

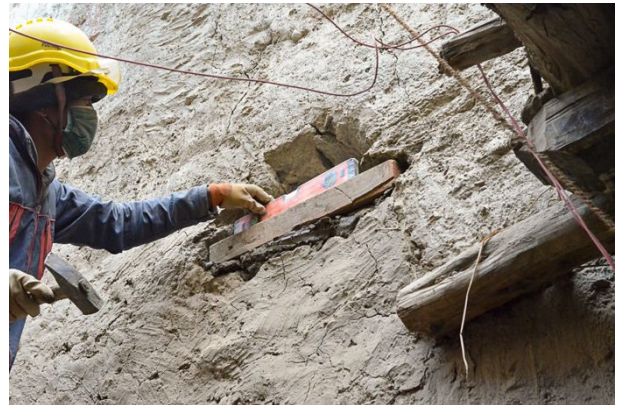
Figure 82: Inside the wall the support for the beam was strengthened by adding a level wall plate.

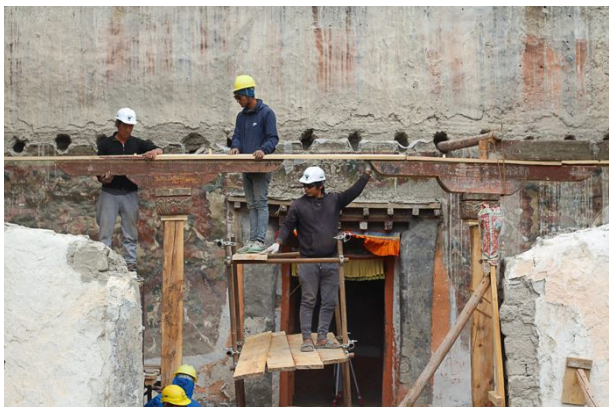
Figure 87: Once the two pillars were erected the laying of the beams was prepared by first placing the boards.

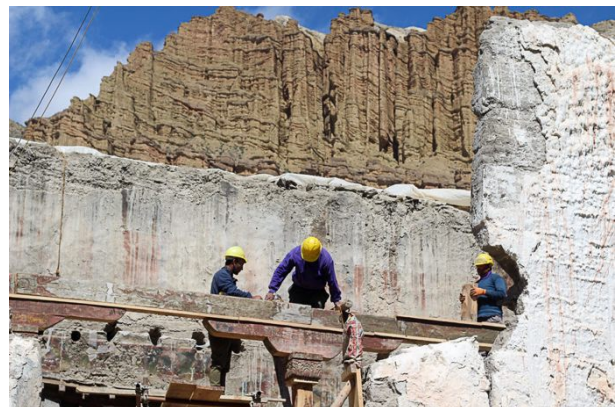
Figure 88: Then the original beams were placed on top of the supports.

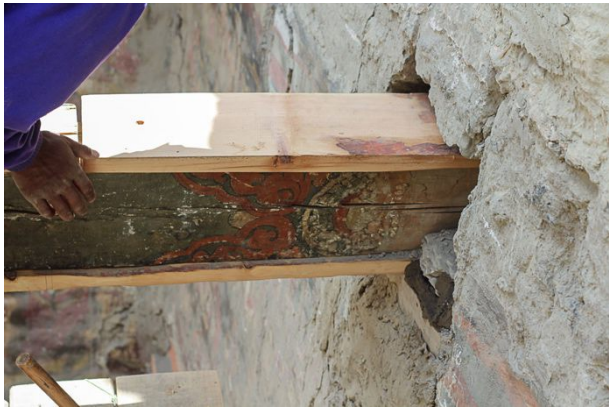
Figure 89: On the wall sides the reassembled beam was placed on a leveled stone plate inside the wall.

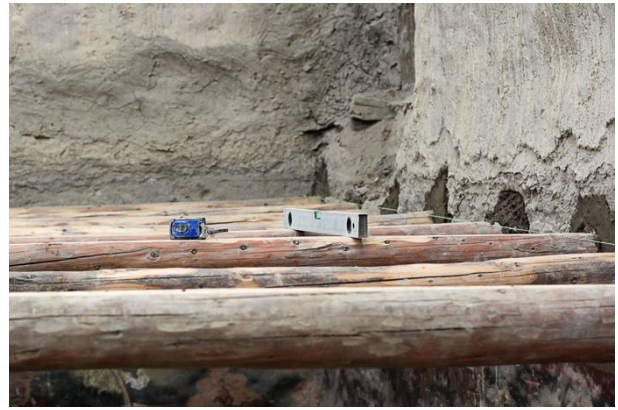
Figure 90: The joists were then refitted into the existing openings to avoid harm to the wall paintings underneath them.

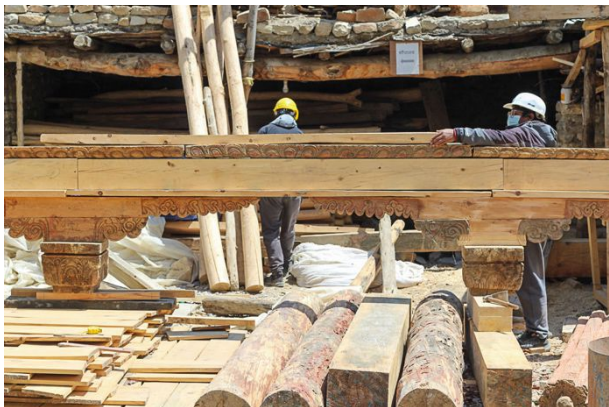
Figure 91: To fit the new and old parts together they were first assembled in the working area.

For the porch the columns needed to be made anew (Figure 92), and also the beam needed to be replaced. First, they were fitted in a trial (Figure 91), and then they were installed in situ. For this the new wooden columns of the porch and their capitals were reassembled, using the old decorated wooden elements.

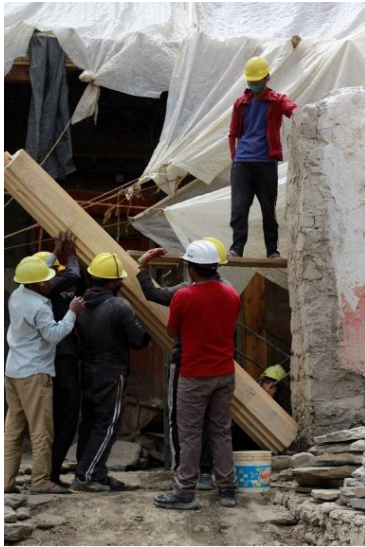
Figure 93: Placing the front column on the bed stone with a projection connecting it to it.

The columns were placed on the solid stone foundation made earlier. They were then joined with the original capitals through connections prepared in advance.

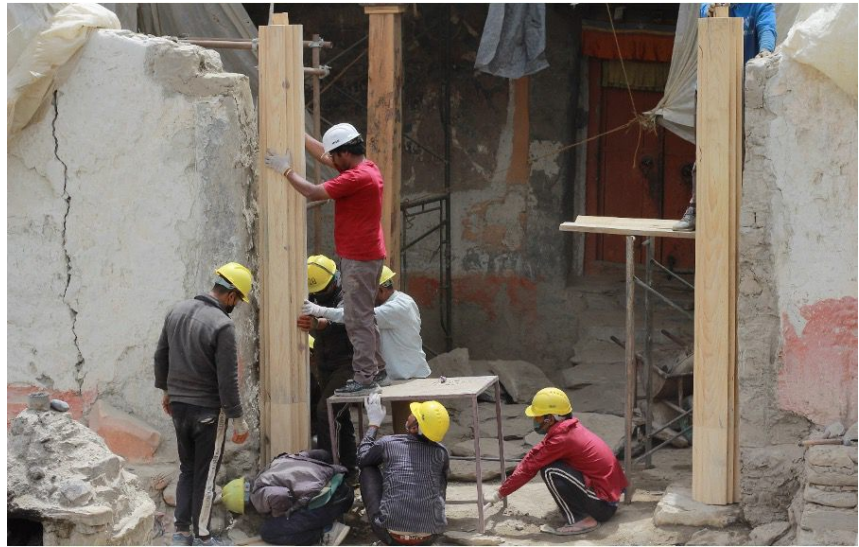
Figure 94: Checking the placement of the new columns with small wooden connectors.

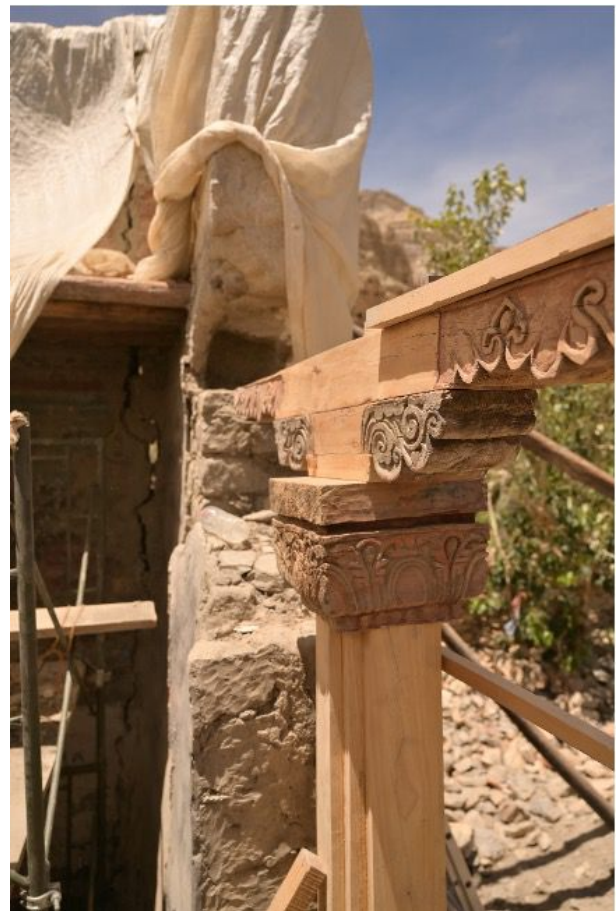
Figure 96: The old capital members placed on the new column aligned with the wall.

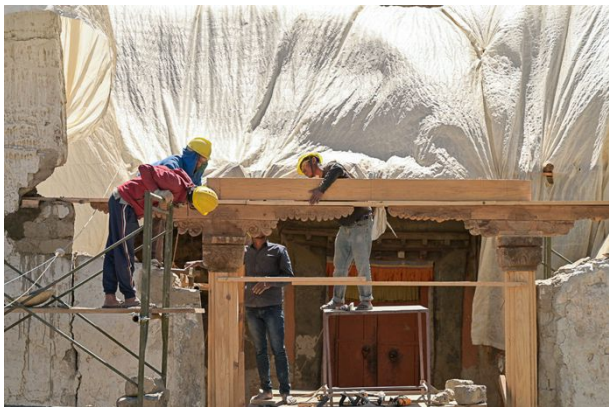
*Figure 98: Arranging the positioning of the central beam as per measurements.*

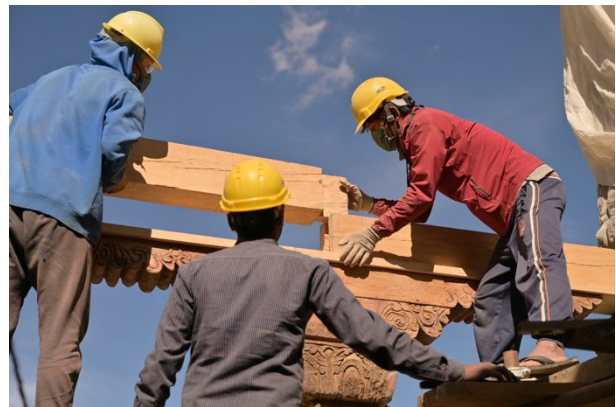
*Figure 99: Connecting the members of the front gate beam.*

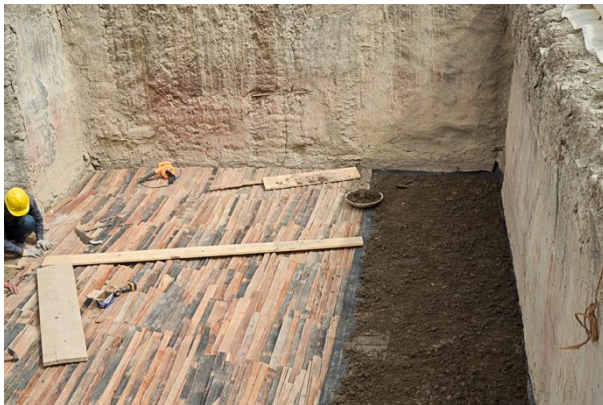
Figure 102: Between the wood splits and the mud layer a breathing fabric was added to reduce dust.

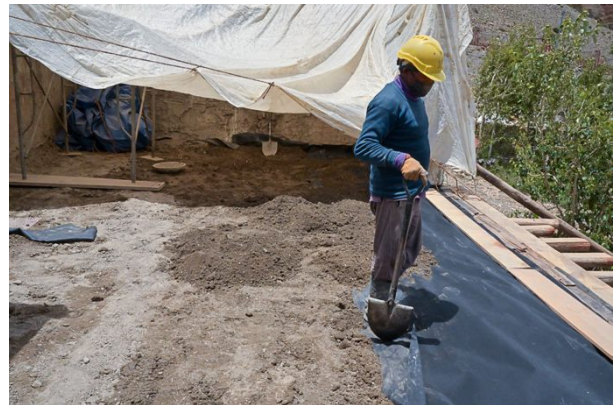
Figure 103: By July 20 the mud layer of this floor was completed.

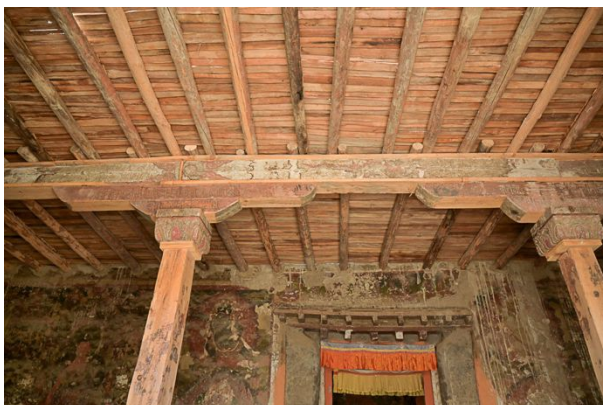
Figure 104: View of the ceiling of the Entry Hall after placing original wood splits on the joists.

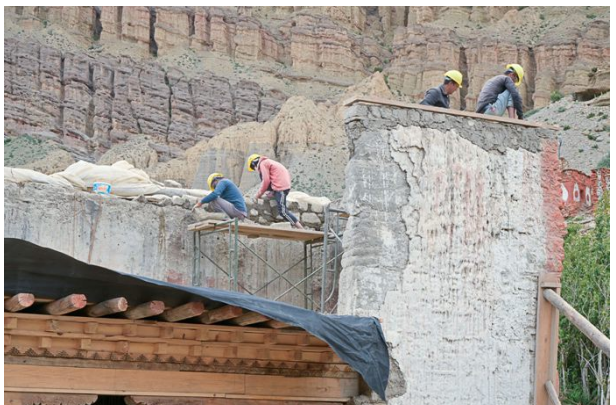
Figure 105: Before the balcony room in the upper floor could be reconstructed the walls needed to be leveled to enable the placement of a wood tie across the corner. In this area the front wall was detached from the side wall.

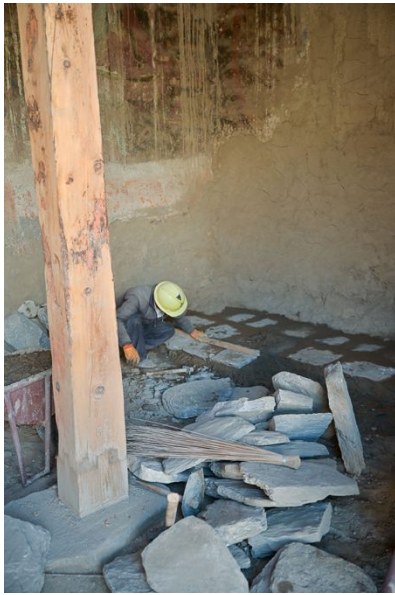
*Figure 106: Laying the stone floor in the back corner of the Entry Hall.*

Inside the Entry Hall, stone slates were used for flooring. These stones were collected from the nearby river. These were then chiseled to the needed shape and size to lay the floor.

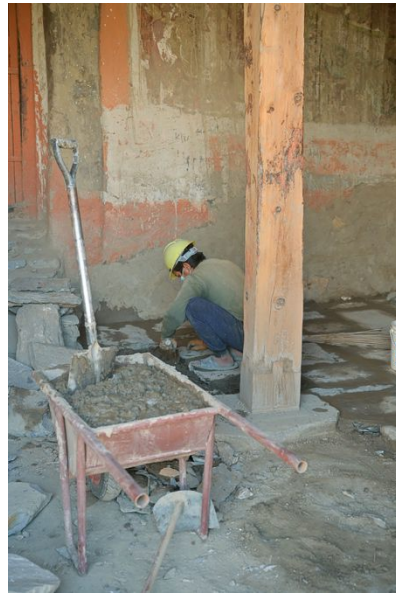
*Figure 107: Work then proceeded on the right side of the Entry Hall.*

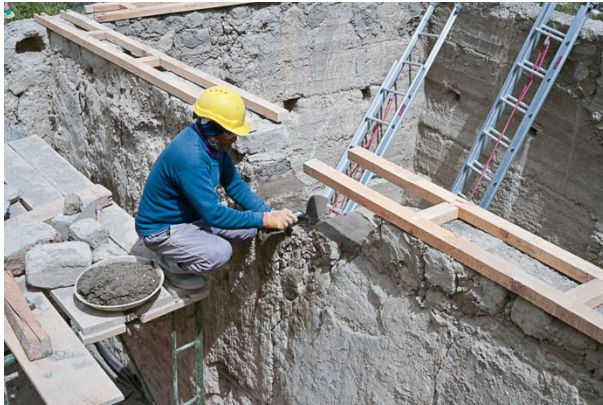
Figure 110: The area where the central beam is to be placed was strengthened by a leveled wooden plate.

Once the Entry Hall was completely reconstructed the balcony room above it could be reconstructed as well. Here the top of the walls was levelled, and a wooden tie layer was added. Then the first-floor superstructure was reconstructed with all its wooden members replaced, as the best-preserved original joists were used for the lower floors to retain their original appearance.

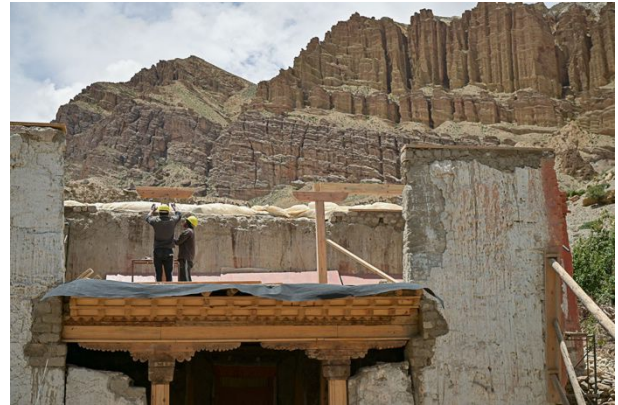
Figure 111: In late July 2023, the central wooden structure of the balcony room was reassembled.

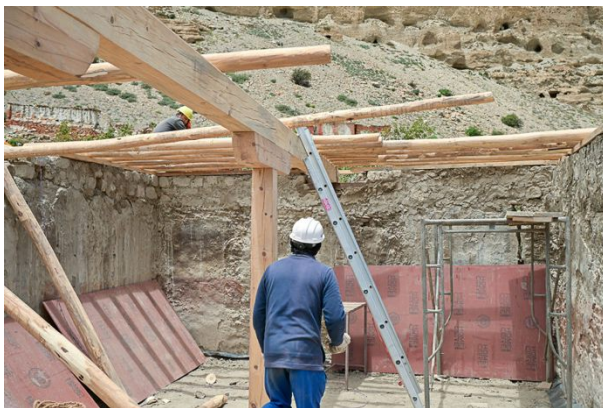
Figure 112: The wooden structure and the joists of this room are entirely replaced, as the best original wooden members were used for the lower floors to retain their original appearance.

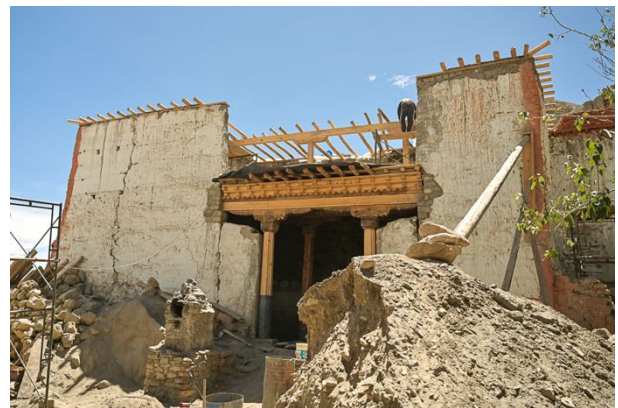
Figure 113: View of the temple with the balcony room partially reconstructed.

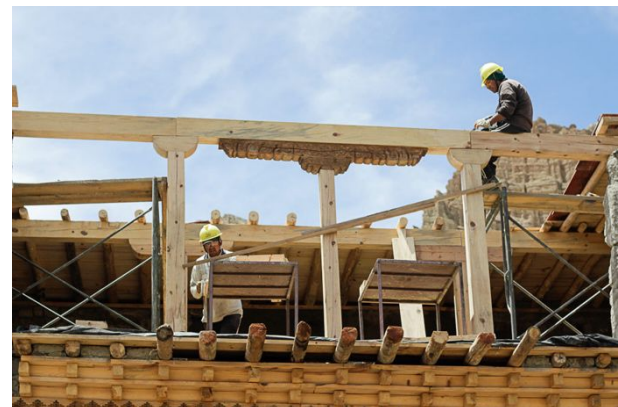
Figure 115: Assembling the wooden members of the balcony reusing the original central capital.

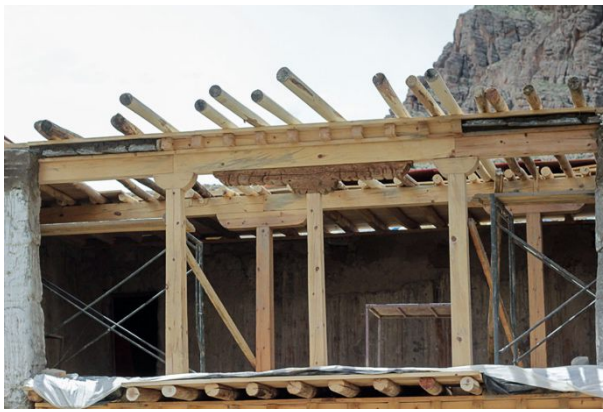
*Figure 116: Placing the joist between the central beam and the balcony area.*

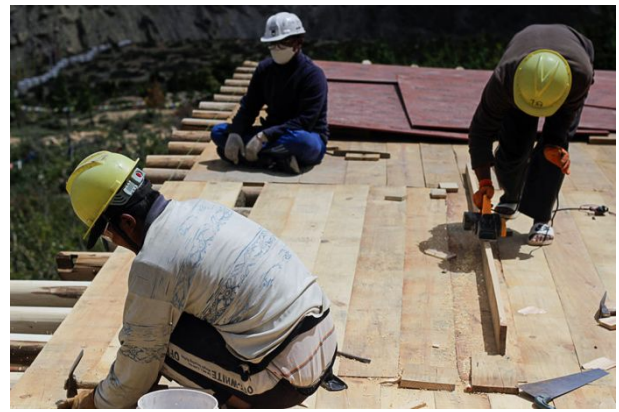
*Figure 117: Planking on roof above the balcony room.*

Once the roof level was reached the wooden planking was installed (Figure 117). Finally, a temporary roof was installed for protection during winter.

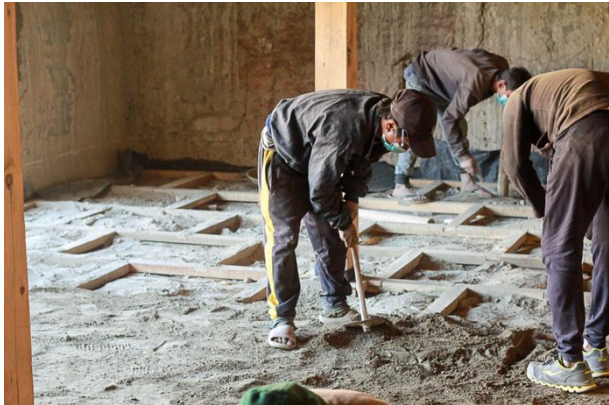
*Figure 119: Laying out the wooden batten to hold the flooring; with the hollow space filled with mud.*

The flooring of the balcony room was finished in late 2023. Above the first mud layer a wooden batten filled with further mud was installed. Then the floor was finished by wooden planks.

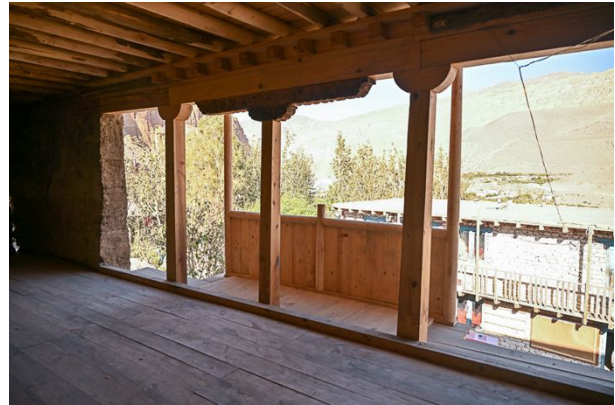
*Figure 120: By late 2023 the new flooring and balcony room was completed.*

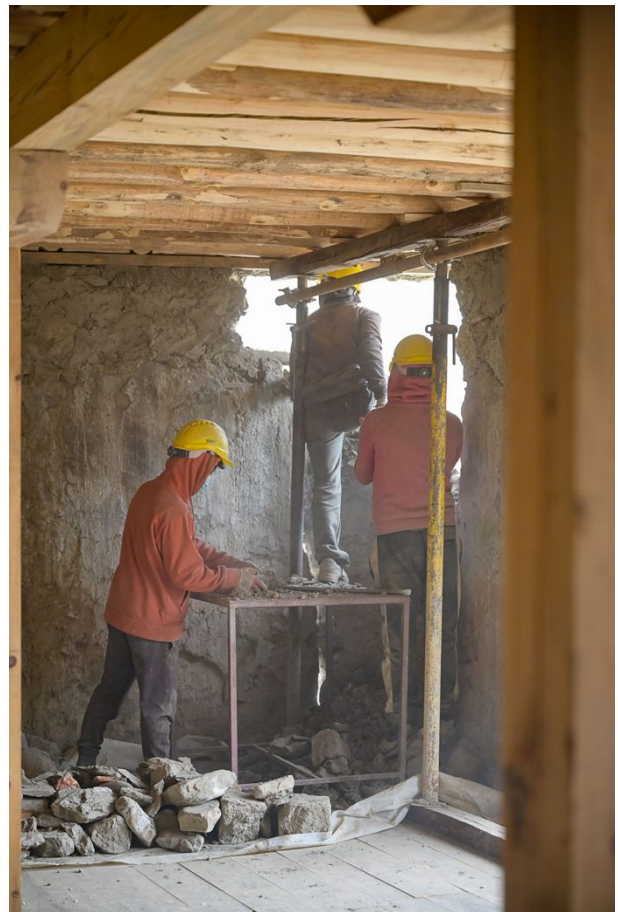
Figure 123: Opening the northeast corner on the upper floor level by dismantling the walls.

First, the walls at the corner had to be taken down, which was started on March 19, 2024. Then the walls were reconstructed using wooden ties with rammed earth to connect them across the corner. This work was finished by March 22.

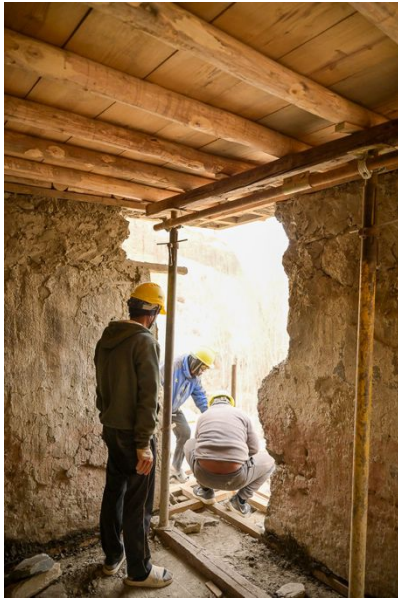
*Figure 125: Placing the lowest wall tie on the upper floor of the northeast corner.*

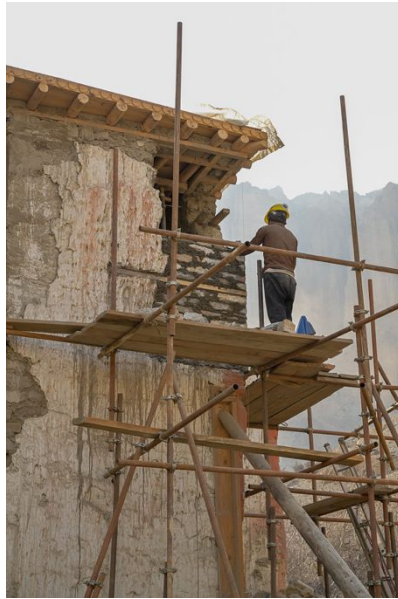
*Figure 126: The northeast corner during reconstruction.*

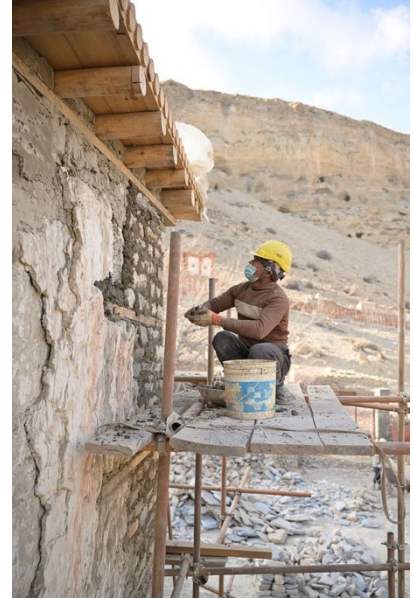
*Figure 127: Finishing the reconstruction of the northeast corner.*

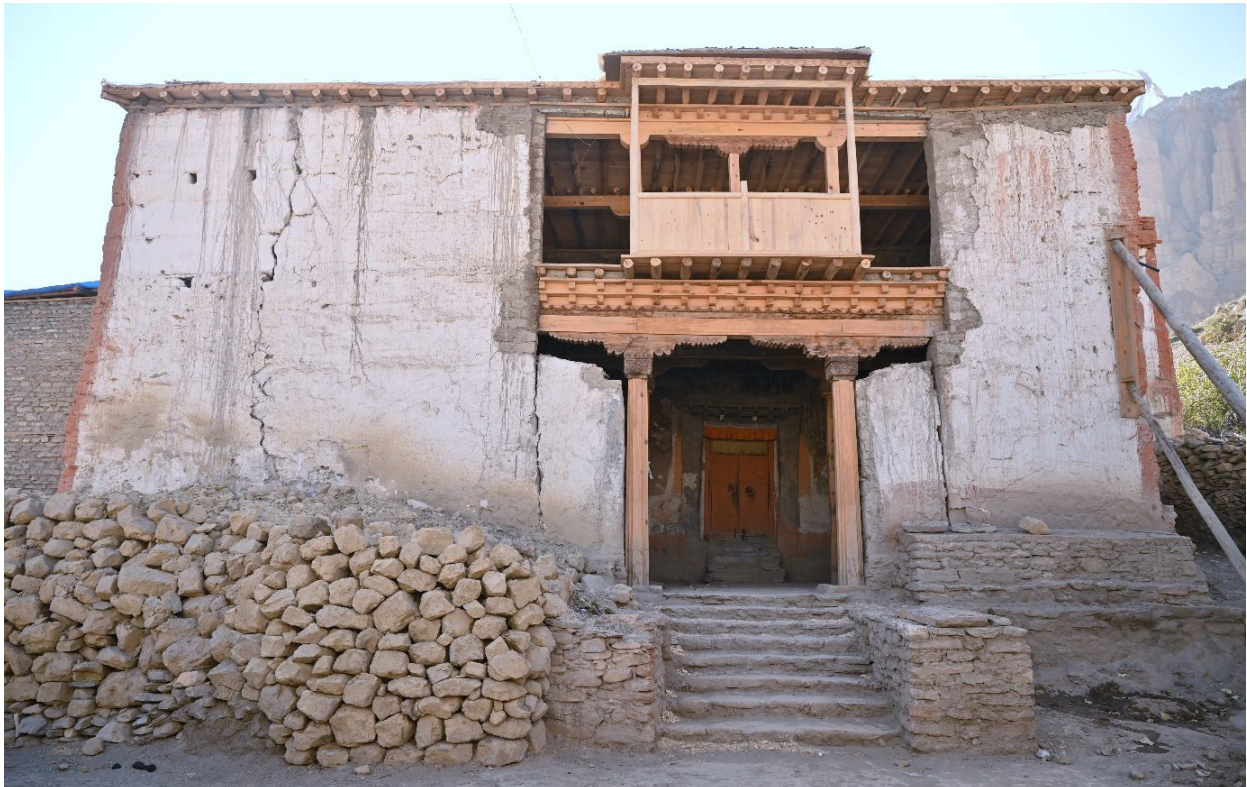
After finishing the temporary roof in late 2023, Sabin Shrestha, against the suggestion and plans of Thomas Schrom, installed a balcony replicating the most recent version in both appearance and technique (Figure 129). This reconstruction did replicate what was preserved at the site, but the areas to its sides remained to be decided on.

*Figure 129: Photo of the reconstructed entrance taken on October 14, 2023.*

In early 2024, it was then decided to keep the narrow balcony and to introduce screens to its side. Accordingly, some adjustment work on the balcony was undertaken March 20 and finished by March 21.

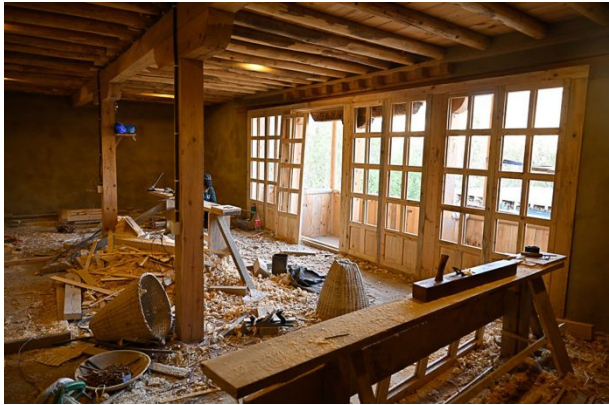
Figure 130: The balcony door has many compartments for glass panels and thus was a complex work.

Work on the balcony door took almost a month to be completed. The door itself was made by two carpenters from October 4 to 17, then the glass panels were installed. This took longer as the number of glass panels needed was miscalculated and more needed to be brought from Pokhara.

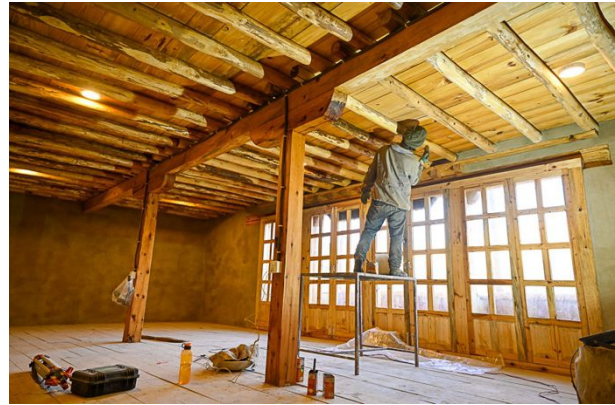
Figure 131: View of the balcony door during the application of linseed oil to its ceiling.

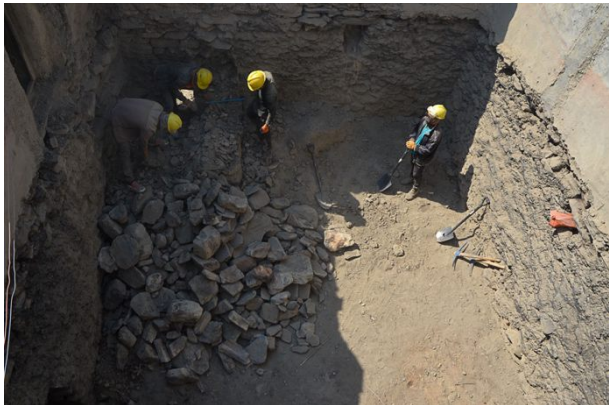
The southern building added to the temple at a later period was in its entirety in a rather precarious condition. In particular, the wooden structure on ground floor level was very weak and emergency supports were installed at the very beginning of the project.

After demolishing the foundation, large stones were prepared to support the two pillars of the room. The previous construction of the ground floor was of extremely poor quality. Thus, new post, capitals, and beams were prepared and installed at that level. Of the joists some could be retained while others needed to be replaced. Then, a new flooring with minimum thickness of mud was constructed.

*Figure 133: The southwest room after dismantling its previous wooden structure.*

The southwestern room is in the back part of the building and has no murals. It was, thus, decided to redo this room first. Again, the entire wooden structure had to be taken down and rebuilt with a stronger foundation, while the walls were retained.

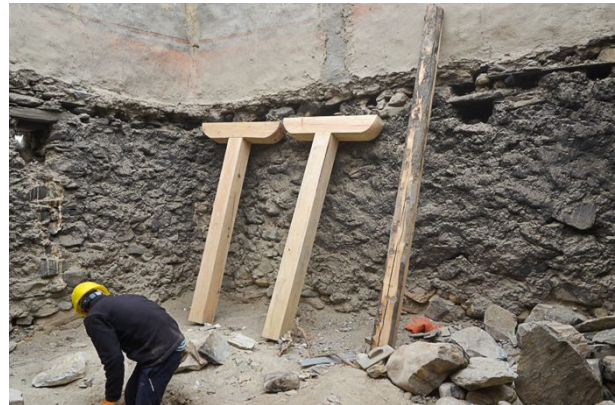
*Figure 134: Installation of the foundation stones; the new pillars and beam being ready for reconstruction.*

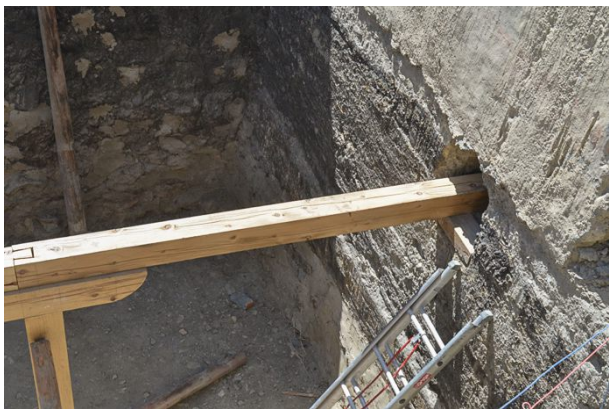
*Figure 135: The new beam was placed on a new wooden support inside the wall.*

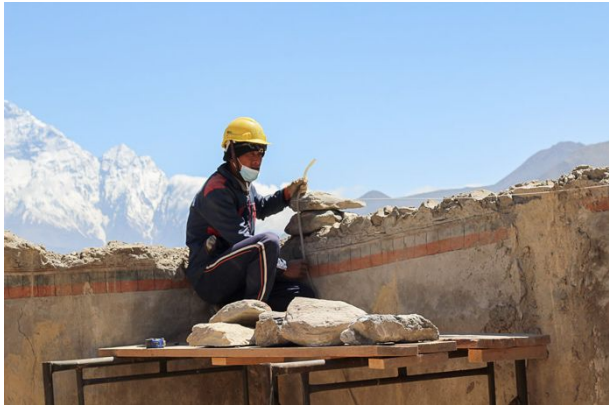
Figure 137: Leveling the top of the wall to enable the installation of wall ties for seismic strengthening.

For the room in the upper floor some of the original wooden members could be retained. Wall plates and wall ties were installed along the top of the wall for seismic strengthening.

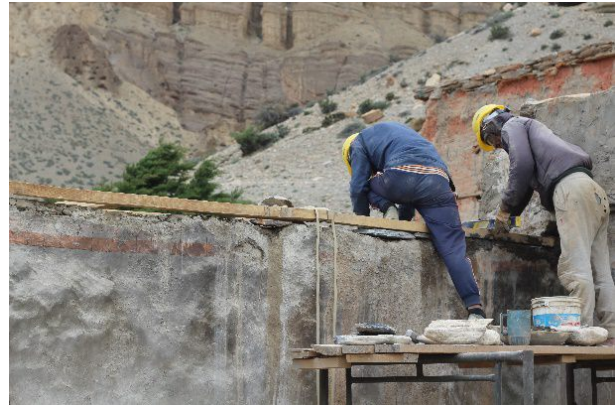
Figure 138: Installing the wall tie on the western wall of the southwest room.

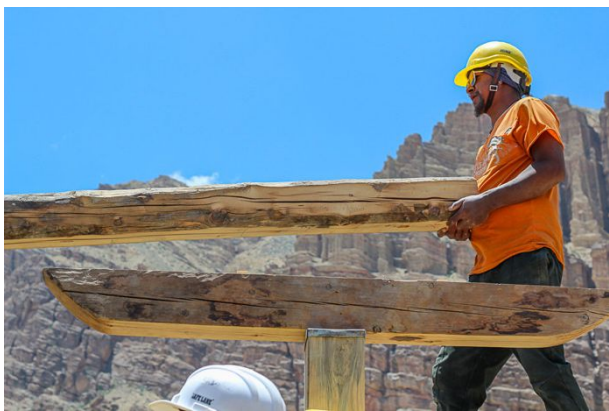
Figure 139: On the upper floor the old capitals could be retained while the pillars and a part of the beam had to be replaced. Note the joints between capital and beam for seismic strengthening.

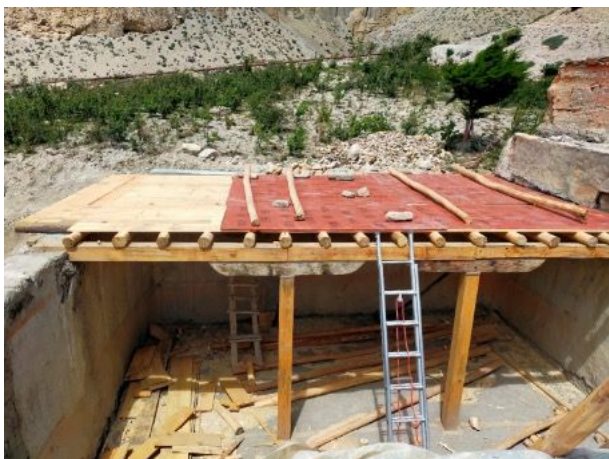
Figure 141: The structural wooden members for the roofing of the southwestern room prepared for assemblage.

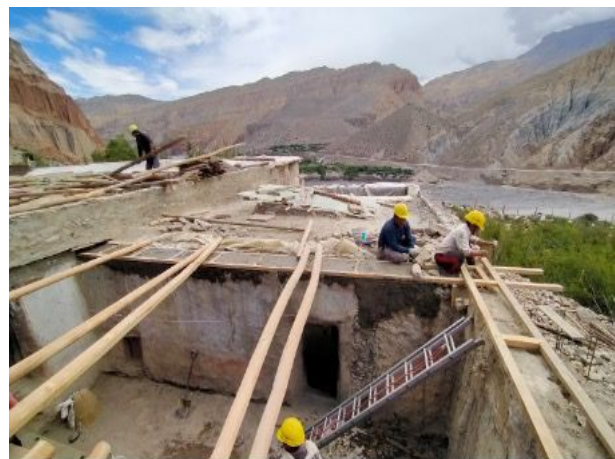
Figure 142: Leveling the wooden ties in the eastern section of the southwestern room.

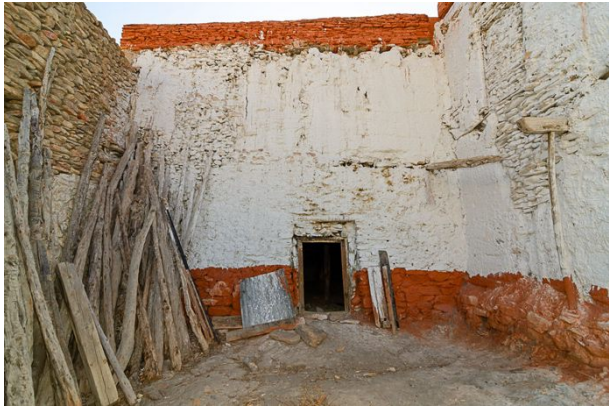
A major bulge in the stonewall at the southeast corner of the southern structure required for the wall to be taken down and rebuilt. This also allowed for wall ties to be added within the stone wall. The tie at the level of the ground floor's ceiling could also serve as support for the joists. The new stonewall was constructed using mud mortar.

Figure 143: The structure in the southeast corner in 2019 revealed many structural issues.

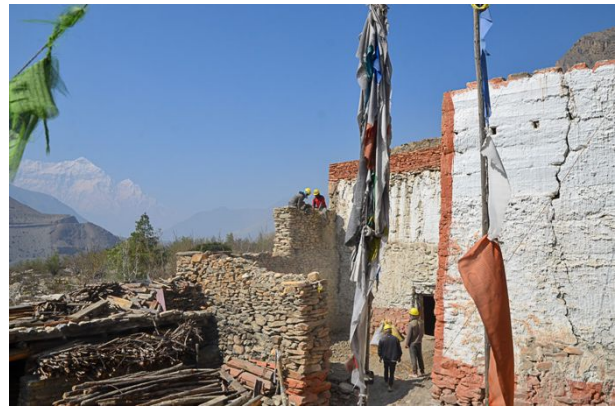
Figure 144: First the wall placed in continuation of the southern wing needed to be removed.

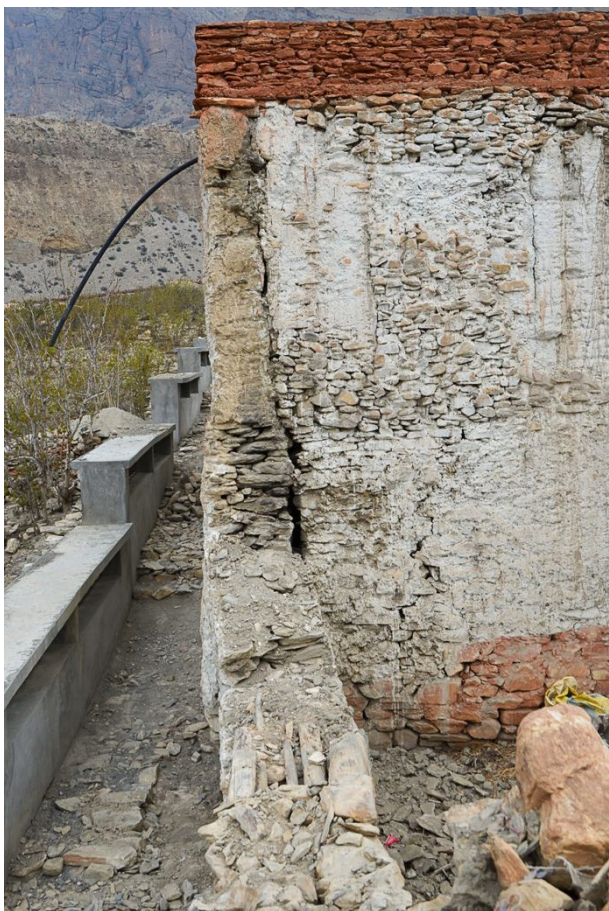
Figure 145: The walls at the corner turned out not to be structurally connected.

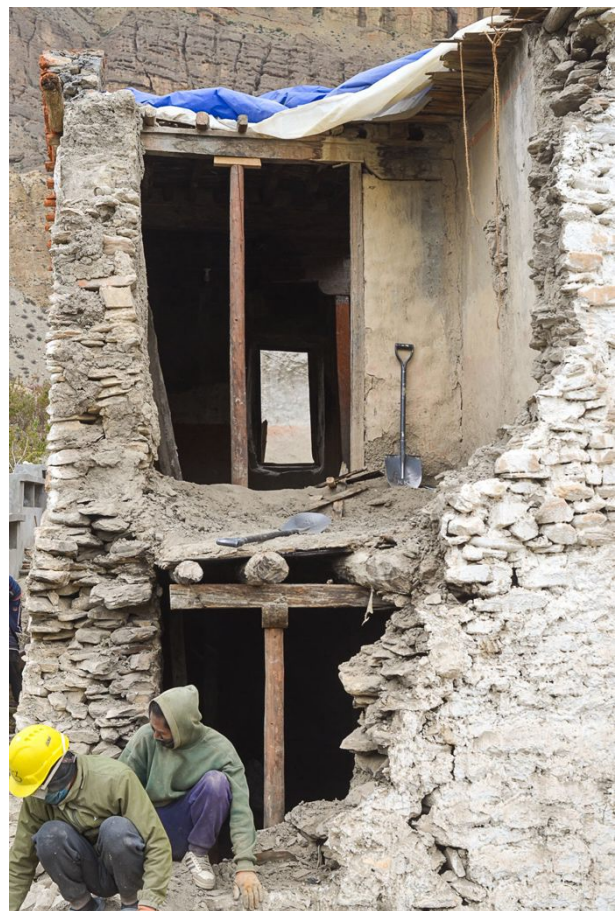
Figure 146: The southeast corner after gradually dismantling the walls.

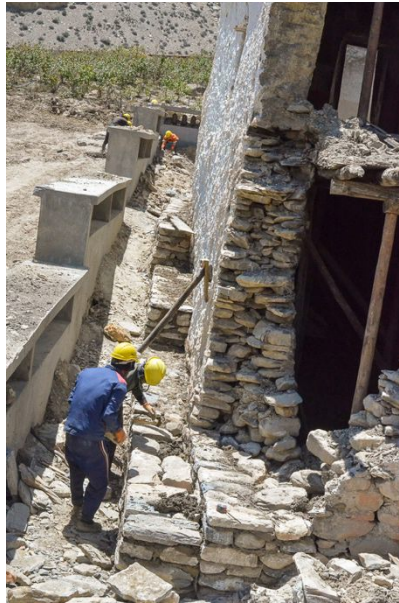
Figure 148: The foundation of the southern wall was reconstructed first.

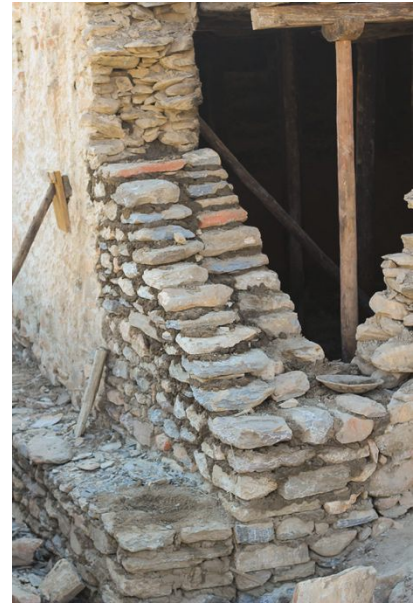
Figure 149: Partial reconstruction of the lower part of the southern wall.

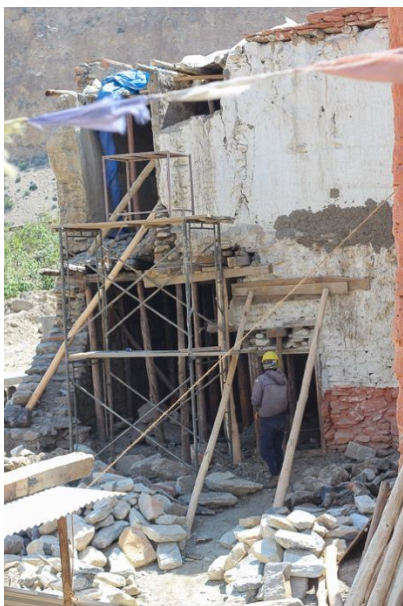
Figure 150: The east side of the corner with temporary supports added while preparing the foundation of the new wall.

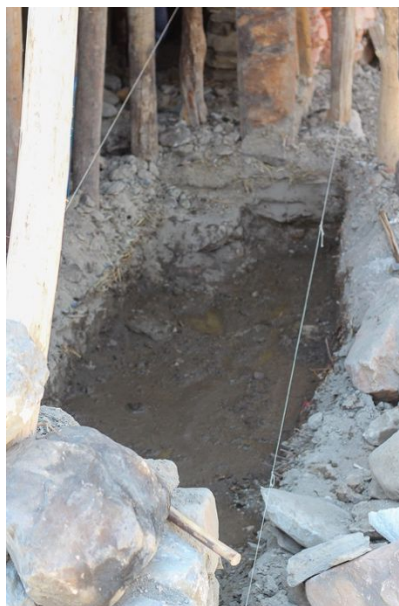
Figure 151: The base of the eastern wall of the corner is much lower than original to provide a proper foundation.

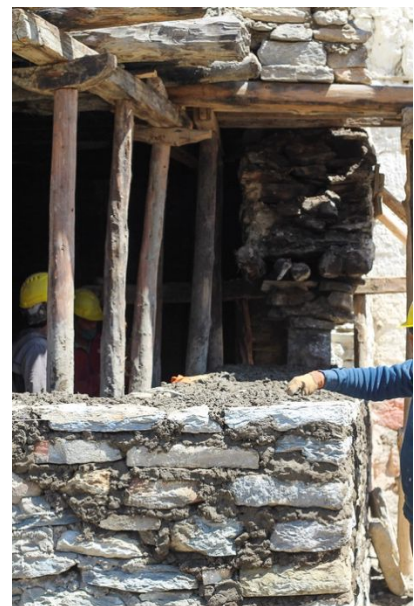
Figure 152: Then the corner was constructed with stones and mud mortar.

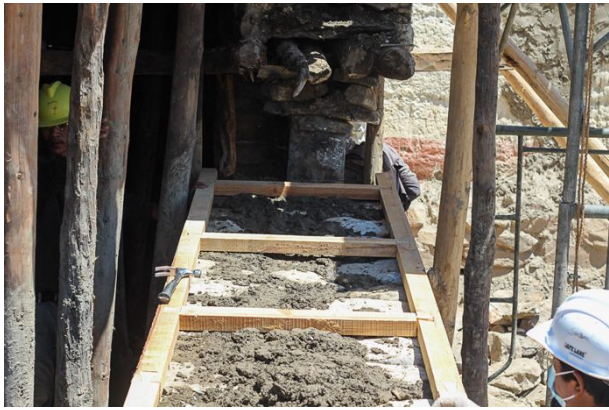
Figure 153: Wooden wall ties were added to the wall for seismic strengthening.

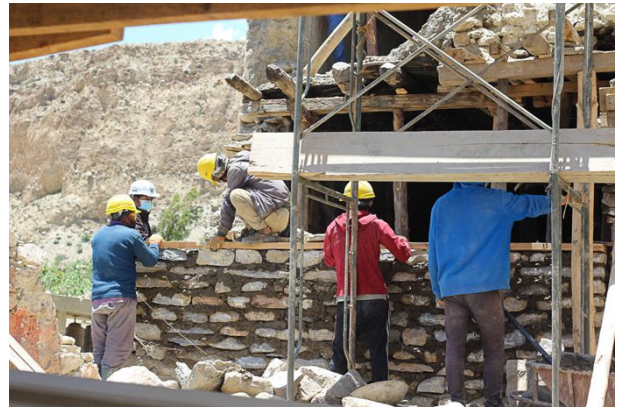
Figure 154: Installation of a wooden wall tie around the corner.

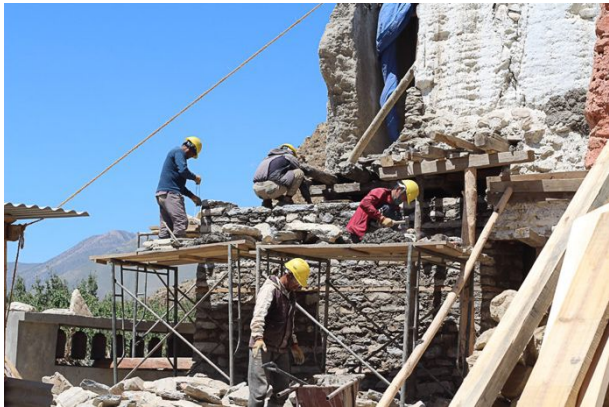
Figure 155: By mid June 2003, the wall was constructed up to the ceiling of the ground floor.

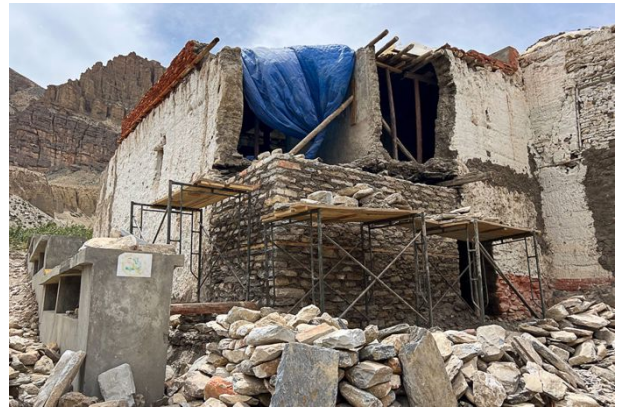
Figure 156: The newly constructed corner with the wall ties.

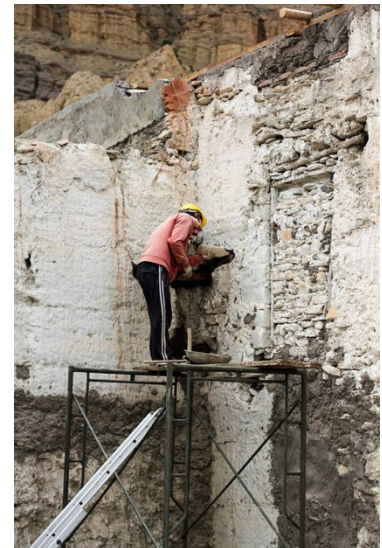
Figure 158: Repairing the adjacent wall with wooden ties.

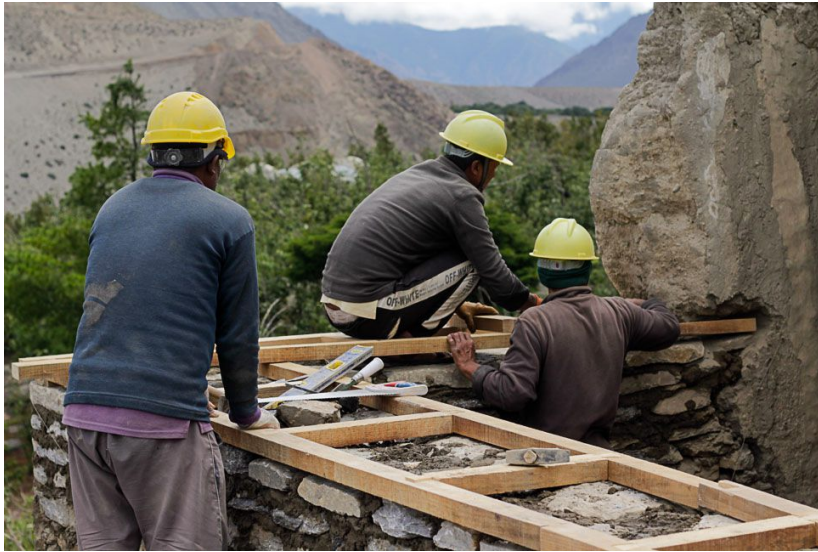
Figure 159: Laying a new wooden tie across the corner to connect the old and new stone walls.

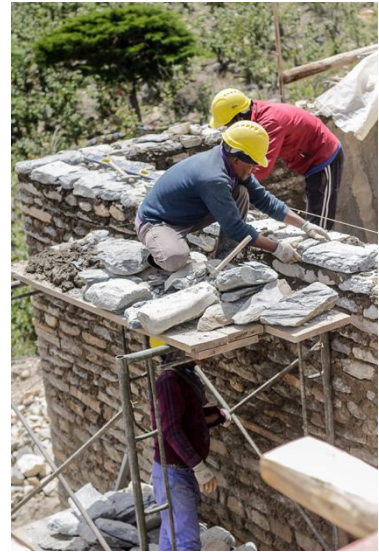
Figure 160: The southeast corner wall is now reaching roof level.
