# Architectural Restoration and Seismic Strengthening of Gönpa Gang

U.S. Ambassadors Fund for Cultural Preservation, Award No. SNP40022GR0039

**Final Project Report, April 2025**

**Norbusum Foundation (NGO)**

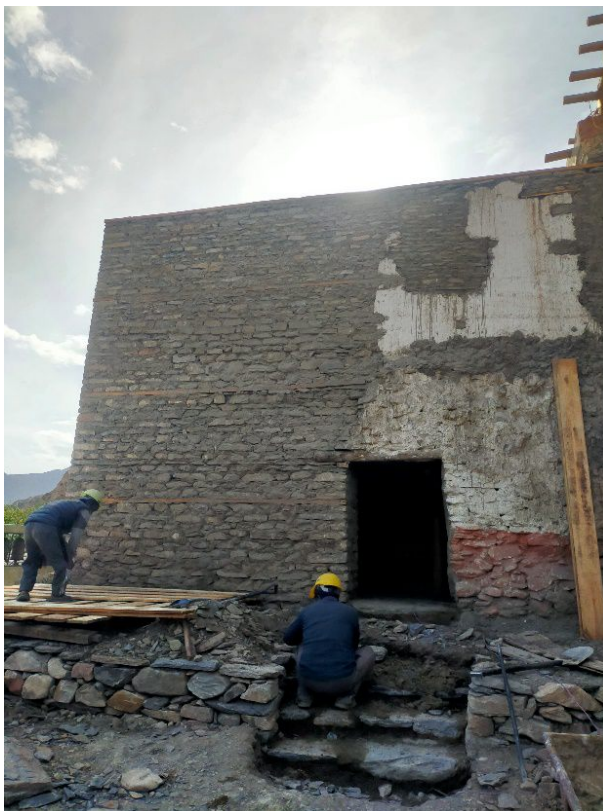
Figure 161: Once the corner wall was completed a stair was constructed to enable easy access the ground floor door.

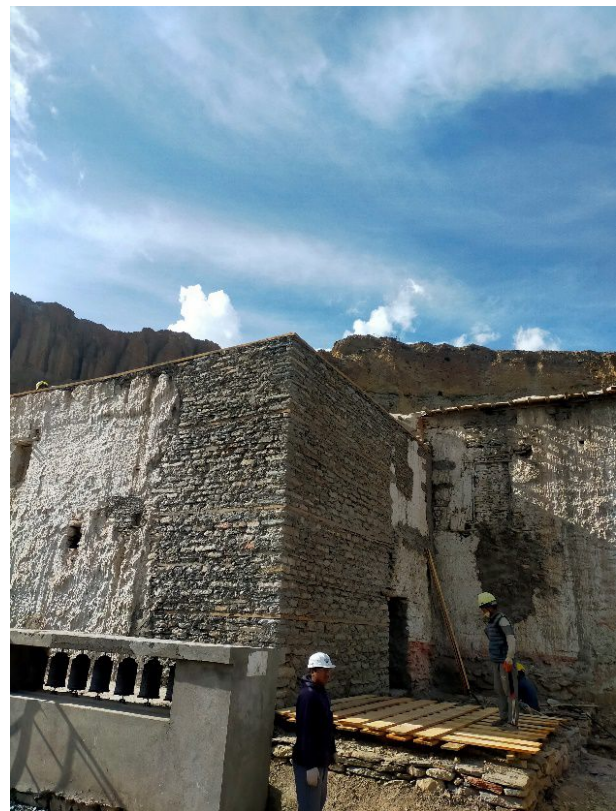
Figure 162: View of the newly stone wall rebuilt in the southeastern corner.

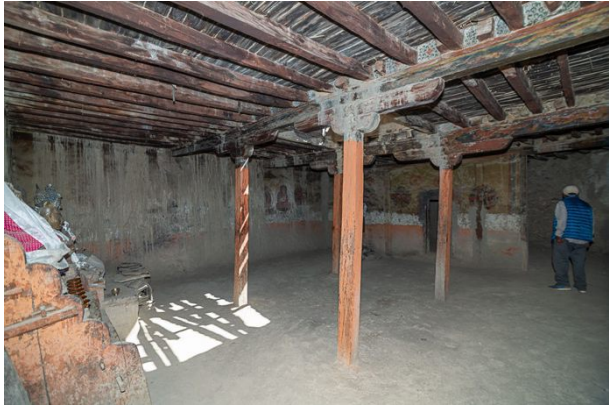
Figure 163: View of the painted room in 2019. The murals in this room have suffered considerable damage, but historically important sections are preserved, such as the portrait in Figure 10.

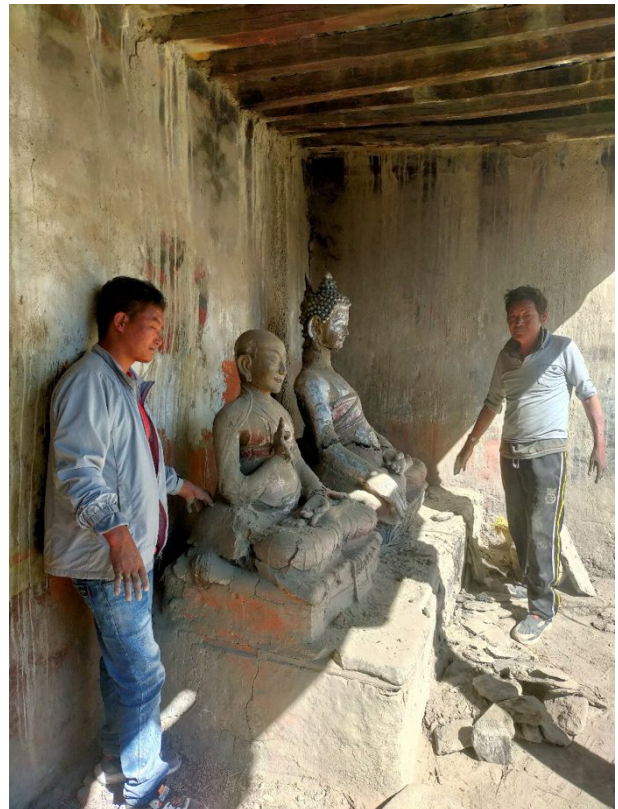
Figure 166: These two large sculptures were too fragile to be moved. This complicated the restoration of this room considerably.

Further the floor underneath the two broken statues in the painted room needed to be finished without moving the statues. This was achieved using wooden supports underneath the images and then replacing the joists underneath them. Then the planking was finished underneath, and a new wooden pedestal was created for the sculptures. This work started in on 14<sup>th</sup> of September and finished on the 23<sup>rd</sup> of September.

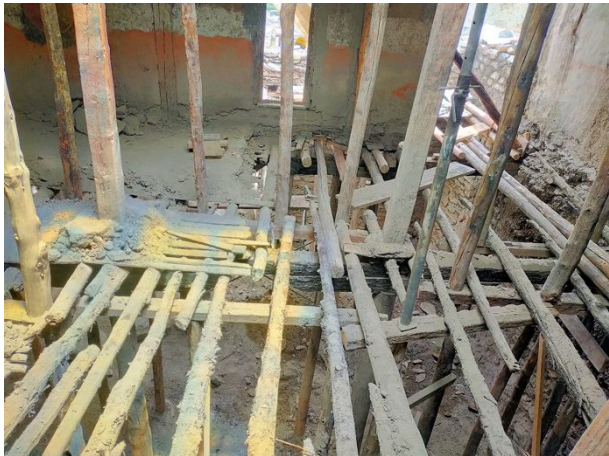
On the ground floor, the eastern part of the south-wing, including the area underneath the painted room, had many supports in problematic condition. Replacing them was challenging as the room above contained the eighteenth-century murals. The restoration, thus, needed to be planned around the painted room. Accordingly, the ground floor supports of this section needed to be dismantled and replaced section by section.

*Figure 167: View of the painted room after removing its floor to enable the replacement of the wooden structure underneath.*

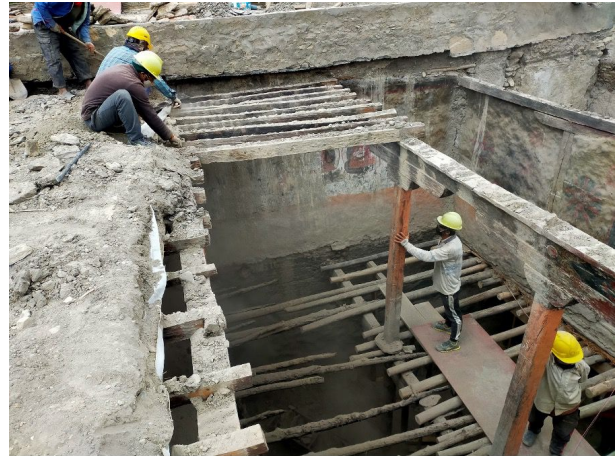
*Figure 168: Dismantling the roof above the painted room to reduce weight on the wooden structure.*

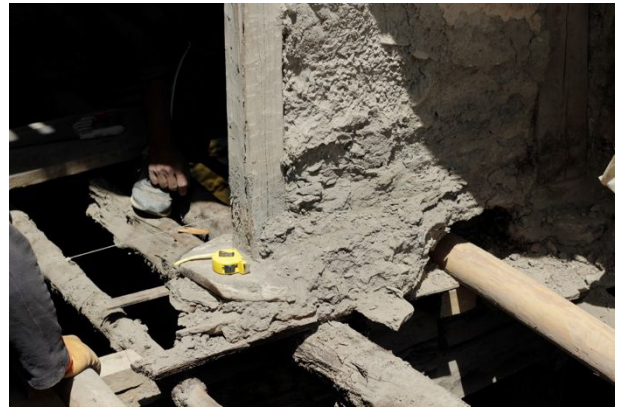
Figure 171: Placing new joist as needed underneath the partition wall.

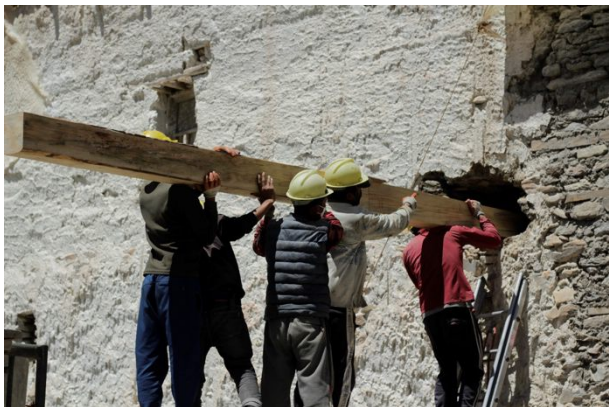
Figure 174: Inserting the new beam to replace old one through a hole in the south wall.

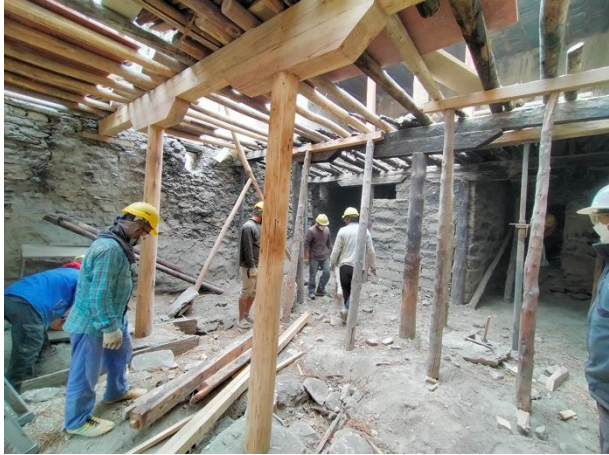
*Figure 176: The ground floor level with half of the wooden structure already replaced.*

First the easternmost area of this section was demolished, and partially rebuilt. Then the restoration moved to the space underneath the painted room. First, the foundations were prepared; large bed stones with joints for the pillars were placed to support the new beams. The original beams needed to be replaced by new ones due to their poor condition. Replacing the beam was most challenging underneath the east wall of the painted room, which also preserved murals and contains an area considered particularly sacred.

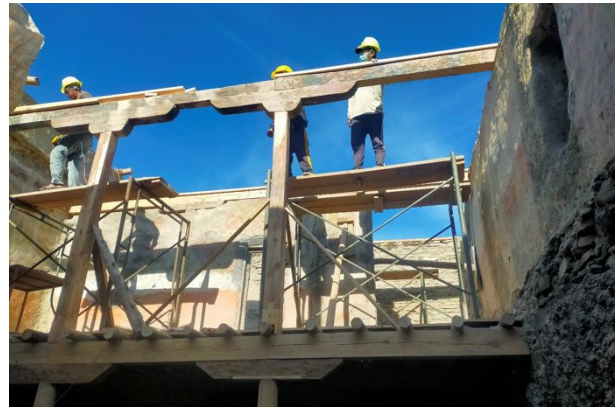
*Figure 177: Reassembling the old wooden structure in the painted room.*

Once the supports on ground floor level were successfully replaced, a new flooring with a minimum thickness of mud was constructed. Some of the original wooden members could be retained to be reused in the upper floor. Wall plates and wall ties were installed on the upper level for seismic strengthening.

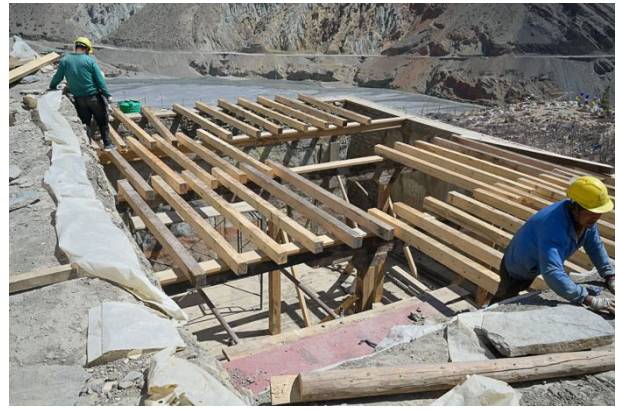
Figure 180: Placing the joists above the south wing.

In 2024, first the temporary roof needed to be dismantled then we started to add the joists that were prepared when work began in March. After adding the joists, planking was installed above them. Then the batten work to finish the floor of the painted room was done. In this process we also integrated an electrical pipe before the mud and floor finish, then we prepared the planks for the floor. Also, the decorative wooden band to finish the roof of the southeast part was done.

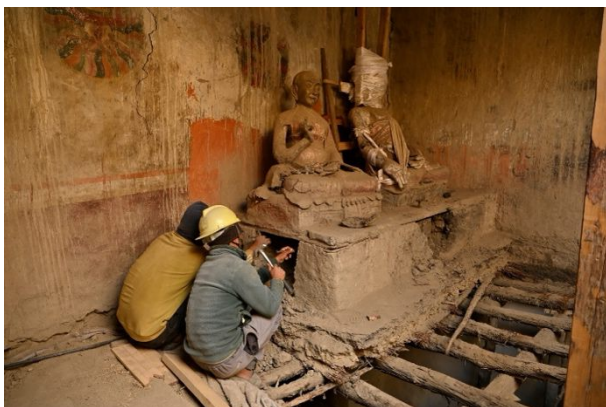
Figure 183: Cutting into the mud pedestal of the sculptures to be able to support them from below.

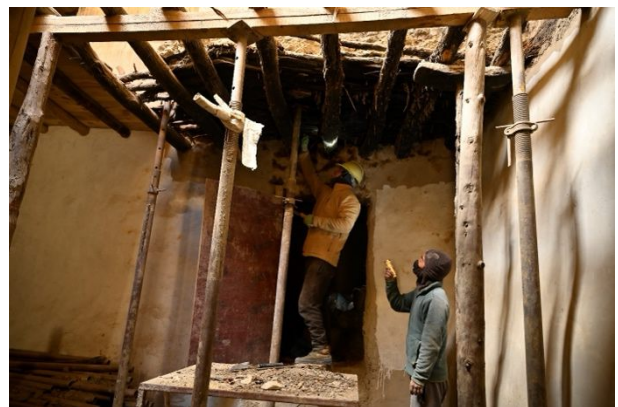
Figure 184: Installing posts from the lower floor underneath the sculptures.

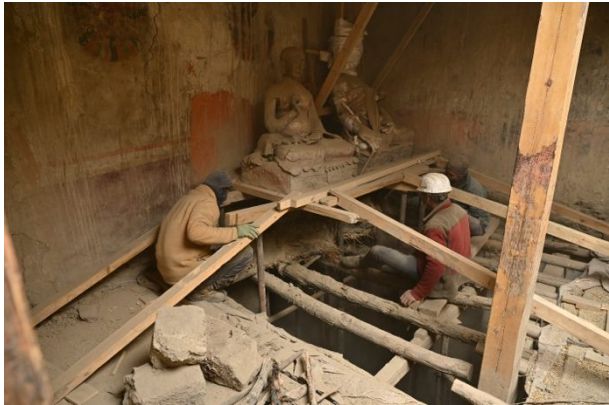
*Figure 185: Installing supports from the sides to keep the sculptures in place.*

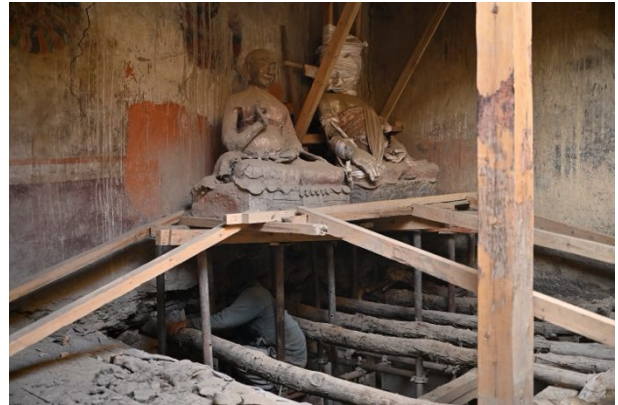
*Figure 186: The sculptures suspended by posts while the old joists are being removed.*

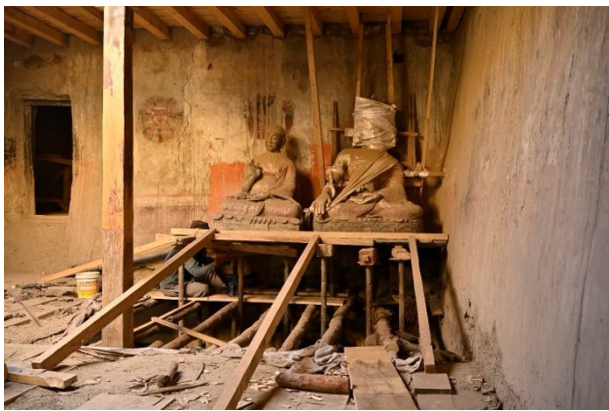
*Figure 187: The supporting structure during the installation of the new joists.*

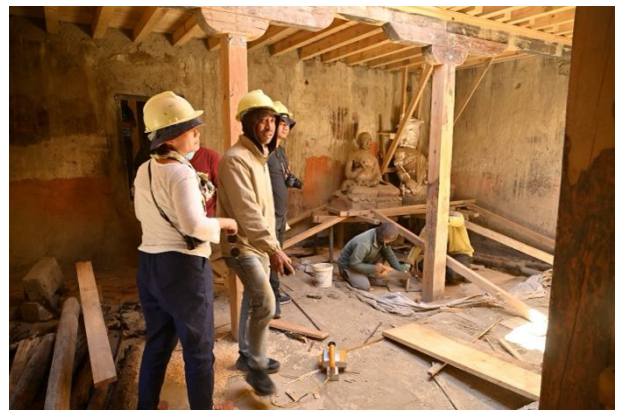
*Figure 188: Planking after joist replacement with visitors in the room.*

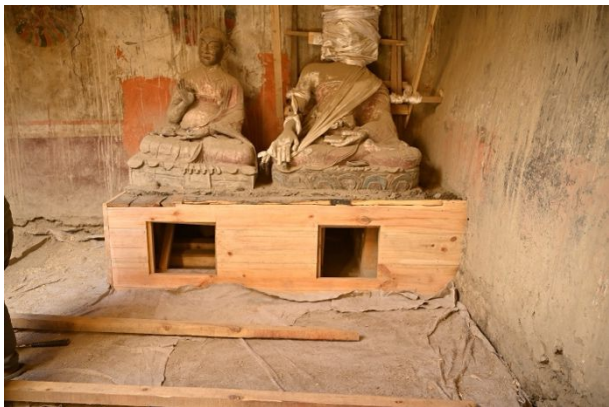
*Figure 189: The sculptures on their new base after completing the flooring.*

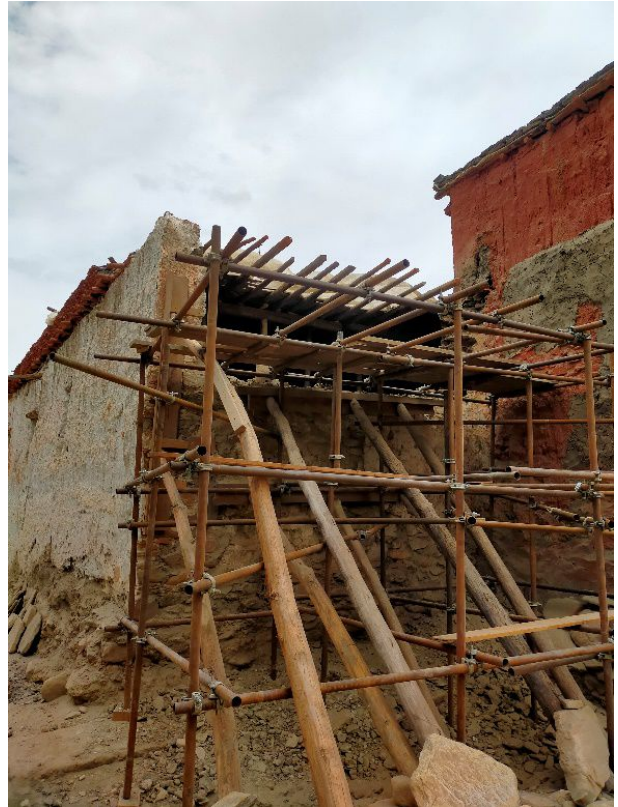
The stonewall in the northwest corner of the temple bulged as it was filled with loose stones. On the ground floor of this corner are some of the most important paintings of the temple including a depiction of the founder of the monument. It thus was deemed

*Figure 192: Then a scaffolding was erected and, after opening a section of the roof, the wall was dismantled from the top.*

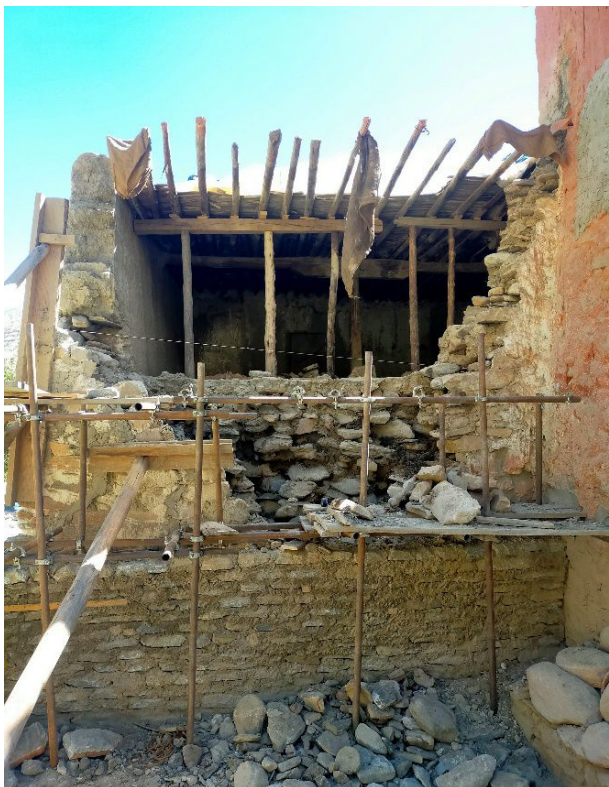
*Figure 193: An extra wall was constructed in front of the problematic wall as support.*

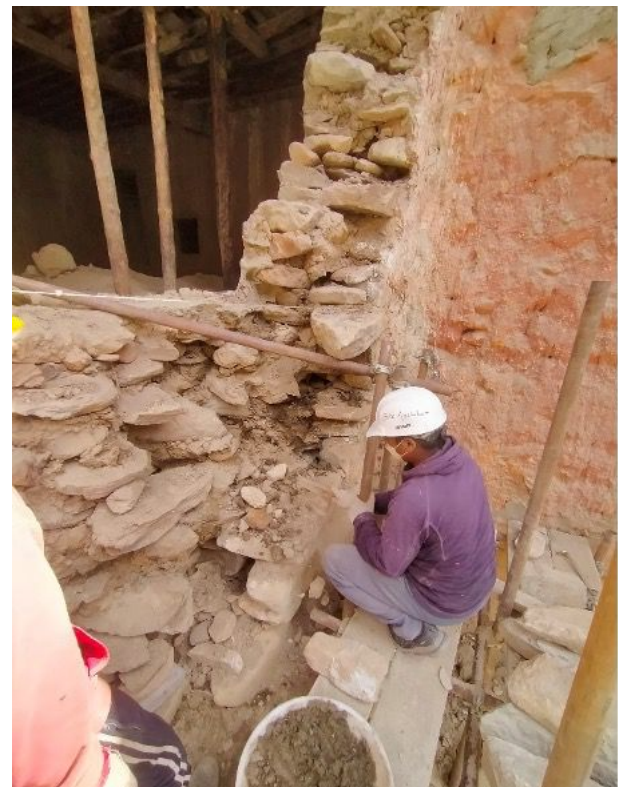
*Figure 194: Investigating the condition of old wall by the site architect to decide on for further steps.*

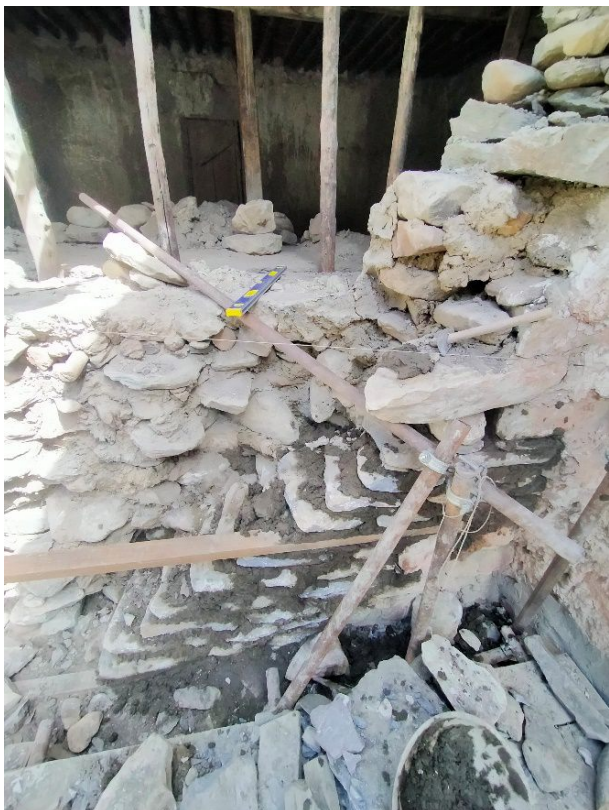
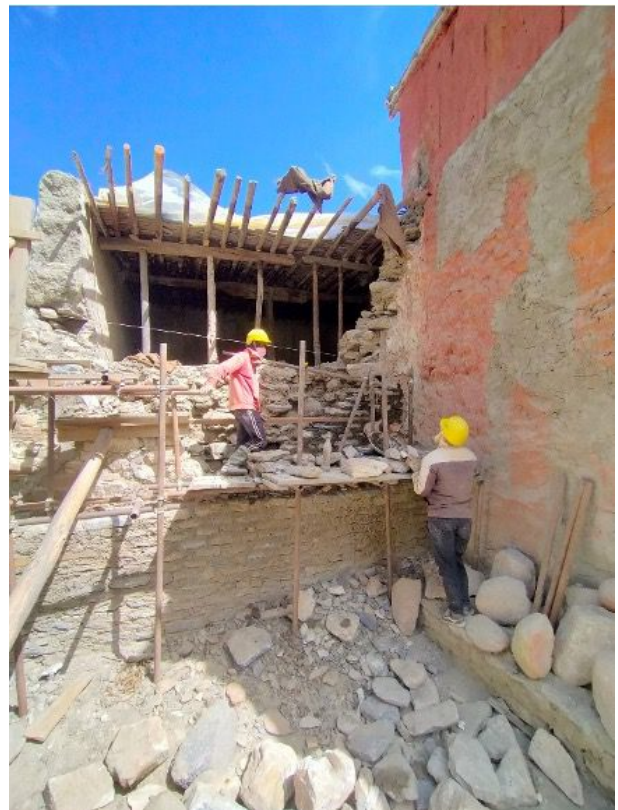
Figure 196: Construction of the new wall along the lower section of the wall and connecting it with the old one.

Figure 197: View of the area during the reconstruction of the wall.

We continued the repair work at the northwest corner wall up to roof level. When reconstructing the wall, we made sure that it was properly joined with the walls to its sides. For this we used wooden ties and wall ties at different levels.

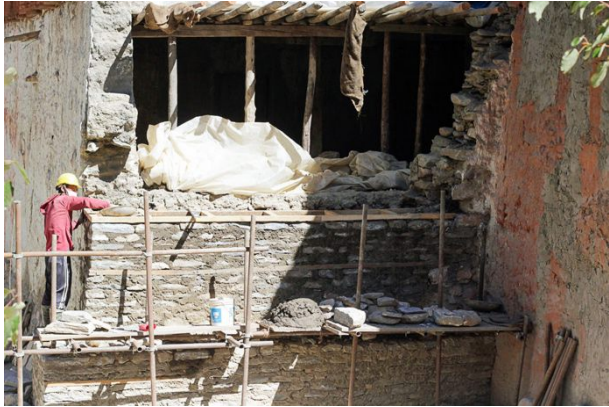
*Figure 198: The wall reconstructed to the level of the first floor, where a wall-tie was inserted.*

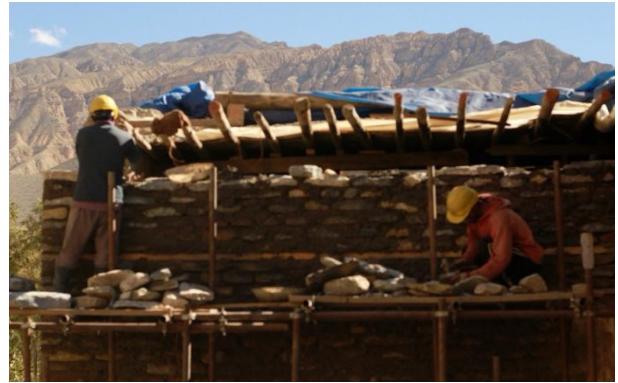
*Figure 199: Reconstructing the northwest corner wall with wall ties.*

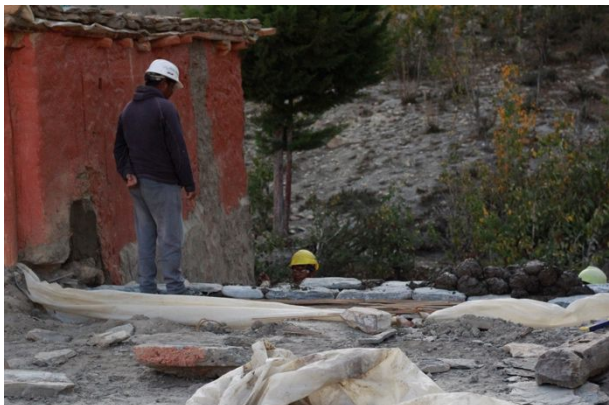
*Figure 200: Installing the temporary roof above the new northwest corner wall.*

The wall had been constructed with wooden ties. For the winter of 2023, it was covered with plastic sheets to prevent snowfall damage. Also the roof supports that were installed before work were left as a security measure.

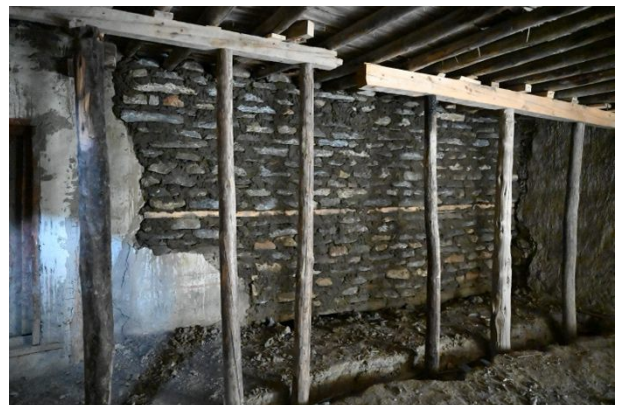
*Figure 201: The second floor of the newly constructed wall from the interior.*

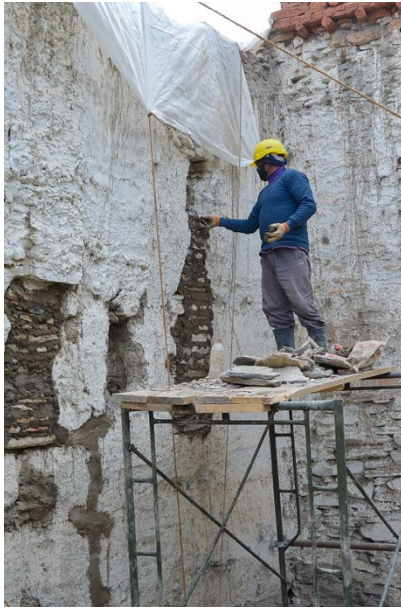
Figure 204: Here an area of loose stones was relayed.

Both on the exterior and interior walls of the building needed to be repaired to cover cracks and areas of losses over time. For this purpose, stones were relayed as needed and the gaps between them filled with mud mixed in the traditional way.

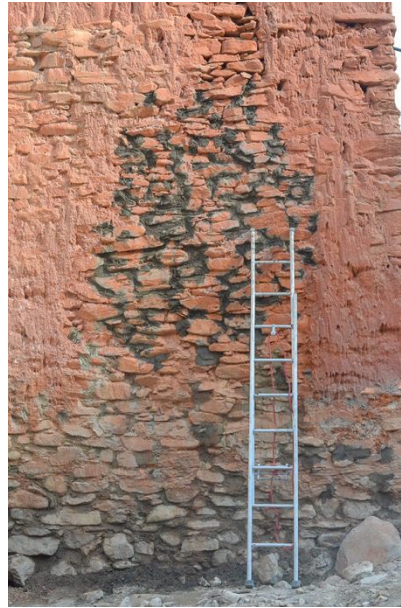
Figure 205: In this section on the west side of the monument plaster needed to be applied between the stones.

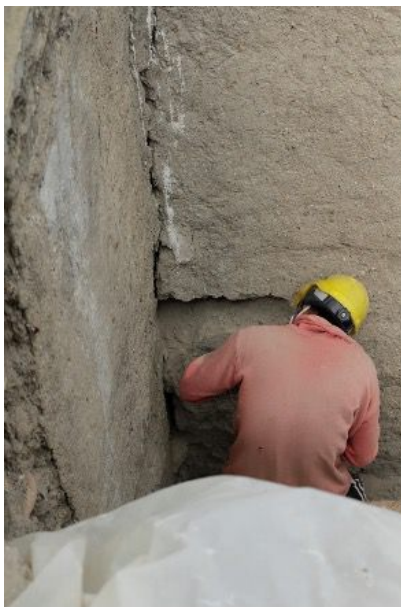
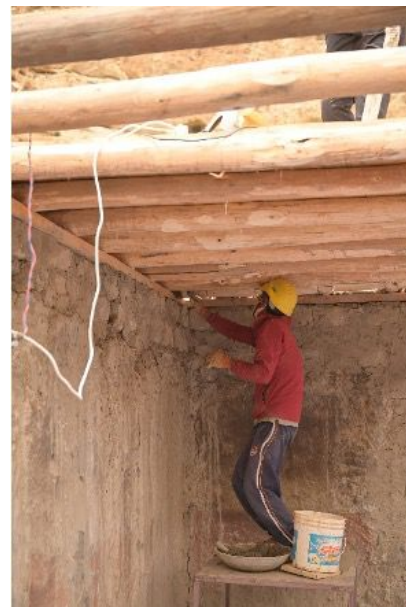
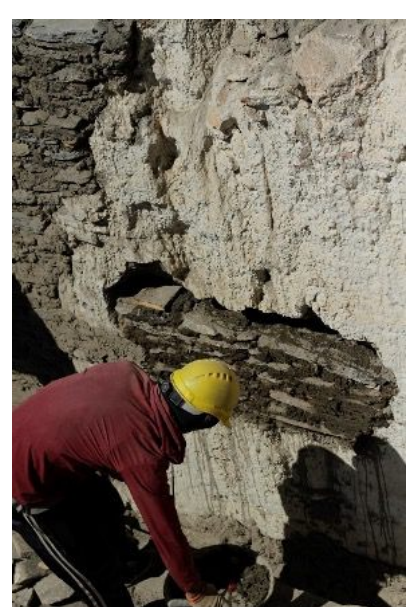
Figure 207: These three images show repair work in different areas of the temple using different techniques as required.

Sections of the monasteries' wall had cracks that needed to be fixed. These were filled with stone, mud and/or wooden ties as appropriate. Also the partition wall with paintings was strengthened by tying it to the adjacent wall. The following images show some examples of such works.

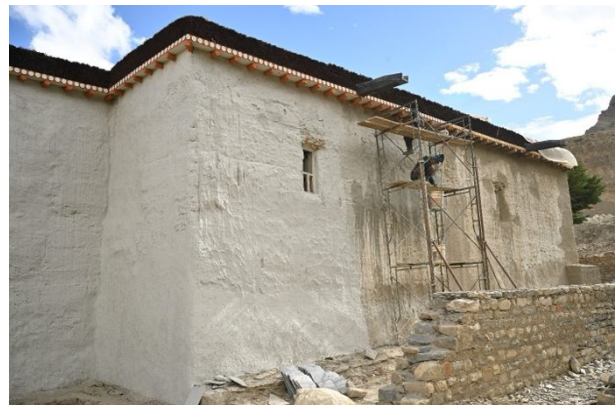
*Figure 210: Whitewashing the north wall of the temple after all repairs.*

As with the South Wing all exterior walls of the temple were repaired and covered with two layers of plaster. Then the whitewash was applied to its surface. While some areas of the wall had to be repaired with mudbricks, others were repaired using plaster mortars only.

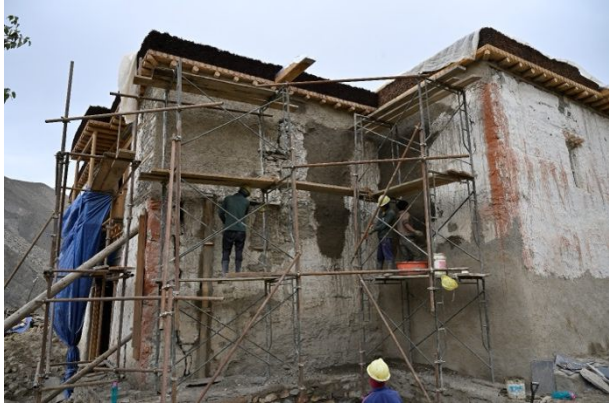
Also a big crack of about 2.5 inches in the northeast corner of Entry Hall was repaired. It was tied with 3 x 4 inch wooden members both vertically and horizontally. A base wall for the corner and wooden members was also built. Further, the south wall of staircase area was also repaired with wooden ties and stone, and then plastered and colored.

Figure 211: Repairing the large crack on the north wall of the Entry Hall with wooden ties.

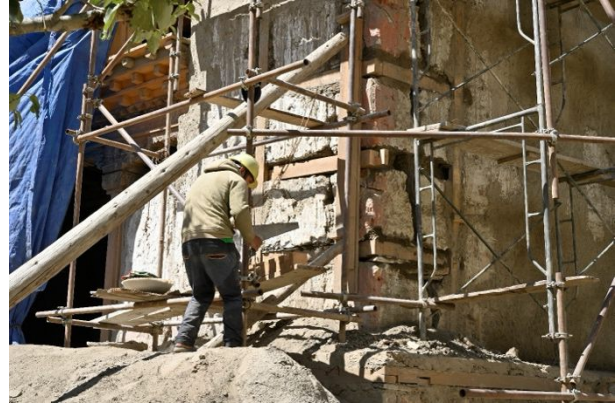
Figure 212: Repairing the lower floor corner of the Entry Hall with wooden ties.

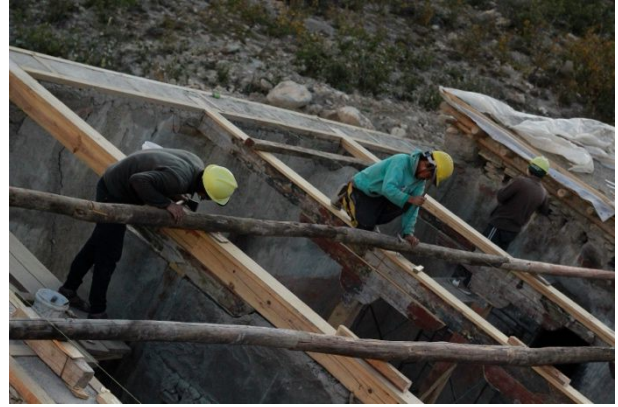
*Figure 217: Installing the supports for the temporary roof at south wing.*

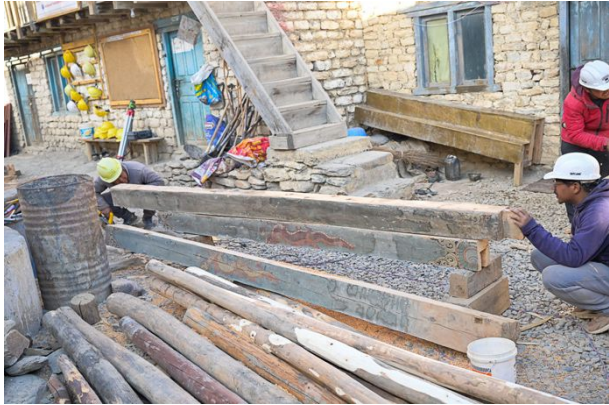
*Figure 248: Inspecting the original wooden beams to prepare them for reuse.*

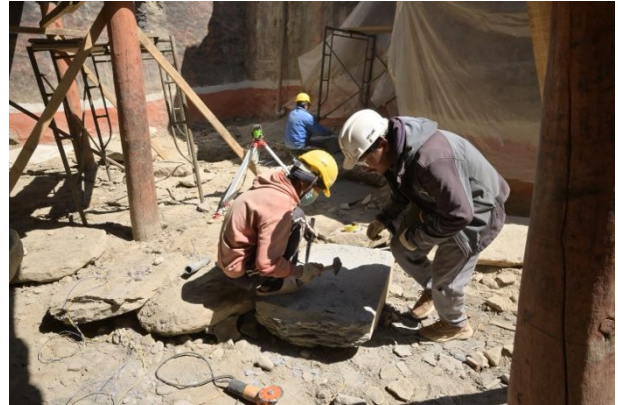
*Figure 249: Preparation of a new stone base for one of the columns.*

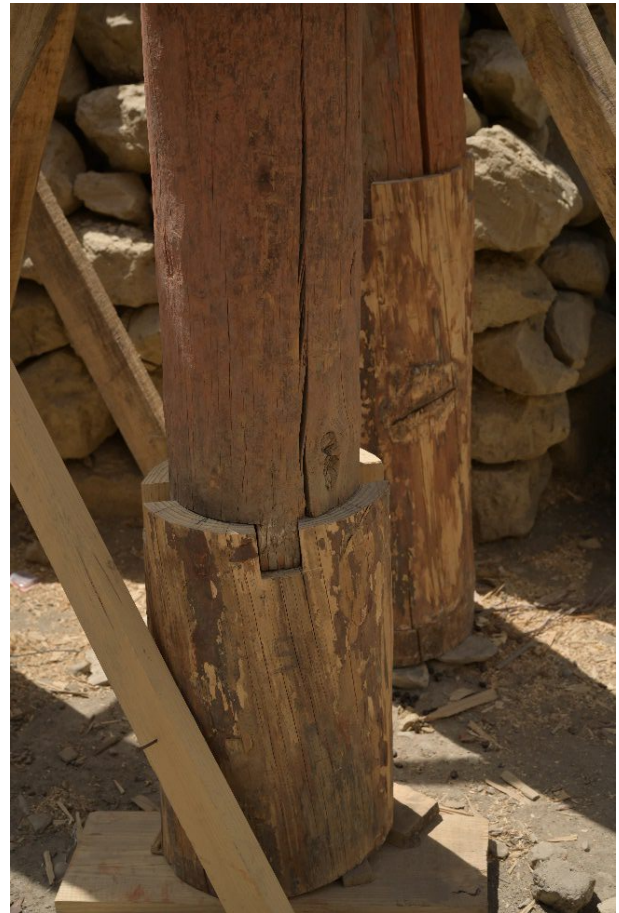
Figure 251: A cross-shaped joint was used to connect the old and the new parts.

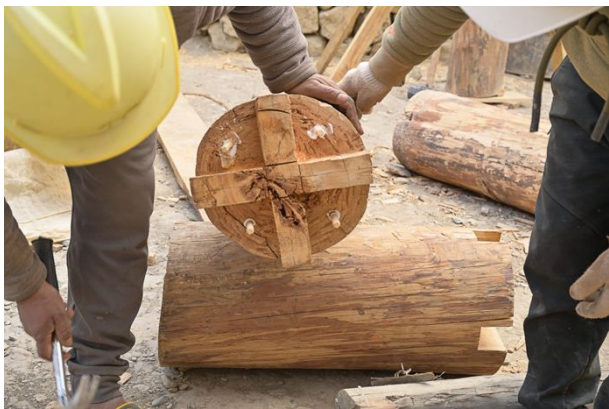
Figure 252: View of the cross shaped joint used to connect the old and new parts of the pillar.

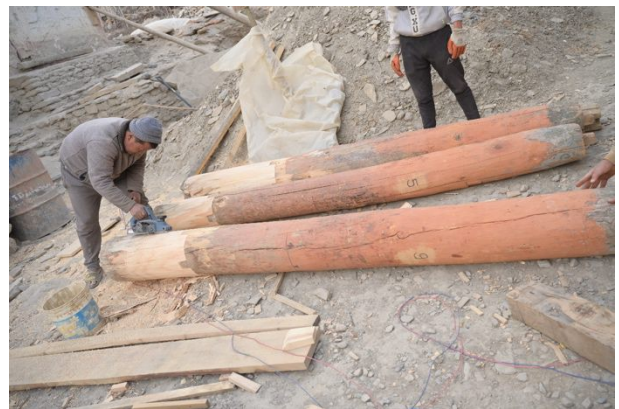
Figure 253: The new parts were then cut to the size of the original pillar.

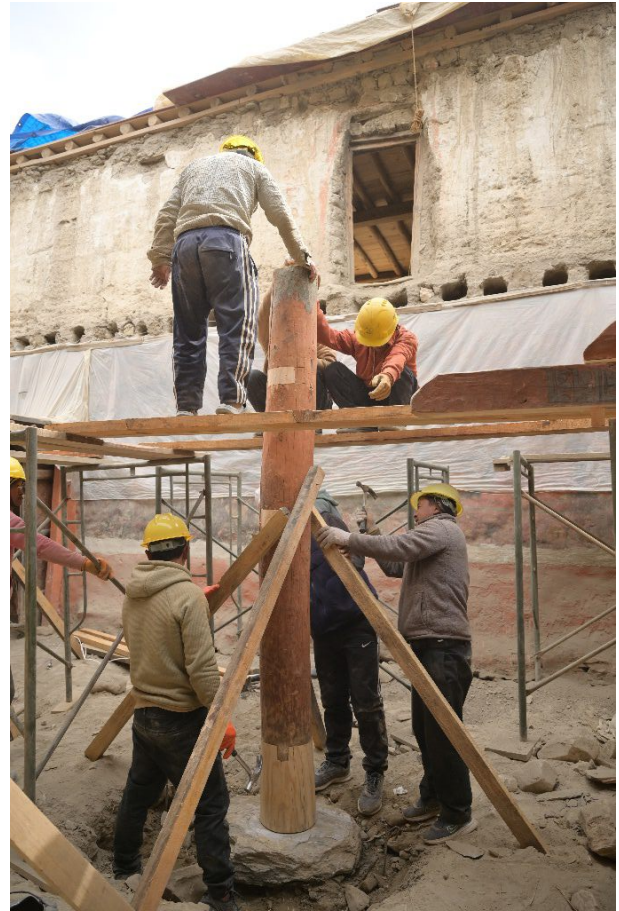
Figure 255: The bottom of the pillar was joined with the new stone base via a mortise joint.

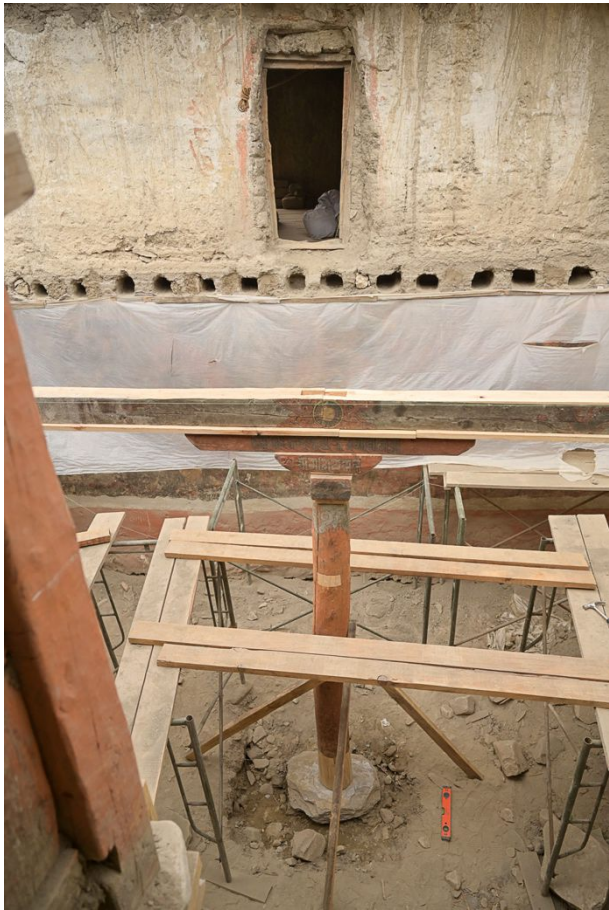
Figure 257: View of one pillar reassembled with its capital and beam, all parts joined to each other for seismic strengthening.

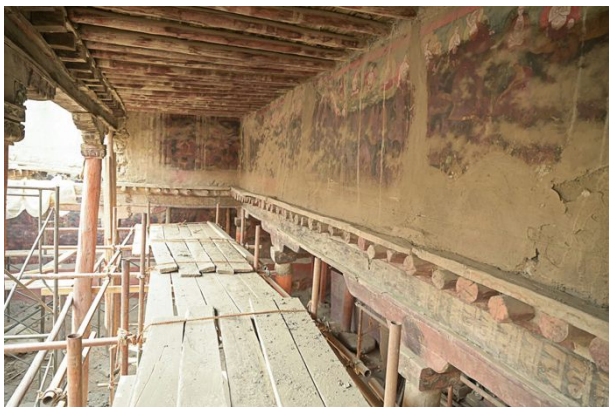
Figure 270: The area of the painted wall above pillar rows three and four.

To level the section of the area of the painted wall, above pillar rows three and four, and to avoid having to raise the painted wall it was chosen to take advantage of the plain section in the lower part of the painted wall. First, holes were made into the plain section of the wall to place the new joists at level. Then planks were inserted above the new joist level to rest the wall on the new joist level. Further supports held up the roof on the upper level, further reducing pressure on the painted walls.

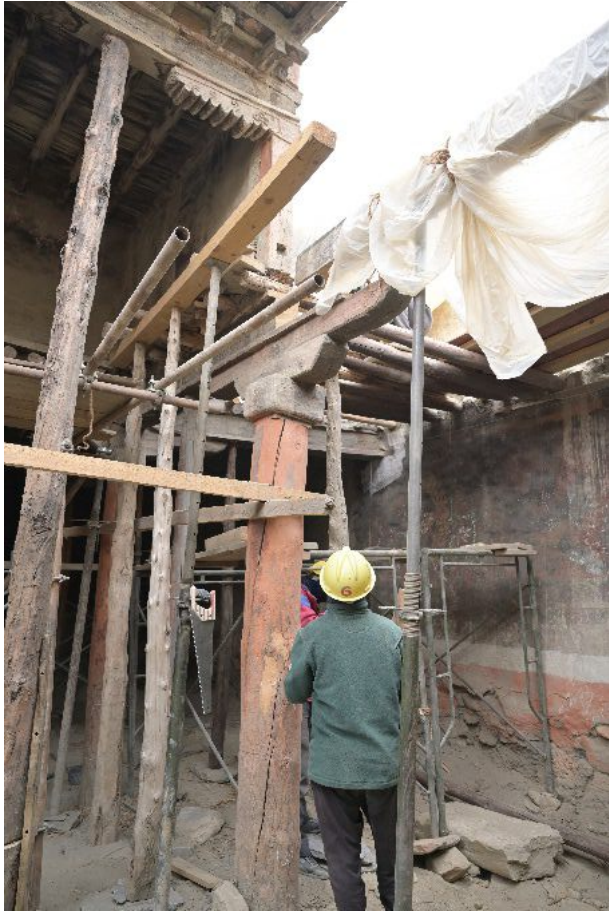
*Figure 274: Preparing to take out the pillar underneath the corner of the painted wall in the third row.*

Once this support structure was established the wooden members underneath the wall could be dismantled for structural restoration. By the end of June, the structural work has reached mid-way to assemble all the wooden members that lies below the half wall paintings. Further, the long columns of the third row still needed to be restored.

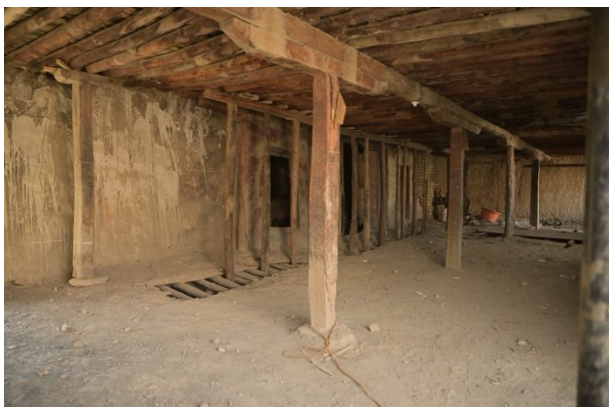
Figure 284: Preparation of the restoration of rows four and five by installing additional supports.

With the approach of summer episodes of rain became more likely, making it risky to remove the roof in its entirety. Thus, also the roof above rows four and five needed to be kept in place during the restoration of the structure underneath. This was achieved by supports from the ground floor level.

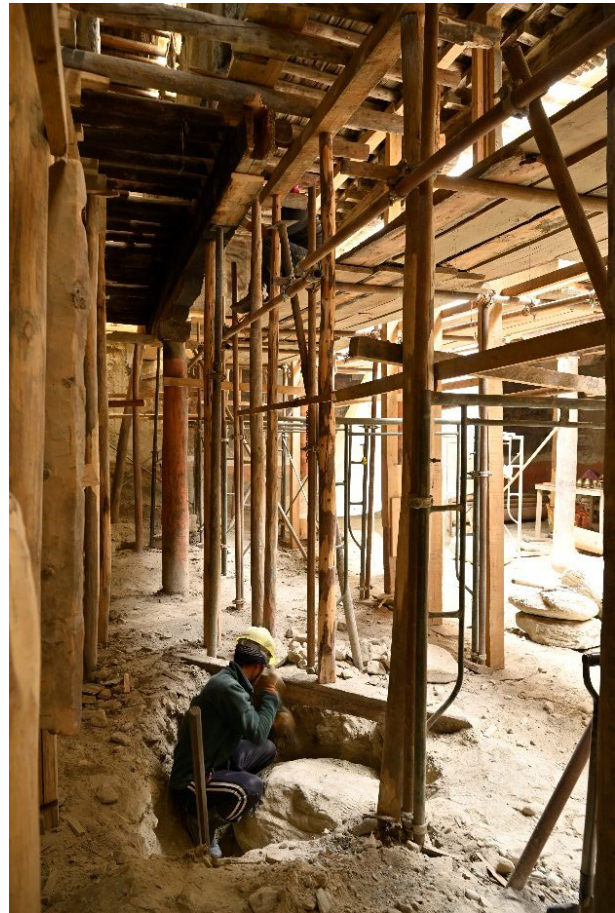
*Figure 288: Digging the new foundation for a pillar and placing its new stone base.*

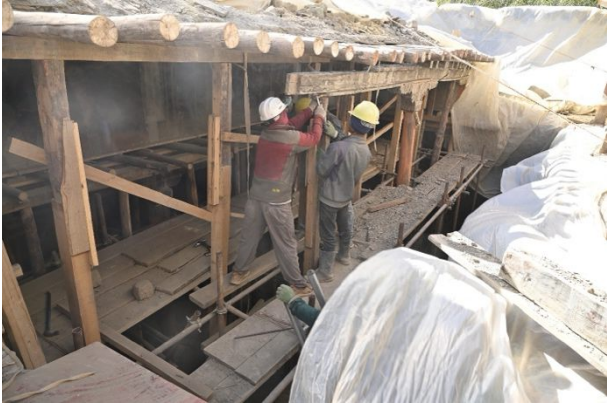
*Figure 297: Dismantling the beams and long pillars along the third row that hold the superstructure above the painted wall.*

Then the joist above the painted wall had to be restored without exposing the painted wall to the elements. First, we removed the clay on top, changed the wooden splits and arranged the old joist. Then we covered them again with mud on the geofabric. Only when the work on the ground floor was finished by July 23, 2024, new pillars, beams, joist and planks were assemble on the upper floor to support the roof. During this process also the

long pillars of row three, which until now had to be kept in place, could be restored and put on a solid base.

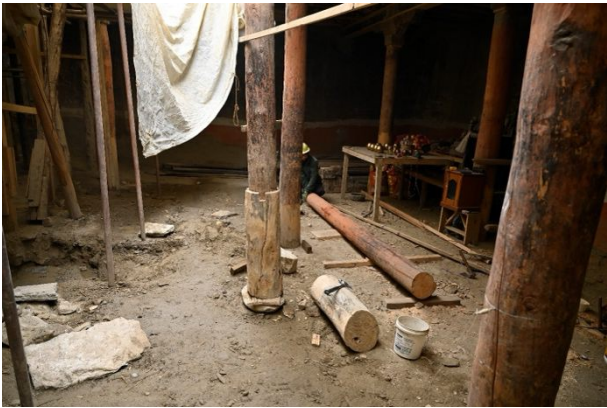
*Figure 299: Preparing the repaired beams to be placed to their original position.*

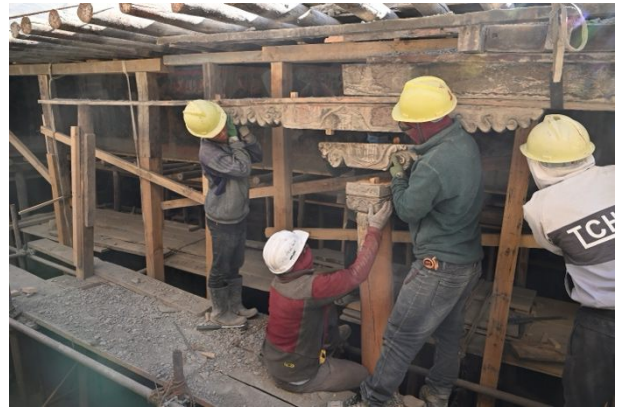
*Figure 300: Reassembling the original capital and beam structure with their new joints.*

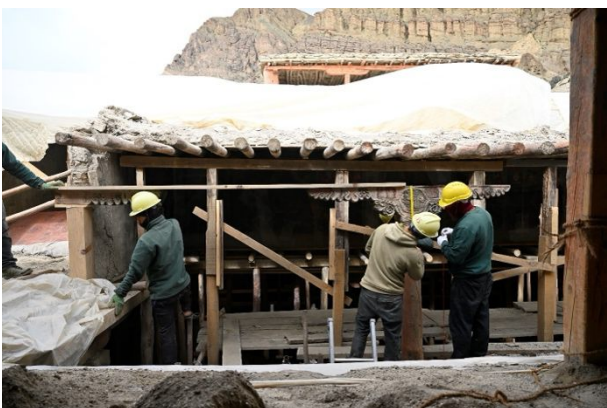
*Figure 301: Continuing to reassemble the original structure supported by the long pillars.*

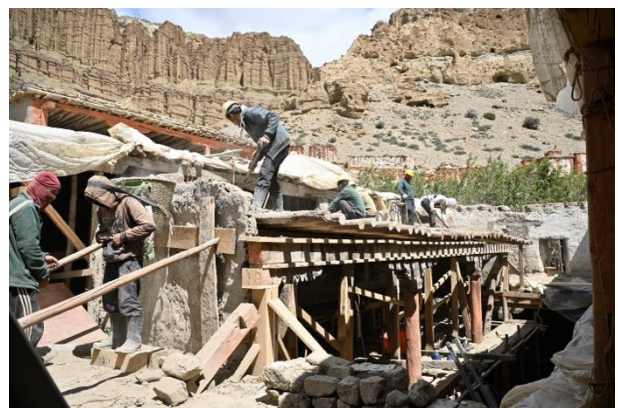
*Figure 302: The reassembled beam with the new planks, compare with Figure 297.*

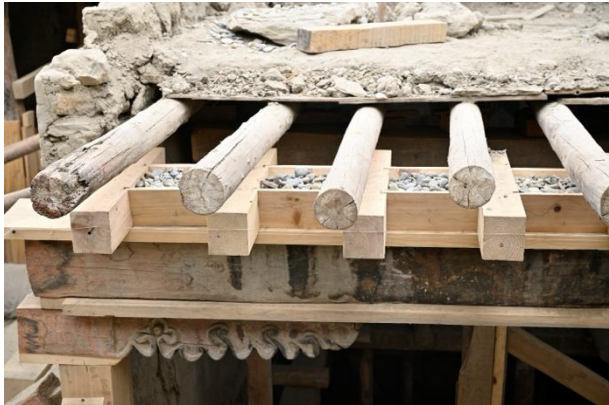
Figure 303: Rebuilding the structure above the reassembled beam following the original construction.

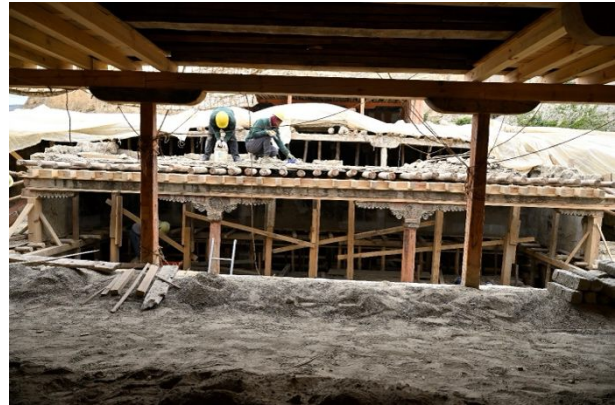
Figure 304: Removing the clay on top of the intermediary roof above the long pillars.

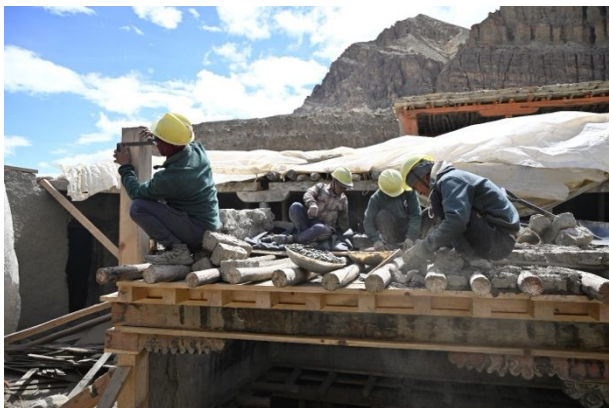
Figure 305: Realigning the joists and placing the corner pillar to support the roof above the painted wall area.

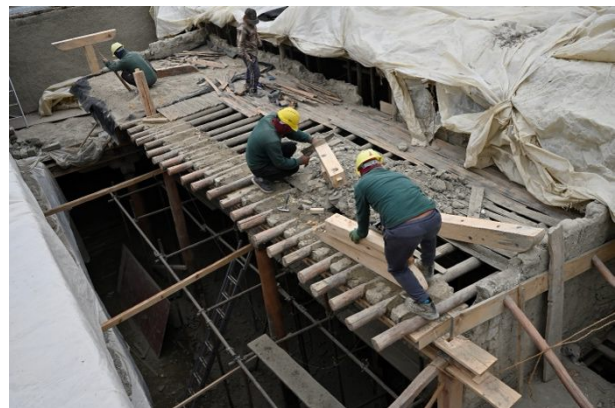
Figure 306: View of the realigned joists while working on the structure to support the roof.

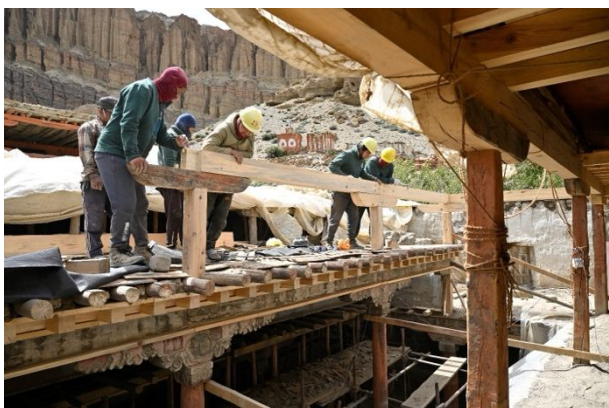
Figure 307: Reassembling the superstructure above the intermediate roof covering the painted wall area.

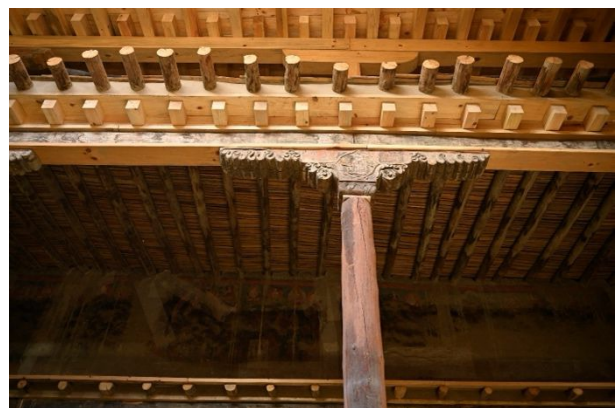
Figure 308: The wooden structure above the long pillars after it has been reassembled.

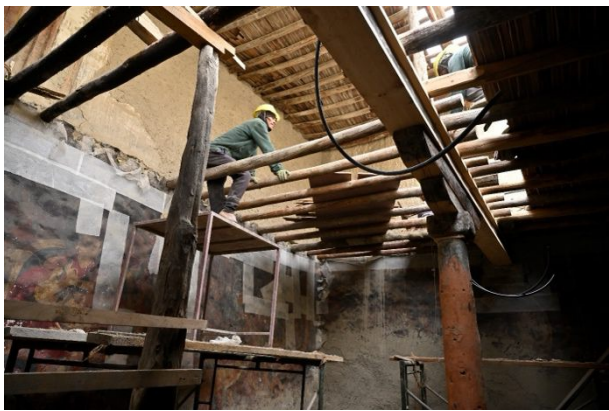
*Figure 314: Replacing the rotten joists between row five and the back wall of the Assembly Hall. Note the Assembly Hall murals and the protective roof on the upper level.*

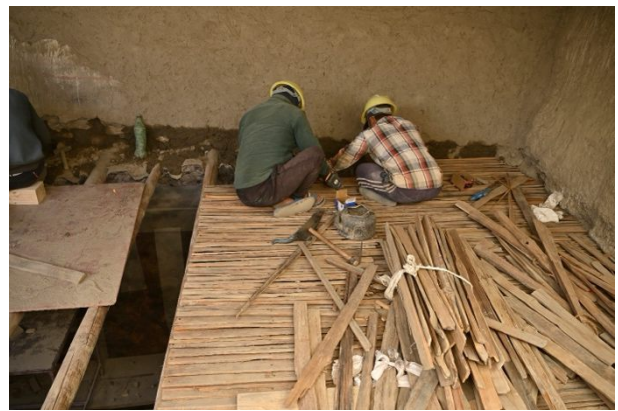
*Figure 315: Laying the wooden shingles on top of the newly arranged joists.*

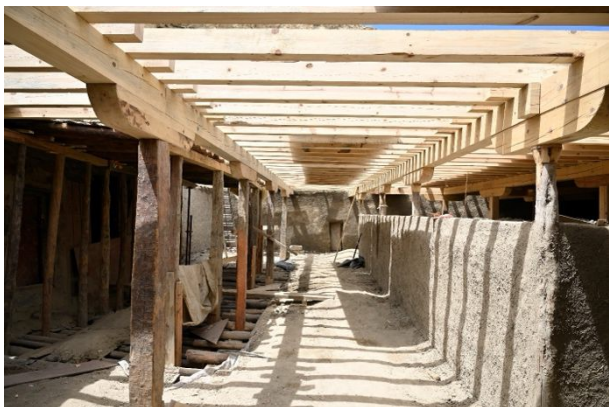
*Figure 316: The area between the painted wall (right) and the main sculpture after finishing the wooden structure.*

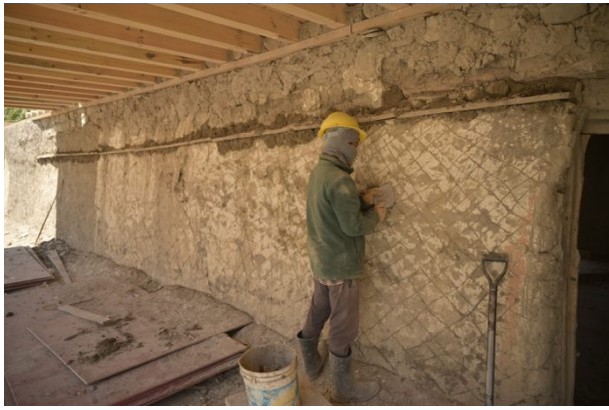
*Figure 317: Preparing the wall above the entrance to the Assembly Hall for replastering.*

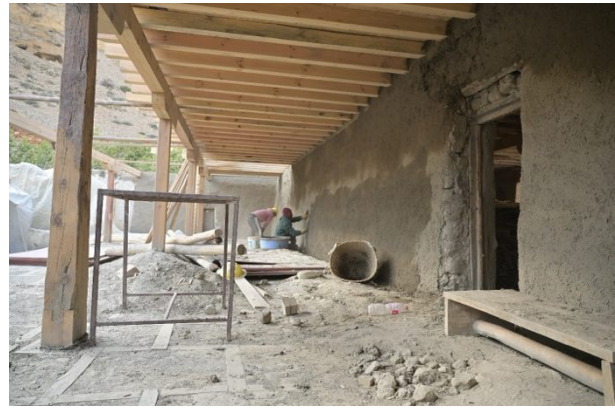
*Figure 318: Plastering the wall above the entry to the Assembly Hall.*

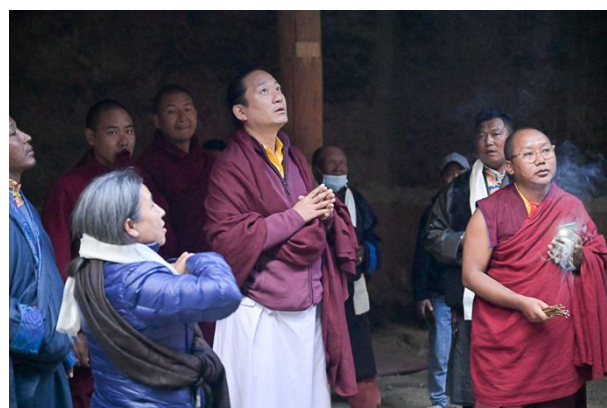
Figure 322: The Rinpoche inspecting the restoration work in the Assembly Hall.

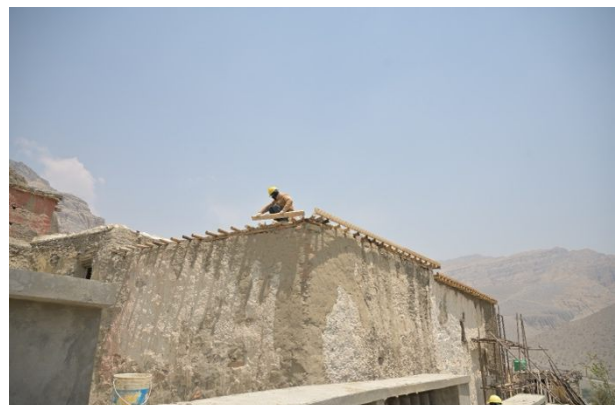
Figure 325: Placing the decorated wooden frieze at the bottom of the parapet.
