# Architectural Restoration and Seismic Strengthening of Gönpa Gang

U.S. Ambassadors Fund for Cultural Preservation, Award No. SNP40022GR0039

**Final Project Report, April 2025**

**Norbusum Foundation (NGO)**

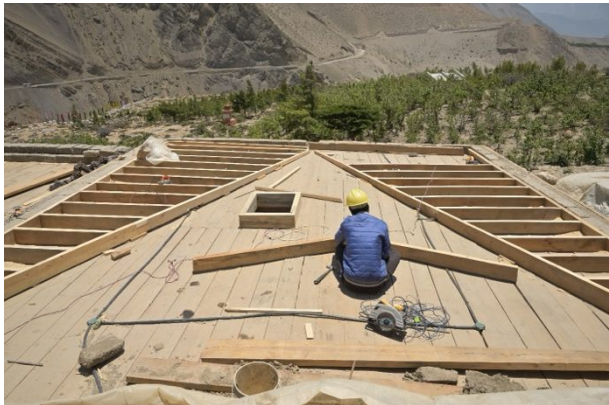
Figure 326: Constructing the wooden frame for the plywood with the sloping.

Once the planking was done a wooden frame was constructed on top of it to create a three-way slope toward the waterspouts (see also Figure 236 above). Then waterproof

marine ply was installed on top of the wooden frame, which was then covered with bitumen sheets for further waterproofing.

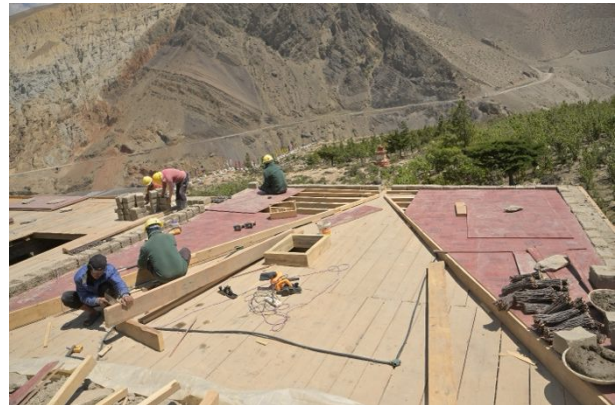
Figure 327: Attaching the waterproof plywood to the frame.

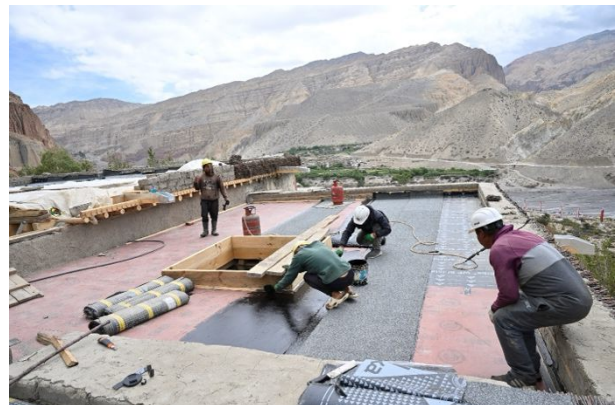
Figure 329: Adding the bitumen layer on top of the plywood.

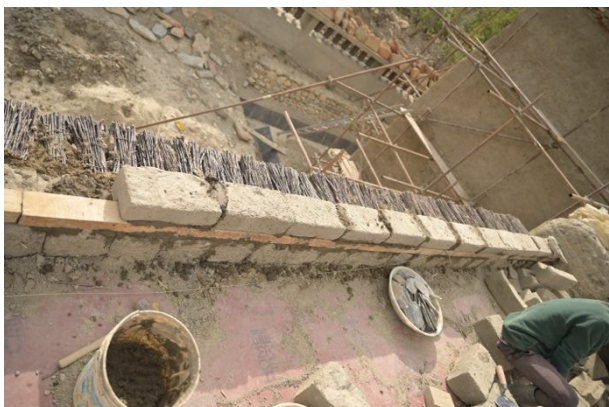
Figure 330: Construction of the traditional parapet with the apple twig bundles on the outside.

Once these works were completed, the parapet wall was constructed with the bottom wooden band and the apple tree twigs to form the so-called *perma* frieze.

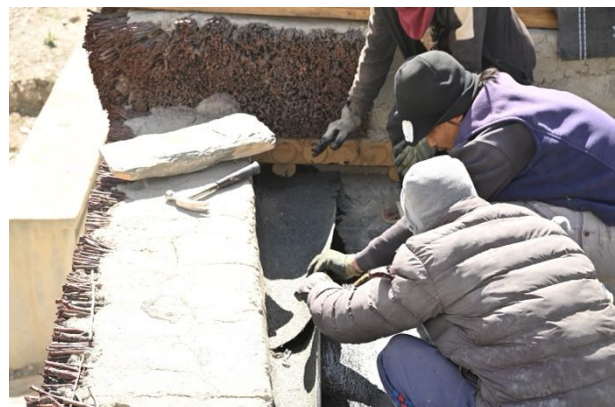
Figure 331: Installation of the bitumen sheet.

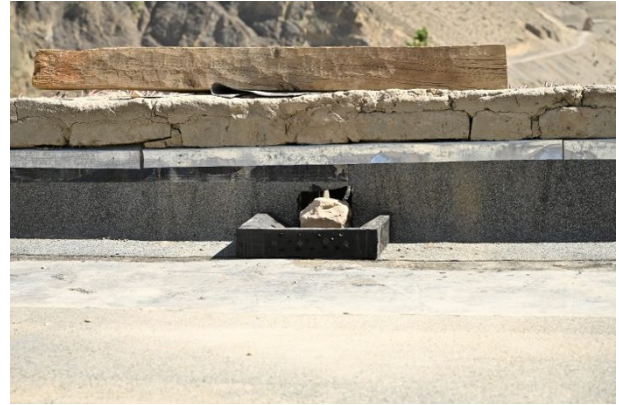
*Figure 333: The aluminum sheet covering the edge of the bitumen sheet.*

After laying the bitumen sheets and the construction of parapet wall on roof, an aluminum sheet band was added to the parapet to cover the edge of bitumen sheet once it is installed. This makes sure that also in very adverse weather conditions no water can penetrate inside the wall. This procedure was then followed in all areas of the parapet wall. Further, Sabin Shreshta decided to install wooden barriers at the collection points of the waterspout to avoid mud running off the roof, a measure that is to be reversed.

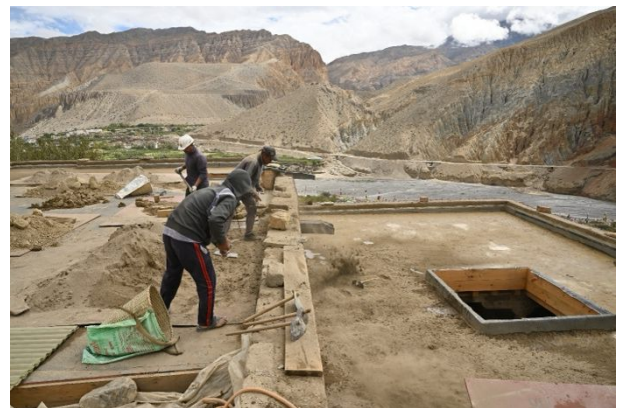
*Figure 335: Laying the fine mud on top of the first layer.*

Then, layers of mud were laid on top of bitumen sheets; first pure yellowish clay was laid at a thickness of one inch, then a second layer of fine mud filtered in 1/8-inch net and at a thickness of 1.5 inches. Volunteers from Chuksang village carried the mud to the roof of the temple.

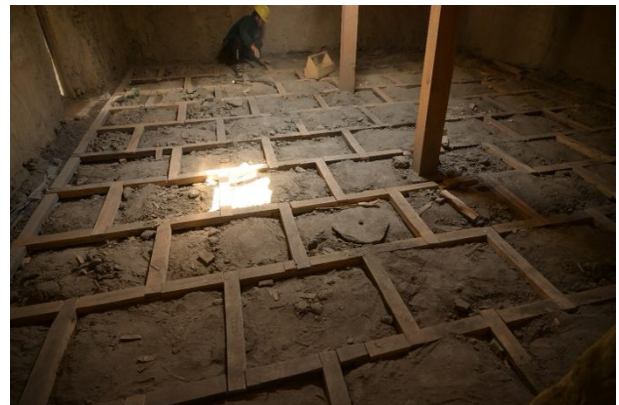
*Figure 15: Completing the frame within the same room.*

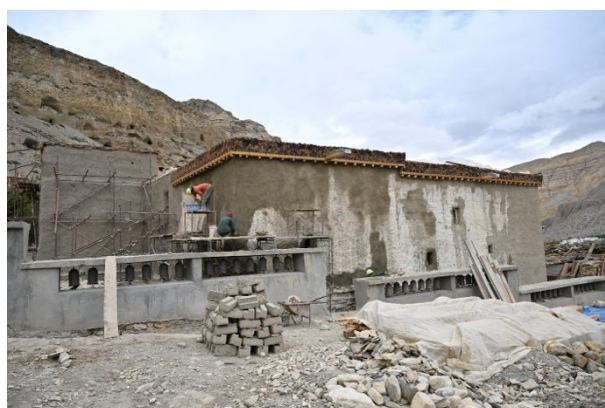
*Figure 345: Repairing and plastering the southwest corner of the South Wing.*

On the outside, also the area of the newly constructed wall was plastered and damaged plaster areas were patched. Then fine paster was applied. The wall was then whitewashed while the projecting wooden members were painted red. A dark maroon color was used to paint the brushwood, the so-called *perma* frieze, of the parapet wall. These are traditional colors sourced and produced locally.

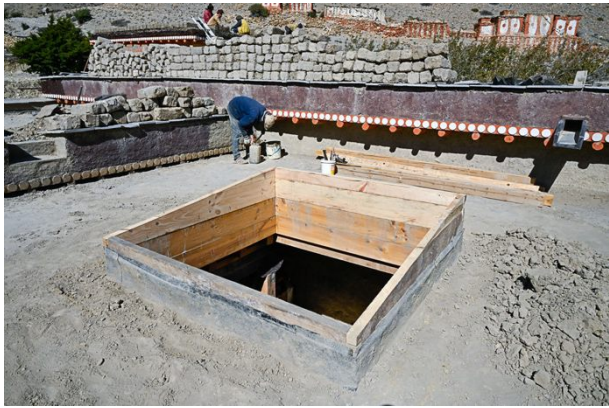
Figure 365: One of the skylights above the southern wing with its interior wooden frame.

Once the roof was completed all skylights were done in a design suggested by Thomas Schrom. While they have a wooden frame on the interior side, clay bricks protect the frame from the outside. Corrugated transparent sheets were attached to the wooden frame. This work started on October 28 and only finished by December 1, 2024.

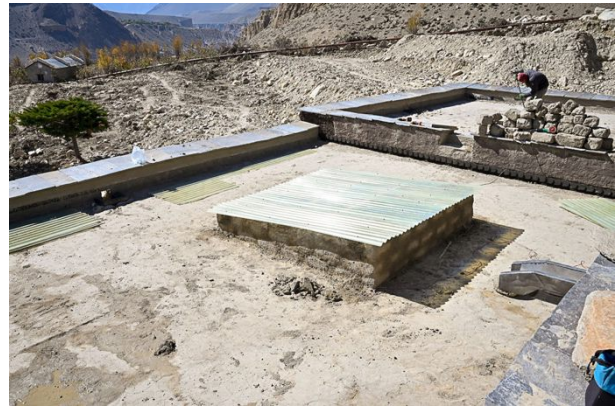
Figure 366: The same skylight with the corrugated transparent sheet as applied. The bricks along the outside protect the wooden frame from rain.

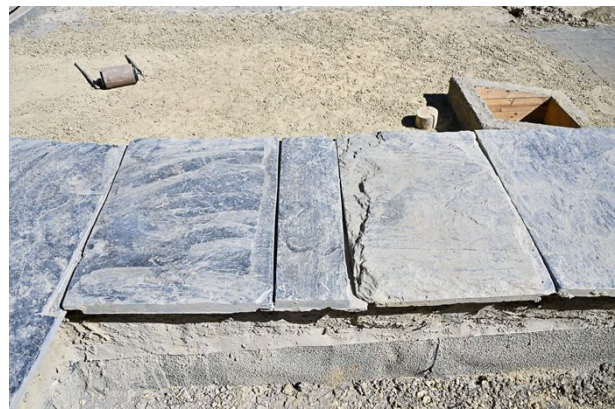
Figure 368: The overlapping slates installed on the parapet.

As the previous installation of the stone slates above the parapet turned out to be insufficient, a specialist was hired to improve on these by adding an overlap between the sheets and sealing the gaps. This parapet improvement was started on October 18 and finished by November 26.

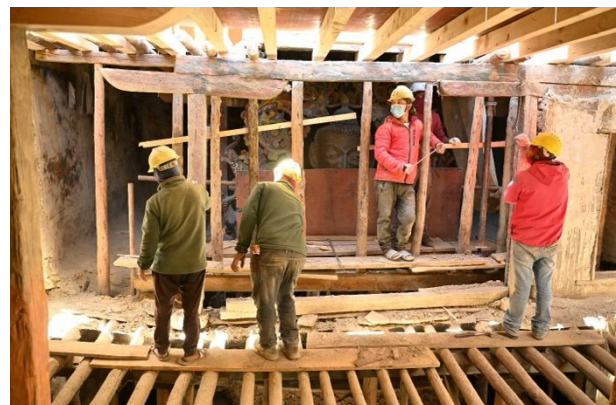
*Figure 373: Preparing the removal of the beam in front of the main sculpture.*

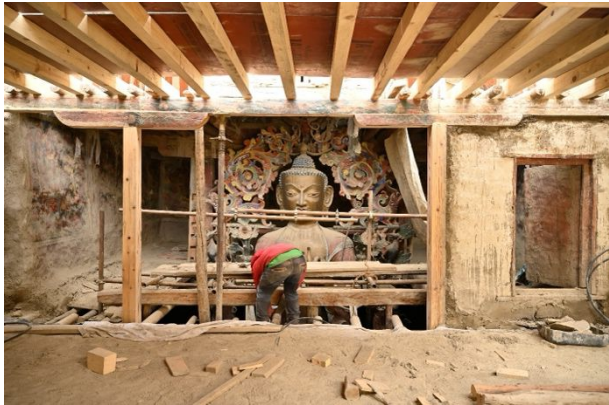
*Figure 374: The upper-level area in front of the main sculpture after the main beam has been restored.*

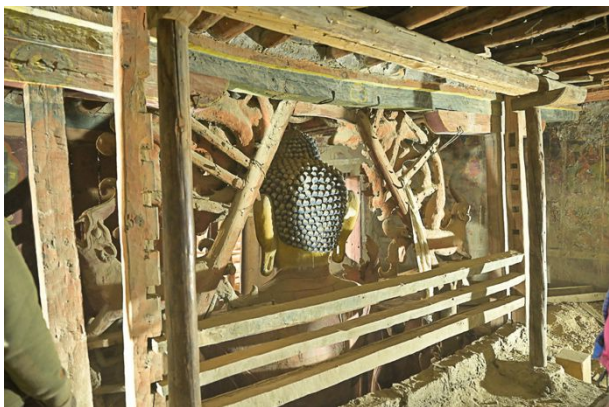
To avoid damage to the main image and assist planning the restoration, the wooden frame around it was removed to be reassembled after the restoration. It fully revealed the damage to the beam in this area that required additional support.

*Figure 376: Removal of the frame behind the main image's head to expose the broken beam in this area.*

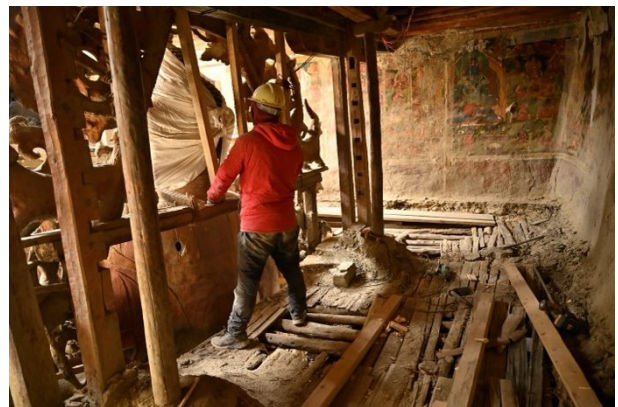
*Figure 377: Installing supports to the back of the main sculpture.*

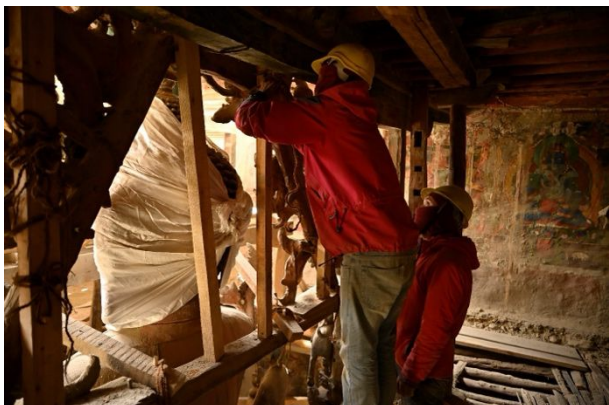
*Figure 378: Attaching the support to the back of the main sculpture.*

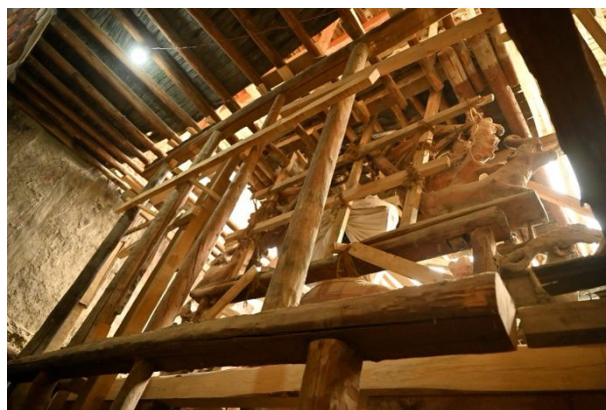
Figure 383: The back of the main sculpture with the broken main beam removed.

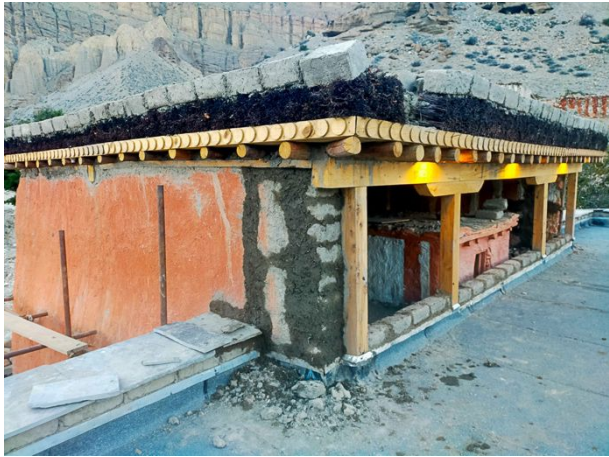
Once the roof was completed it turned out to be higher than previously in the area of the third-floor lantern. Thus, its side and front needed to be sealed to avoid water intrusions. For this work new bricks had to be made to complete the parapet, and clay had to be applied to the roof above the lantern as well.

*Figure 395: Repairing the side of the third-floor extension above the sanctum.*

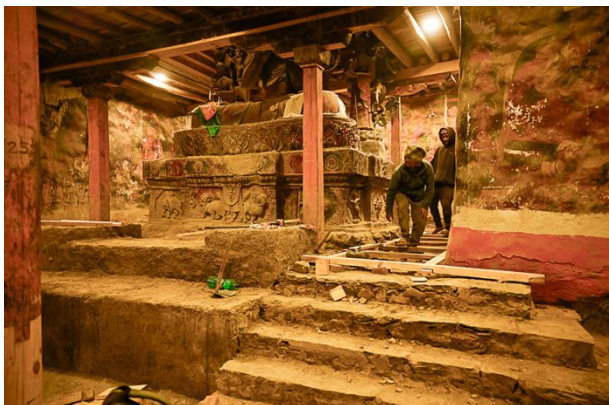
Inside the temple's Assembly Hall, a number of works needed to be completed. Without prior consultation Sabin Shrestha had massive stone stairs built to lead from the Assembly Hall to the Ambulatory around the Maitreya image. Since its design invited elder people to touch the murals in that area for their support when climbing the stairs, these needed to be dismantled again and replaced by straight wooden stairs with railing.

*Figure 415: Installing the wooden frames for flooring the Ambulatory around the Maitreya sculpture. Note the massive flight of stairs installed at that stage.*

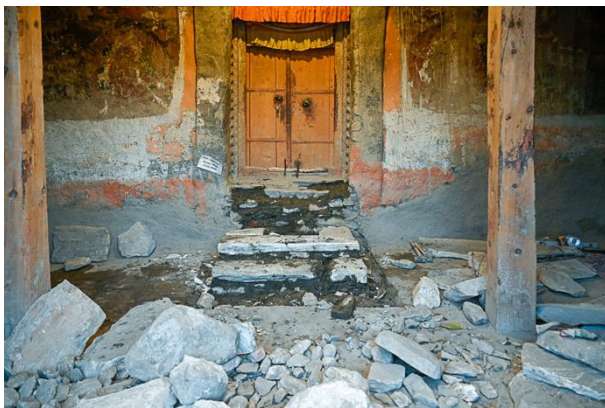
*Figure 420: Improving the steps in front of the entrance to the Assembly Hall.*

In the Entry Hall the door frame in front of the stairs that lead to the upper floor was improved. Further, the steps leading from the Entry Hall to the Assembly Hall were improved.

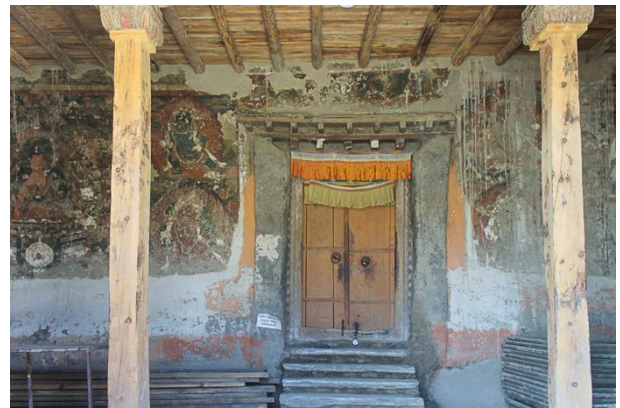
*Figure 421: The entrance to the Assembly Hall after the steps were completed.*

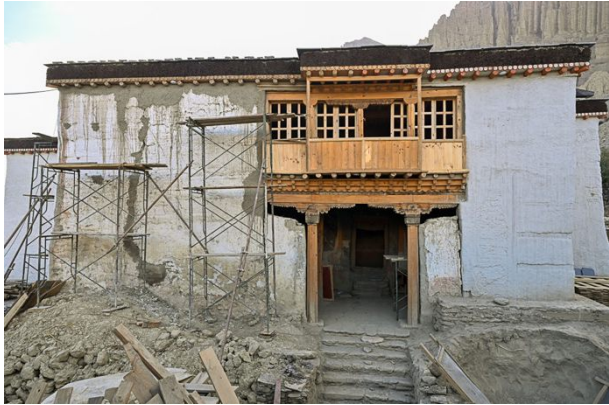
Oddly a massive crack on the left side of the entry wall of the temple was never restored. In October this crack was first patched up, then wall-ties were installed in the upper area. Completing this work also enabled the painting of this area.

Figure 422: The patched-up crack in the entry wall before the installation of wall ties. Note that the balcony door is still without glass.

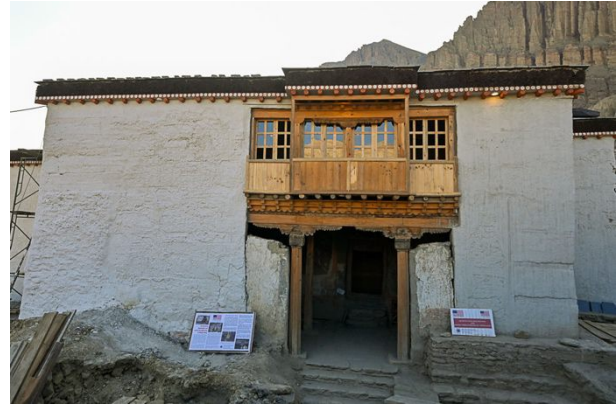
Figure 423: The entry wall in late October after finishing the wall ties and painting the wall. Note that now some of the glass panels on the balcony are installed.

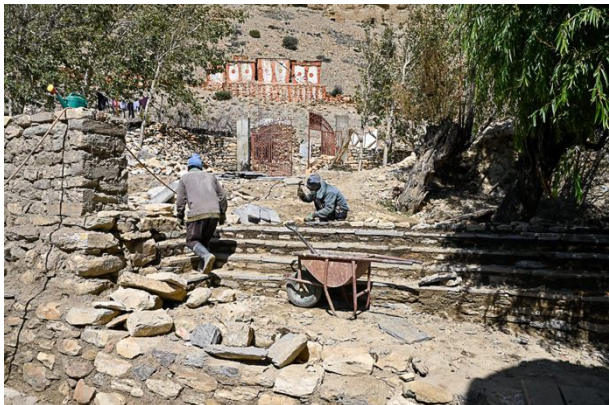
Figure 424: The stairs constructed between the entrance to the compound and the monastery courtyard.

Then this side of the entry area need to be supported in the same way as the wall on the other side of the door. More broadly the area in front of the temple needed to be cleaned up. Work on the drainage also resulted in a steep decline between the entrance to the compound and the courtyard in front of the temple, thus stairs needed to be built there.

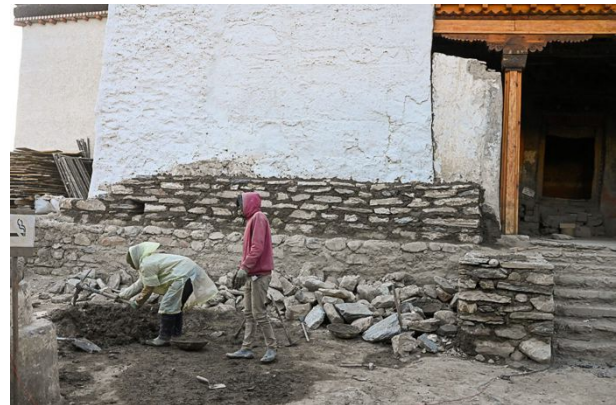
Figure 425: Completing the support along the bottom of the entry wall.

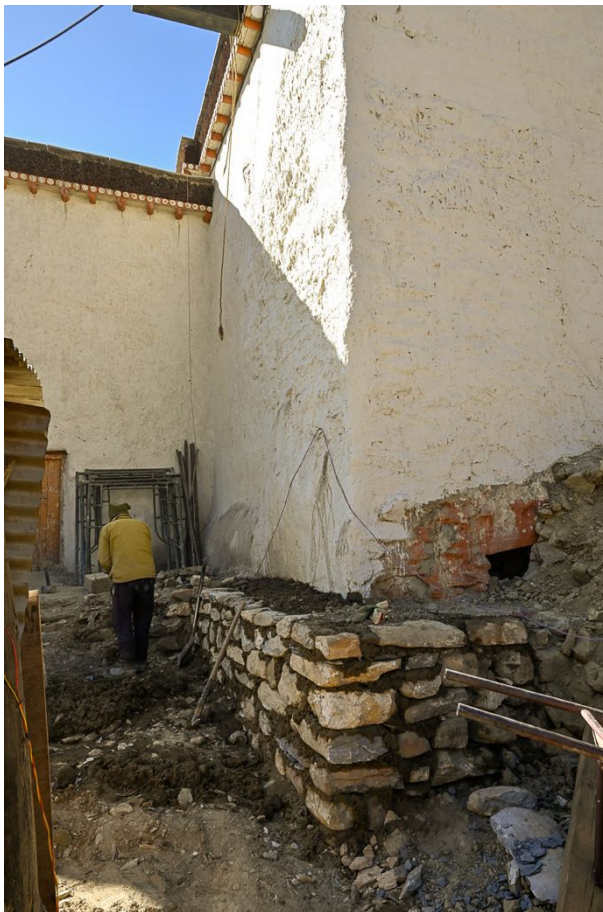
Figure 426: Expanding the foundation support around the southeast corner of the Entry Hall.

In late October and early November, the outside of the temple was painted. Further, in the southeastern corner of the Entry Hall the supporting wall along the foundation was extended and heightened. This work started on November 17 and was finished on December 2. The eastern ends of the drainage could not be finished anymore.

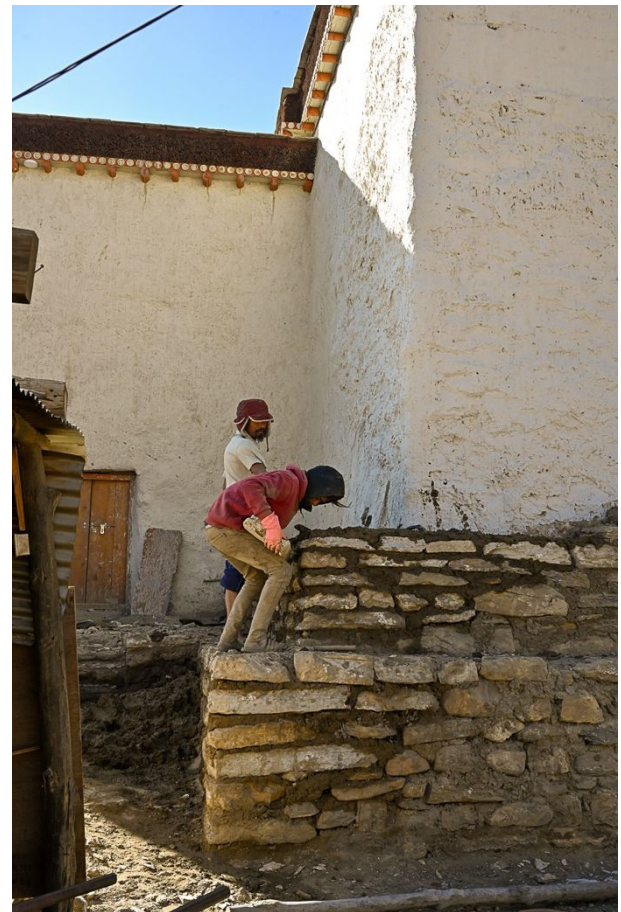
Figure 427: Later it was expanded further to make it the same size as in front.

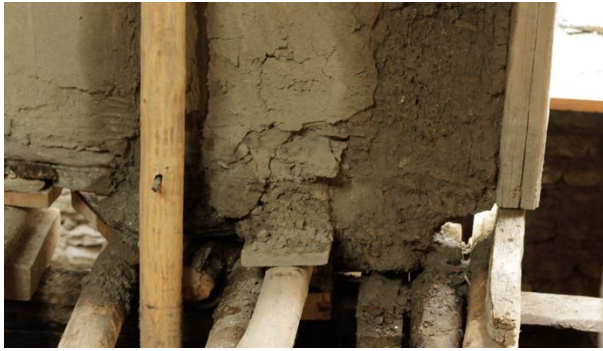
*Figure 431: Rain damage to an exposed section of a wall which was later repaired again.*

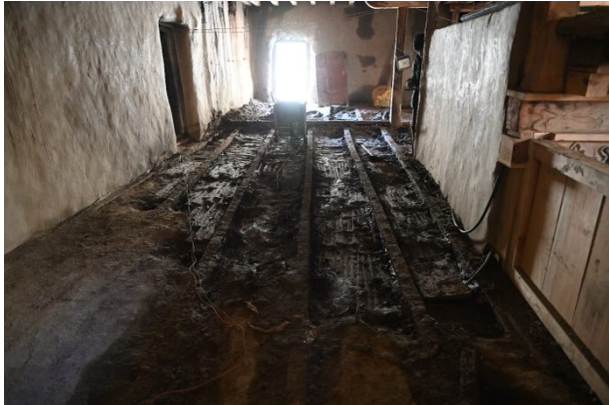
Late September two days of heavy rain led to an unavoidable water intrusion. Part of the unfinished area was soaked in water, and the painted wall to the right side of the sculpture niche on the upper level was damaged.

*Figure 435: Parts of the floor on the upper level drenched in water after the rain.*

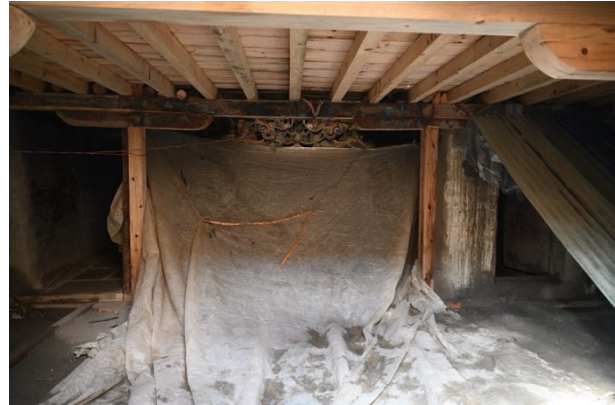
*Figure 436: Tarpaulin sheet protecting the main sculpture, while the wall to the right shows water streaks.*

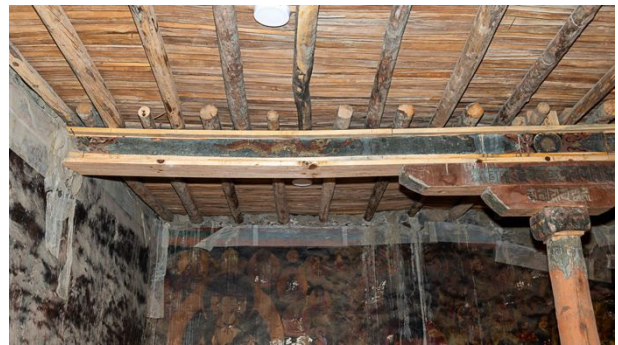
Figure 457: The broken beam after restoration.

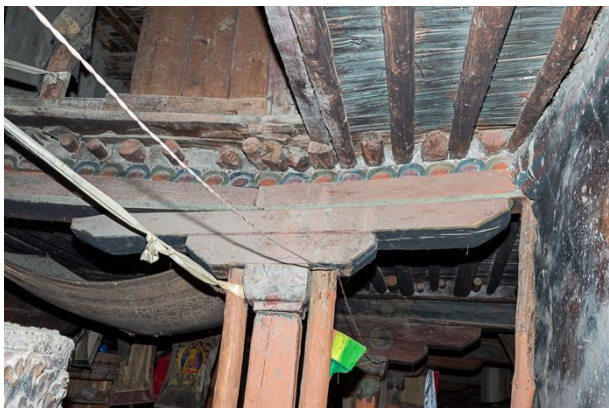
Figure 458: View of the distortion of the wooden structure due to the sagging of a pillar immediately in front of the main Buddha image.

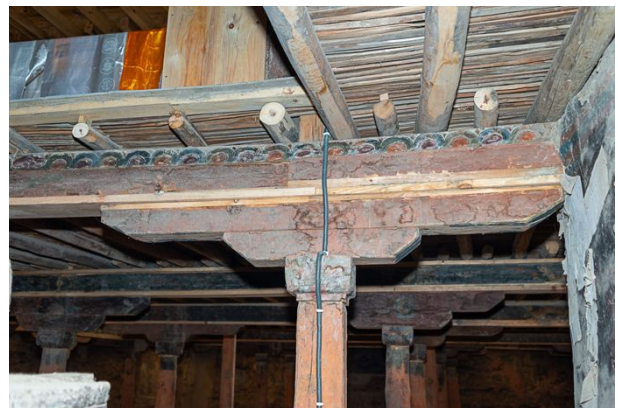
Figure 459: The same area after restoration with the beam above the capital levelled.

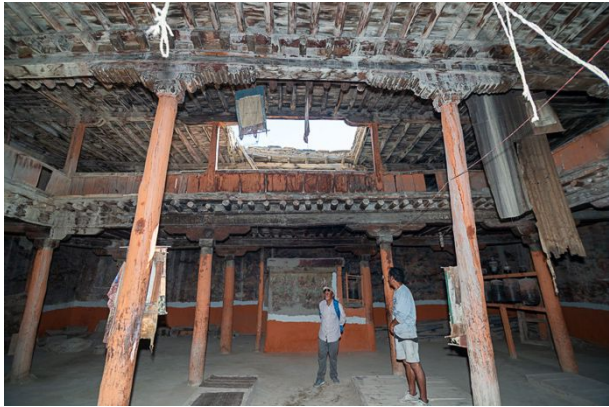
Figure 460: View of the entry area of the Assembly Hall with the railing and skylight above before restoration.

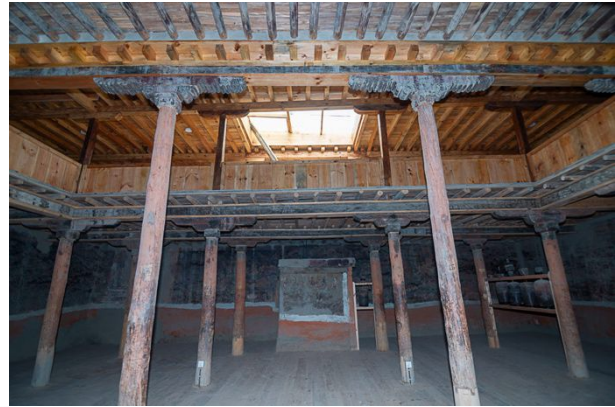
Figure 461: View of the same area after restoration.

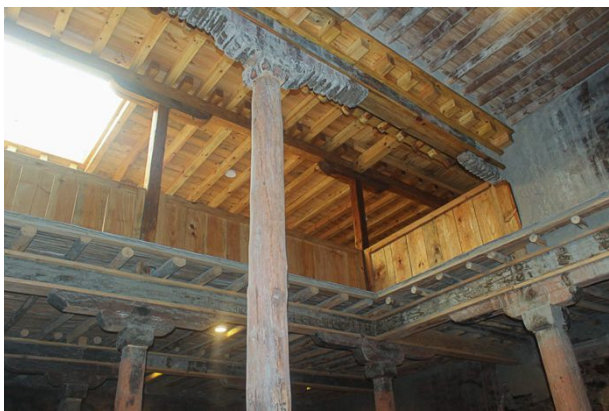
Figure 462: View from the Assembly Hall towards the upper floor after restoration.

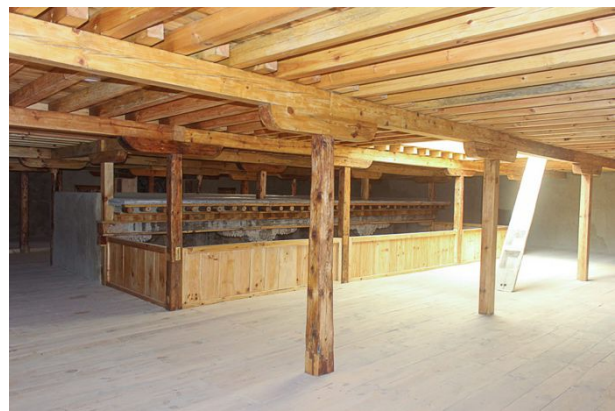
Figure 463: The same balcony corner as seen on the upper floor.

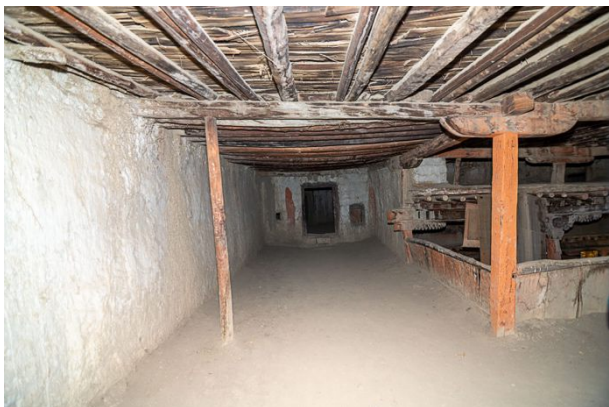
Figure 464: View from the entrance to the upper floor with an intermediate entrance.

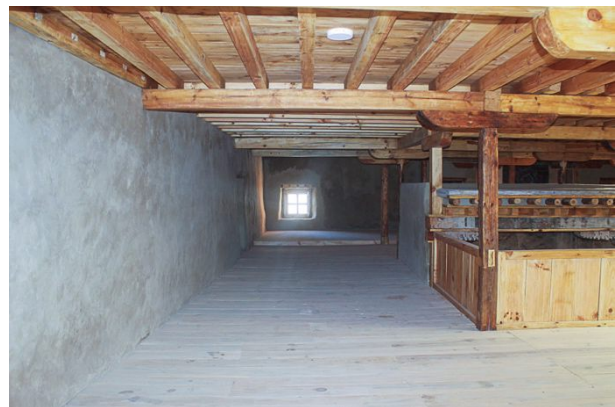
Figure 465: View from the entrance to the upper floor after restoration. The window in the back originally was a door leading to a later added and poorly constructed living room. This structure was removed at the very beginning of the restoration (see Demolition above).

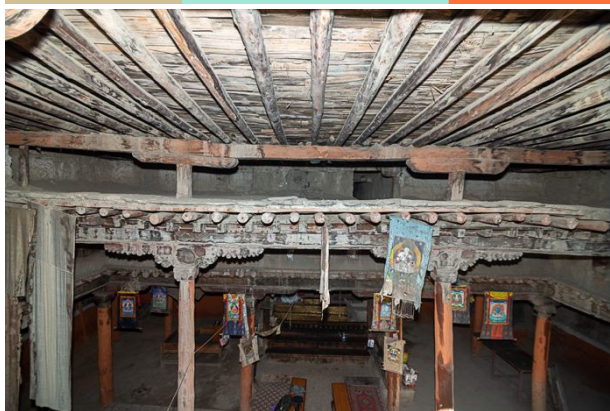
Figure 466: View from the upper floor into the Assembly Hall and towards the main image before restoration.

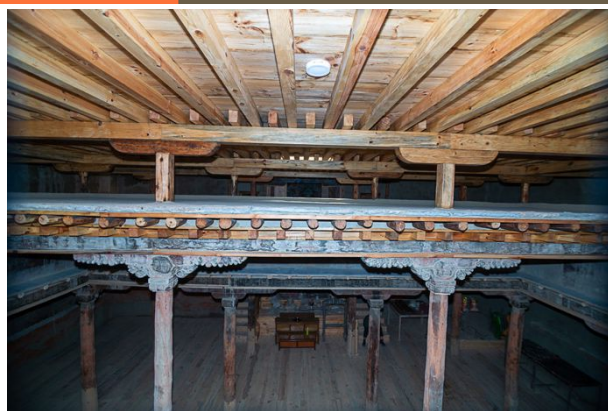
Figure 467: View from the upper floor into the Assembly Hall and towards the main image after restoration.

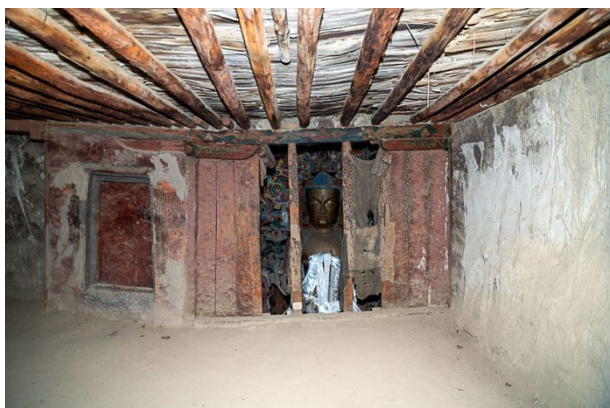
Figure 468: View of the area in front of the main image of Buddha Maitreya before restoration.

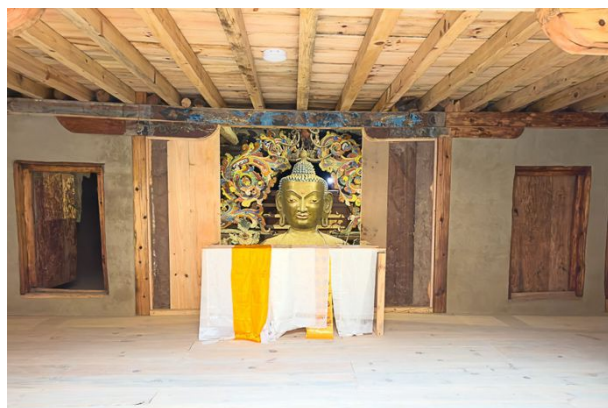
Figure 469: View of the area in front of the main image of Buddha Maitreya after restoration with the lighting on the Buddha image.

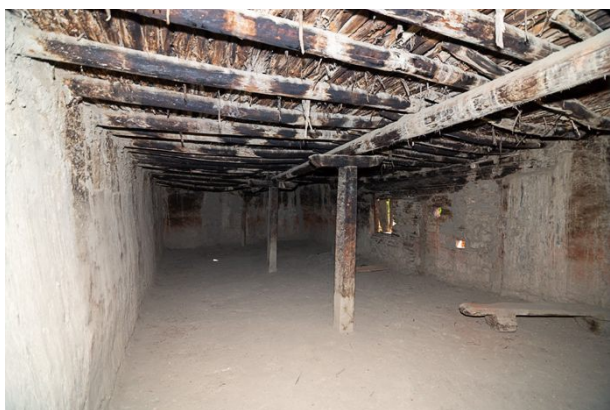
Figure 470: View of the balcony room before restoration.

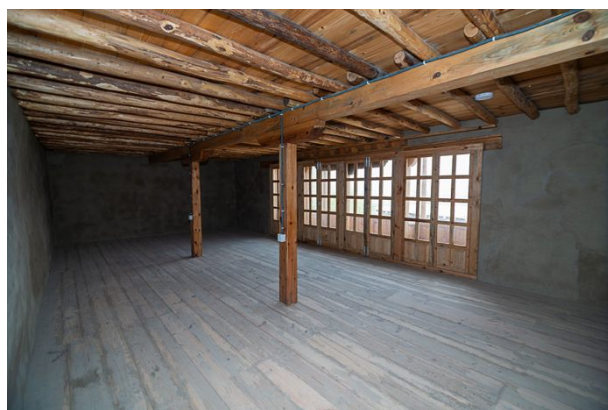
Figure 471: View of the balcony room after restoration.

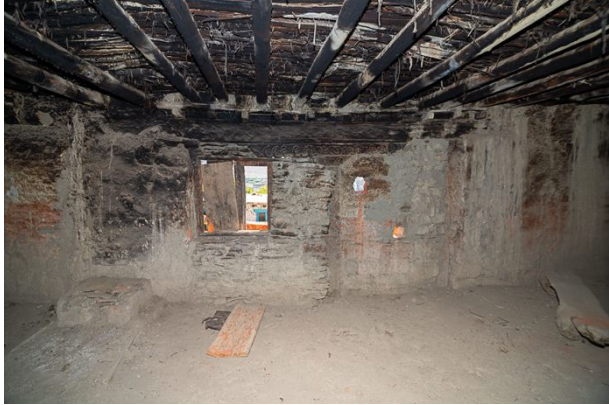
Figure 472: View of the balcony area before restoration, note the wooden members inside the wall.

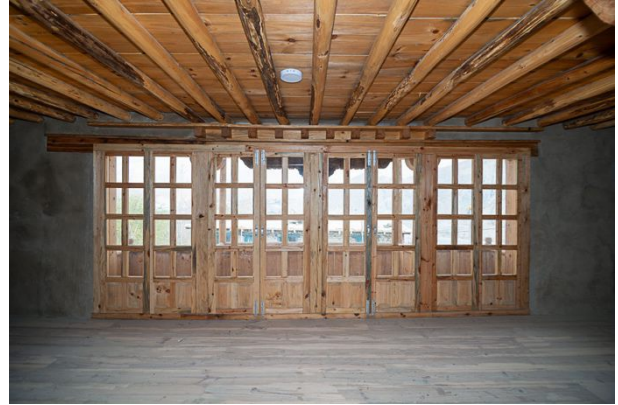
Figure 473: View of the balcony room after restoration, the centre capital is now outside the glass doors.

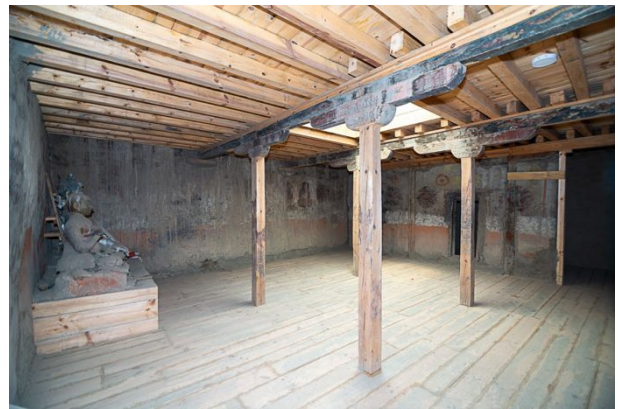
Figure 475: View of the painted room after restoration.
